# **Investigation and Analysis Report for Silver Lake Flat Dam**

## **Appendix D**

**MCMILLEN, LLC**

American Fork-Dry Creek Watershed  
Utah County, Utah

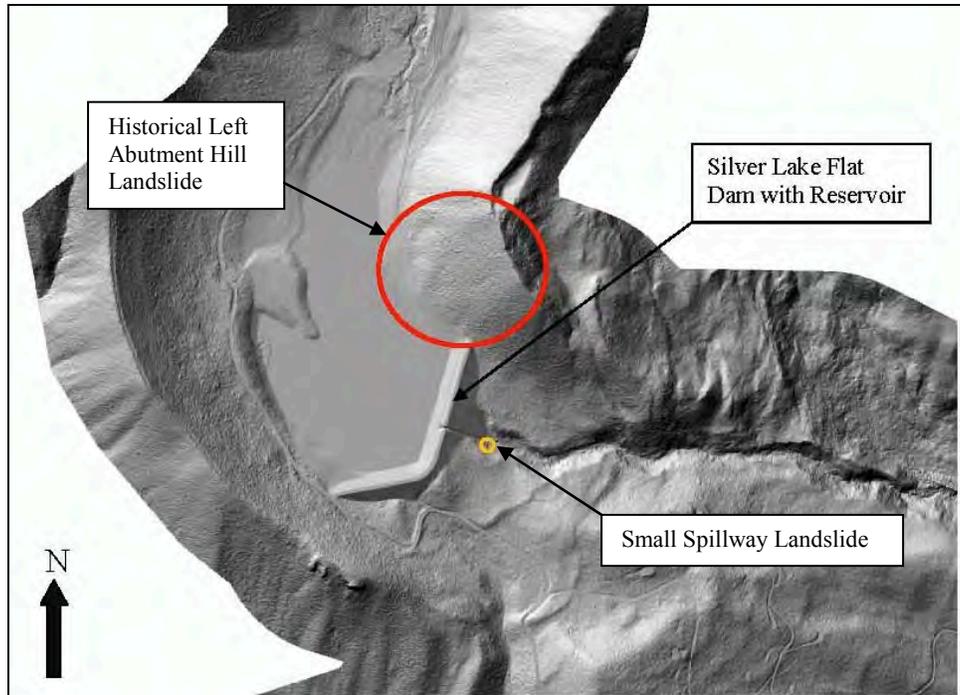
**Figure D-7. Landslides**

A historical landslide is located on the hill near the left abutment of the dam that probably predates the most recent glacial episode (NRCS 2012a). NRCS (1995) stated the evidence this unconsolidated material is landslide material is the presence of shale and limestone in the trenches dug. Additionally, it states there is no upstream source of shale and limestone and the rocks would not have survived in glacial transport; therefore, the left abutment is not totally of glacial origin (NRCS 1995). NRCS (1995) stated this area has no large vegetation, while to the southeast the trees and stumps show curvature (J-shape trunks) due to active soil creep processes. These J-shaped trees are located at the base of the hill just above the reservoir high water elevation. If this landslide does predate the most recent glacial episode then this glacial event would remove geomorphic evidence of the ancient landslide. The LiDAR depicted in Figure D-7 (NRCS 2012a) demonstrates the continuity of the hill with no evidence of an active landslide; however, the hillslope has abundant soil creep as do many slopes in the region. If the left abutment hill were to fail, it has the potential to affect the reservoir and dam. However, the hill has experienced three to four events in the last 6,000 years that could have triggered this left abutment hill to fail. This hill did not fail during these seismic events during the last 6,000 years and suggests the left abutment hill is most likely stable (NRCS 2012a).

A small landslide has been documented near the existing spillway on the right side. This landslide is associated with an area of active seep and should be mitigated during the proposed rehabilitation by collecting the seepage and discharging the seepage into the new stilling basin. A small slide occurred at this location in 1984 and partially filled the spillway. This event was noted to be relatively minor, did not impact the integrity of the spillway and was not of dam safety concern (NRCS 2012a).

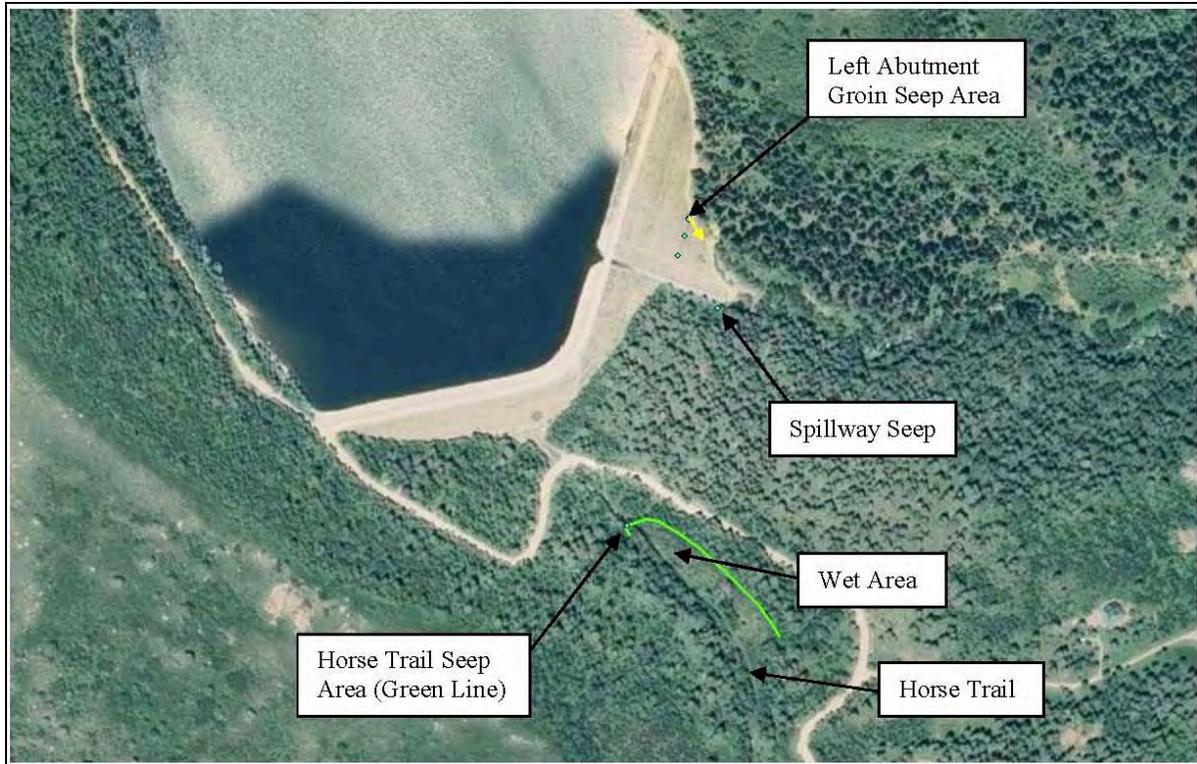
**Figure D-8. Groundwater Springs and Seeps**

Examination of data from the piezometers, historic water levels recorded during drilling, and observations of the seeps downslope of the embankment indicate that the embankment is mostly dry while water is occurring in the foundation. However, several springs and seeps have been documented at and near the dam embankment as shown in Figure D-8 (NRCS 2012a):

- **Groin Seep:** Seepage has been documented in the left downstream groin of the dam off of the embankment. This seep is active during normal to wetter precipitation years and not visible in dry years. Only clear water has been noted flowing from this seep.

- **Spillway Seep:** Seepage has been documented on the southern side of the spillway near the stilling basin. This seepage is associated with a small landslide area and water has been noted to spill over the concrete walls into the spillway. This seep is active during normal to wetter precipitation years. Only clear water has been noted flowing from this seep.

- **Horse Trail Seep:** Seepage has been documented approximately 300 feet downstream of the right embankment of the dam. This seepage crosses underneath the access road and daylight into wetland area. Flowing water is present year-round with higher volumes when the reservoir is at high levels. Only clear water has been noted in the flows.

These seeps and springs indicate that water is seeping through the foundation of the dam below the cutoff wall. The conveyance route for this water may occur in sand and gravel in the glacial moraine material or the Horse Trail Seep may be following relict fluvial deposits. A review of all the data suggests the presence of two distinct and separate aquifers at the dam site: a shallow perched aquifer, and a deep and confined aquifer.

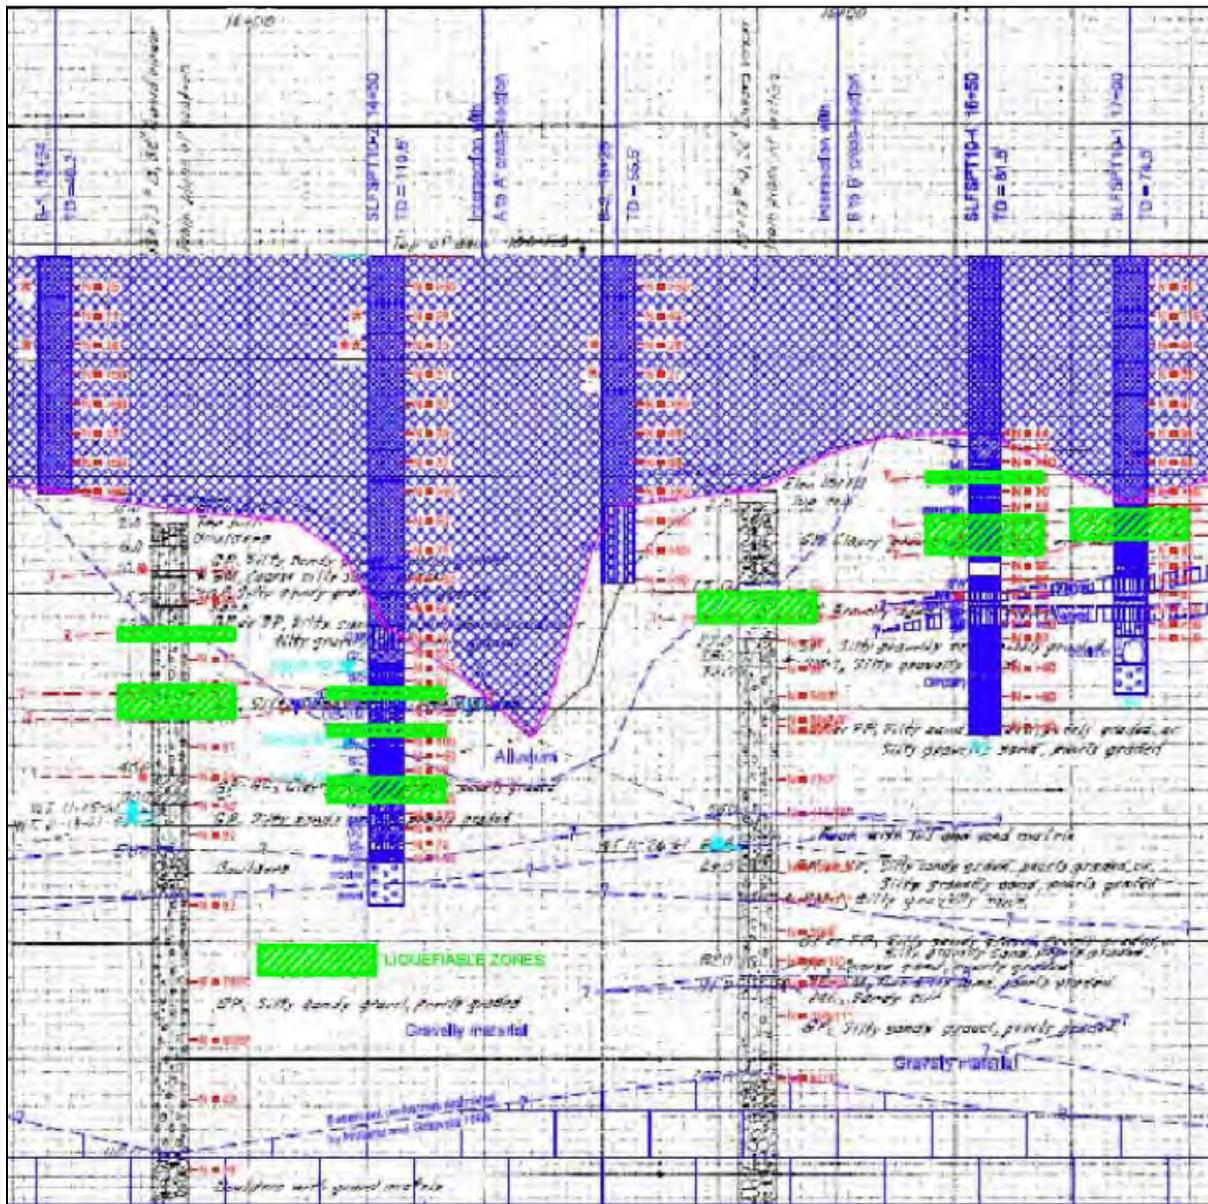
Figure D-11. Liquefaction Zones

The zones of liquefaction from the above analyses were plotted on the geologic cross-section at the centerline of the dam. A portion of the geologic section with the plotted liquefaction zones is shown in Figure D-11. From this figure it can be seen that generally a zone is found in the upper portion of the foundation, and liquefiable zones occur in the upper half of the alluvial foundation as well. Due to the depositional nature of the foundation, these areas are most likely thinly bedded and not continuous. For the purpose of analysis it was conservatively assumed that pocketed zones 15 feet thick, covering 50% of the length in the upper portion and the alluvial section of the foundation are liquefiable.

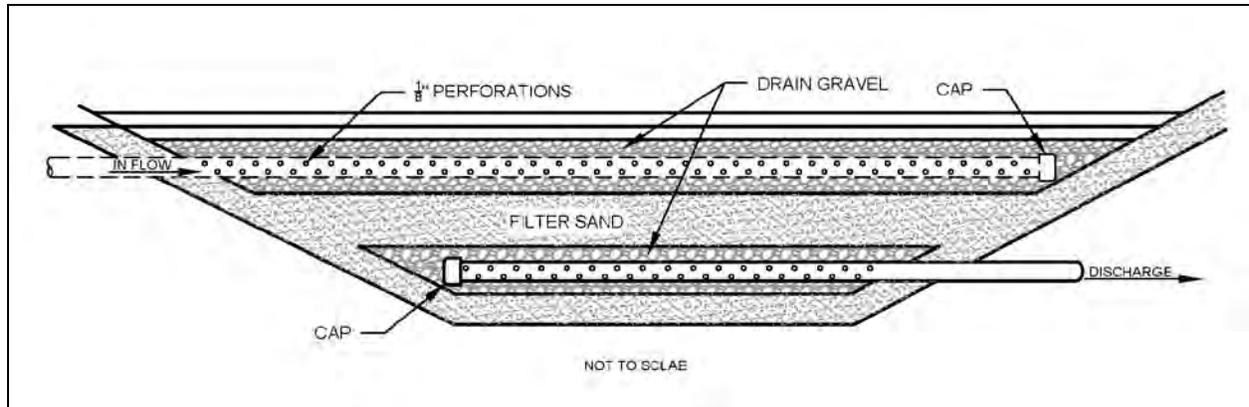
**Figure D-12. Drain Isolated Filter System**

It was initially recommended by UDWR that the existing toe drain system be abandoned and replaced with an appropriately design system. This would involve grouting off the collection and discharge pipes. Due to the isolation of the existing granular drains by the grouting work, the relatively acceptable materials in the existing granular drain trenches could be left safely beneath the embankment. The existing drain system is considered to be acceptable and does not need to be replaced.

It is recommended, however, that an isolated filter system be placed at the discharge ends of the left toe drain to collect seepage and filter all seepage prior to discharge (Figure D-12). The isolated collection systems should be monitored with a piezometer to provide information as to any blockage that may occur. This provision would allow for continued drainage and provide information of potential internal deterioration in the existing drains, precluding excessive internal erosion. In addition, it is recommended that a filter envelope be placed over the end of the right drain discharge pipes and around the end of the extended outlet conduit. Due to the isolated collection system at the end of the left toe drain discharge pipe, no filter envelope will be needed there.

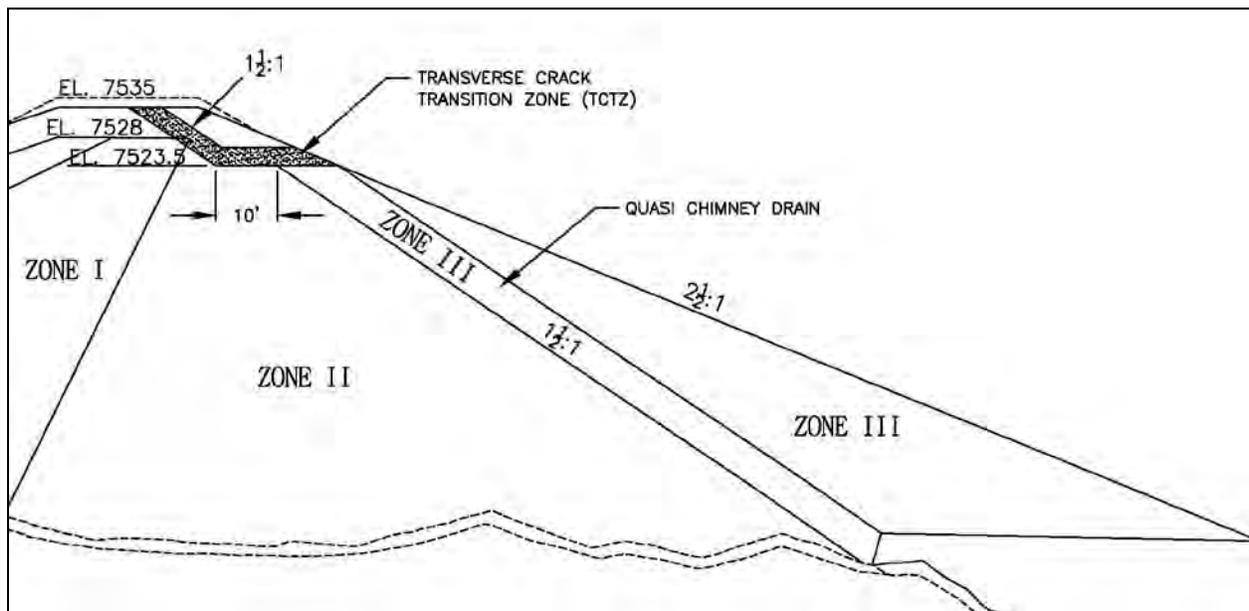
Figure D-13. Transverse Crack Transition Zone

Transverse cracking within the embankment due to an earthquake is possible. The severity of transverse cracking due to an earthquake is heavily dependent upon the deformation of the embankment caused by the earthquake ground motions. An embankment provision is recommended for slope stability and deformation purposes, including that the sloping downstream berm at the maximum section be implemented. With this provision, the depth of the potential cracking is expected to be about 6 feet deep. In addition, the steepness of the right abutment at the spillway will likely result in the specific location of potential transverse cracking. As such, a Transverse Crack Transition Zone (TCTZ) is recommended, to be constructed at the right abutment of the maximum section, in the area of the existing spillway, and extending 300 feet from station 13+50 to 16+50. The transition zone would extend into the embankment to a depth of 10 feet and tie into the quasi filter/chimney drain as shown on Figure D-13.
