# The Impacts of 2011 Induced Levee Breaches on Agricultural Lands of Mississippi River Valley

- By Kenneth R. Olson, Professor of Soil Science, NRES, ACES, UIUC and Lois Wright Morton, Professor of Sociology

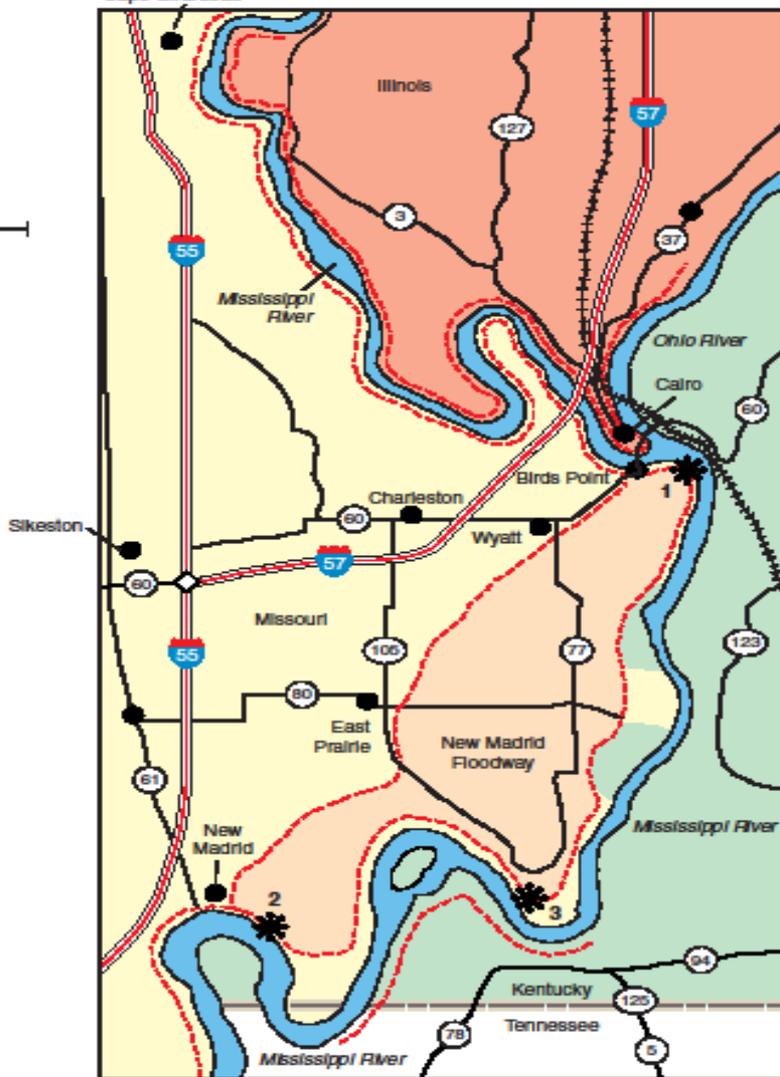
- The New Madrid Floodway was built in 1928 after the Great Flood of 1927. The land area is bottomland and part of a natural levee system created by the Mississippi River overflowing its banks.
- The New Madrid Floodway covers 133,000 ac and is surrounded by levees. The area is between 4 and 10 miles wide and between 33 and 36 miles in length. The Floodway is totally in Missouri.

| Levee blown up in 3 places | Illinois |

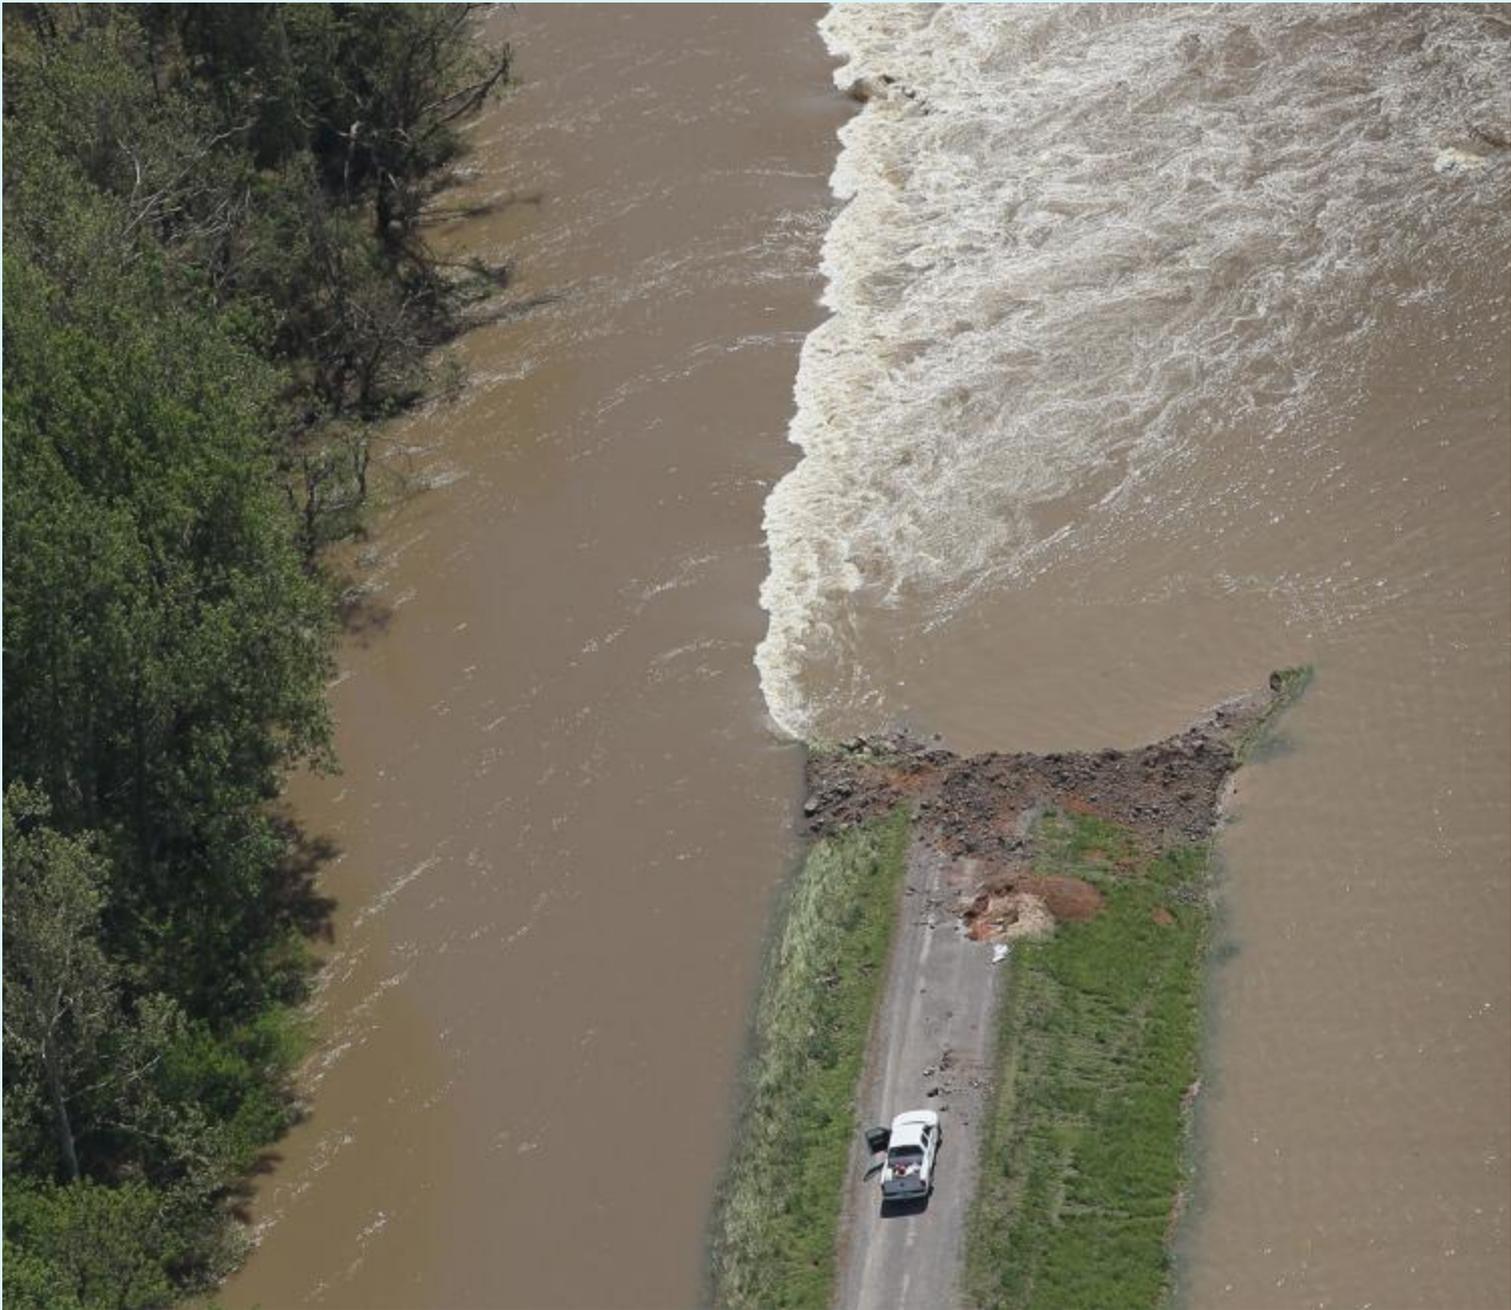
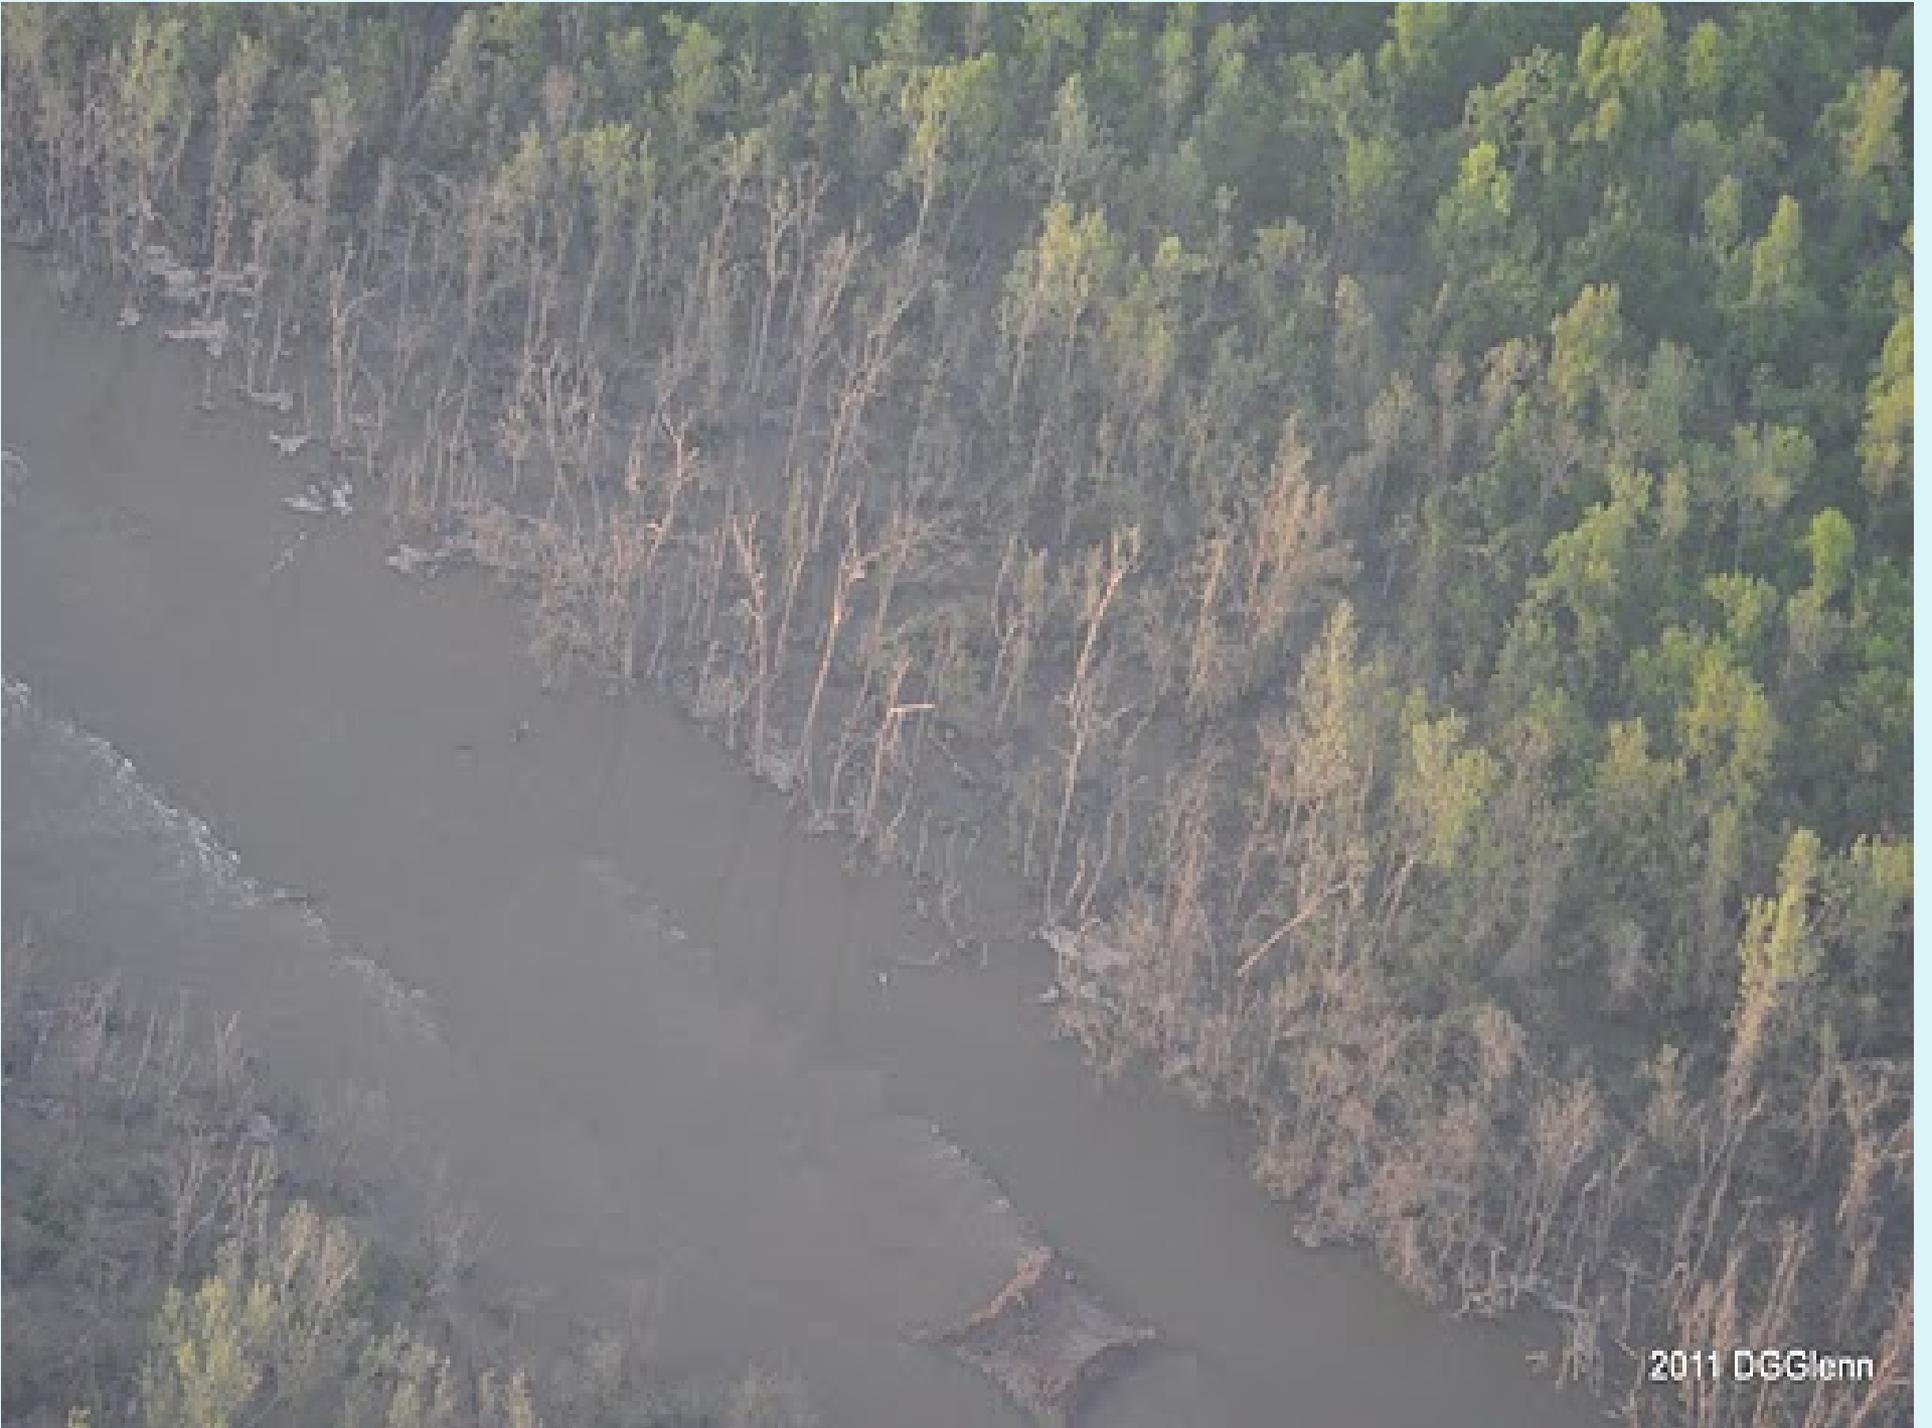
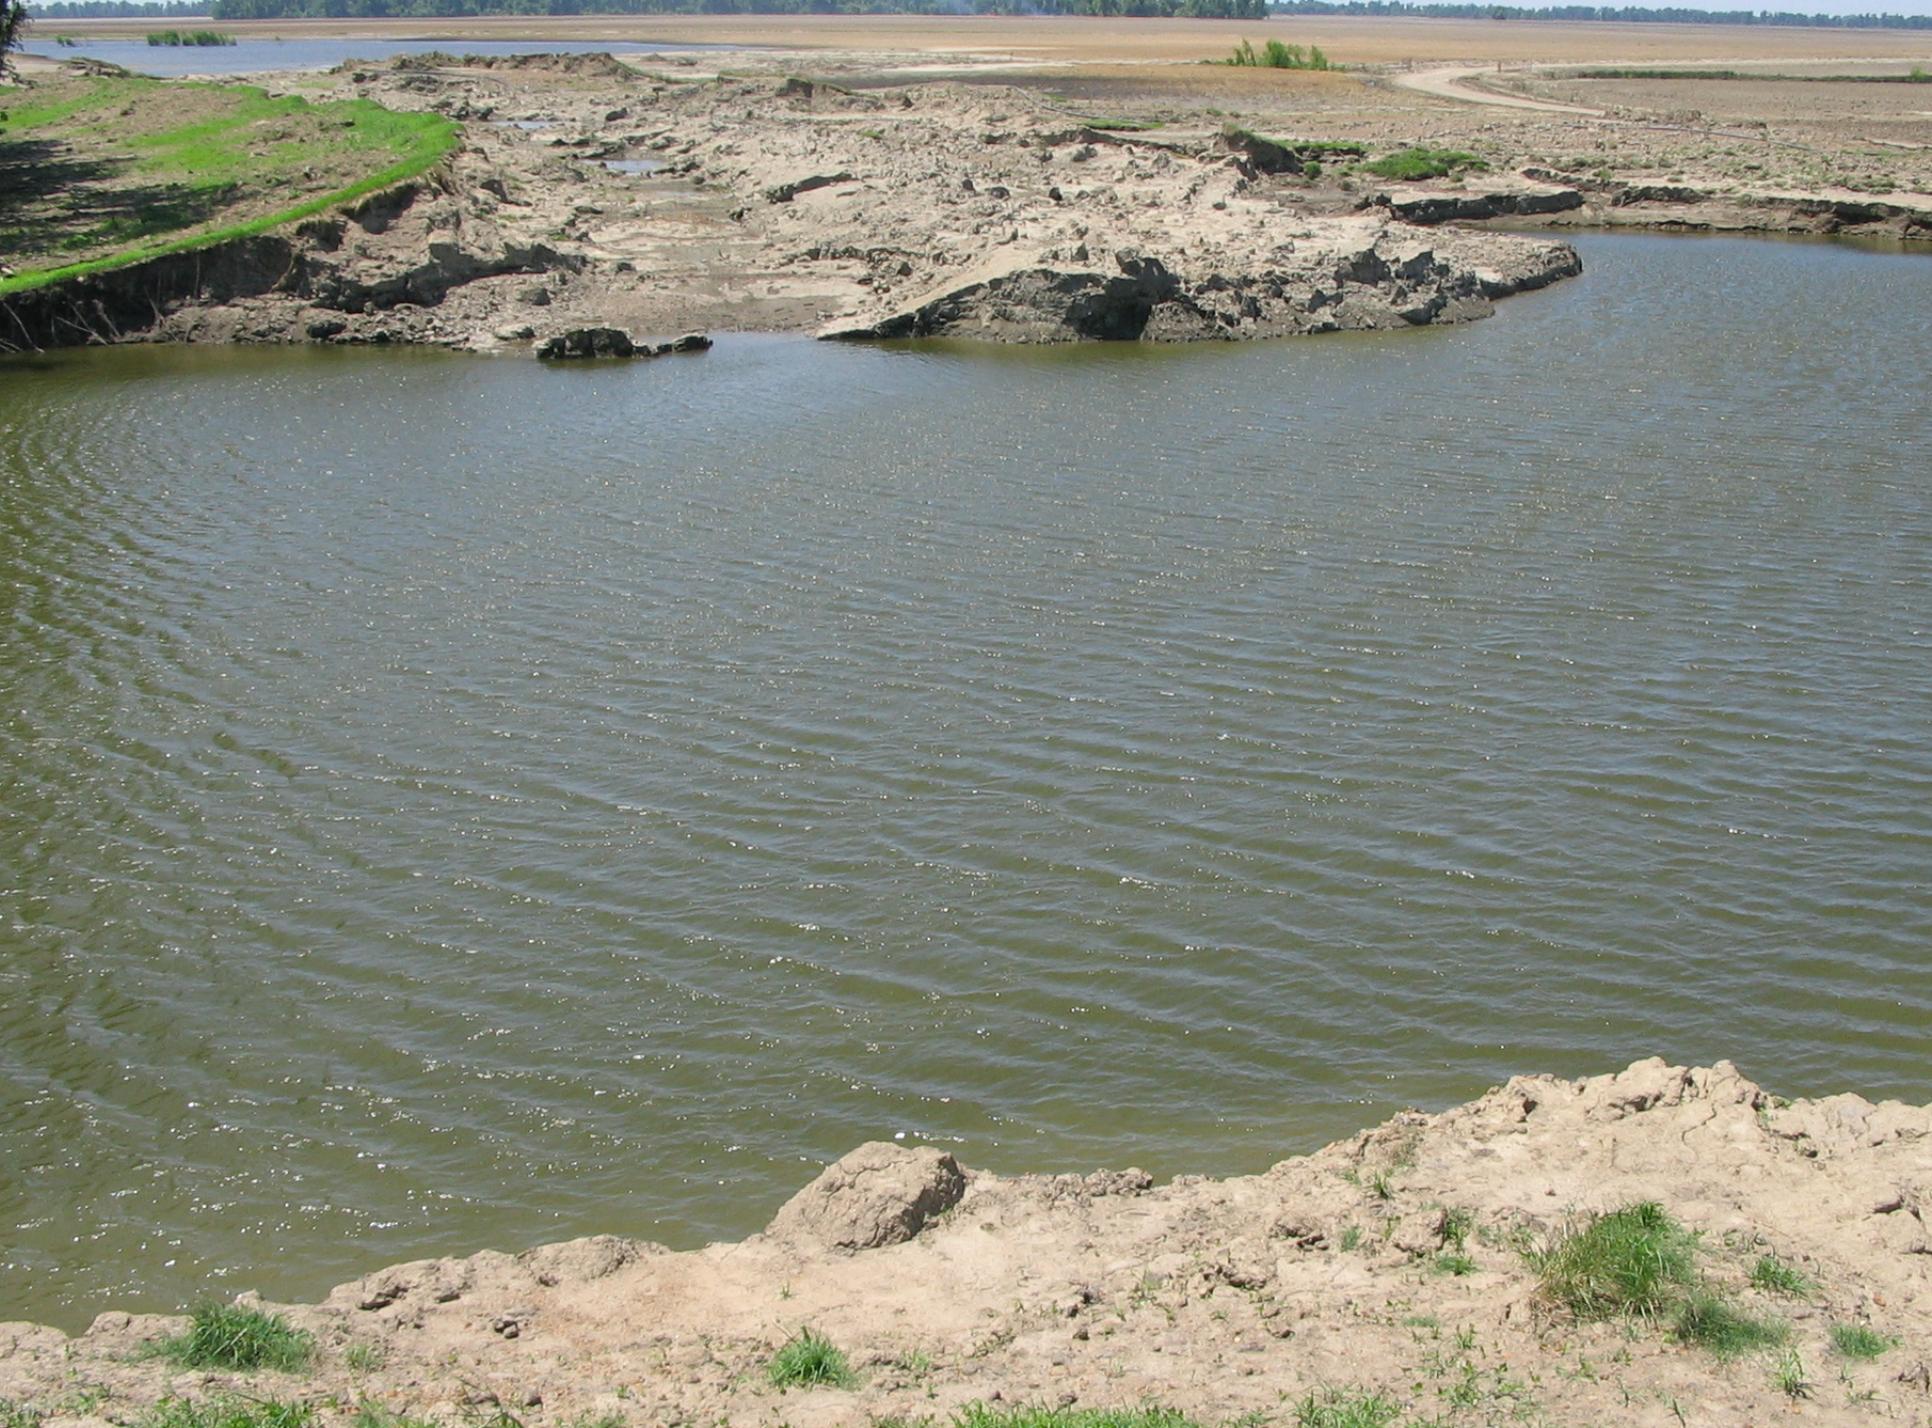
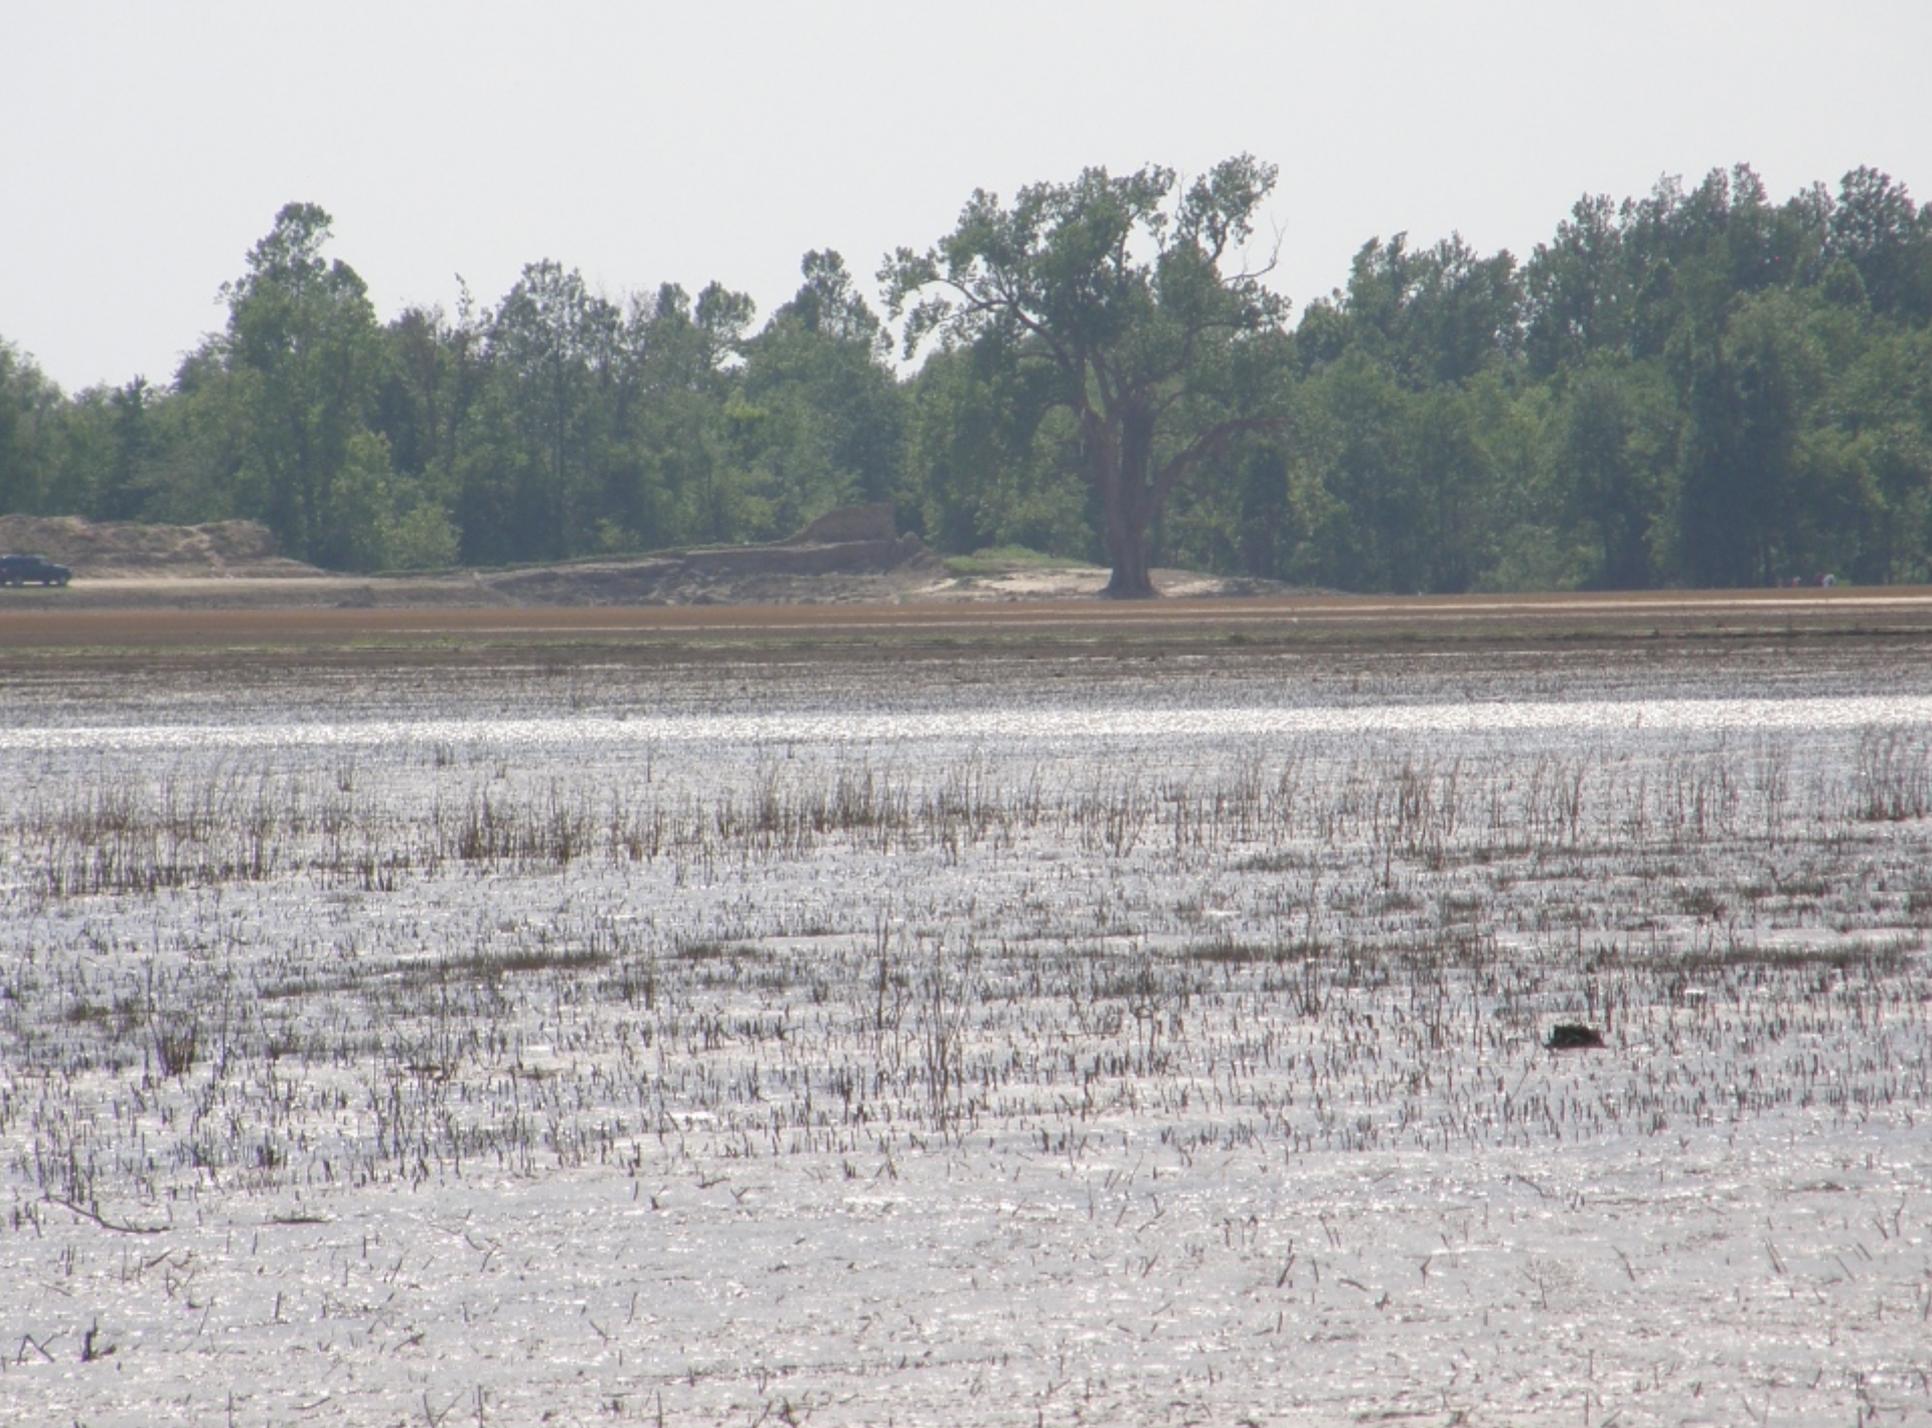
# Flooding of the New Madrid Floodway

- The Mississippi River went from 61.72 ft to 59 ft and dropping in 48 hours. Flood levels in Paducah, KY on the Ohio River dropped 3 ft and the Mississippi River at Cape Girardeau, MO dropped 1.9 ft in the same time period.

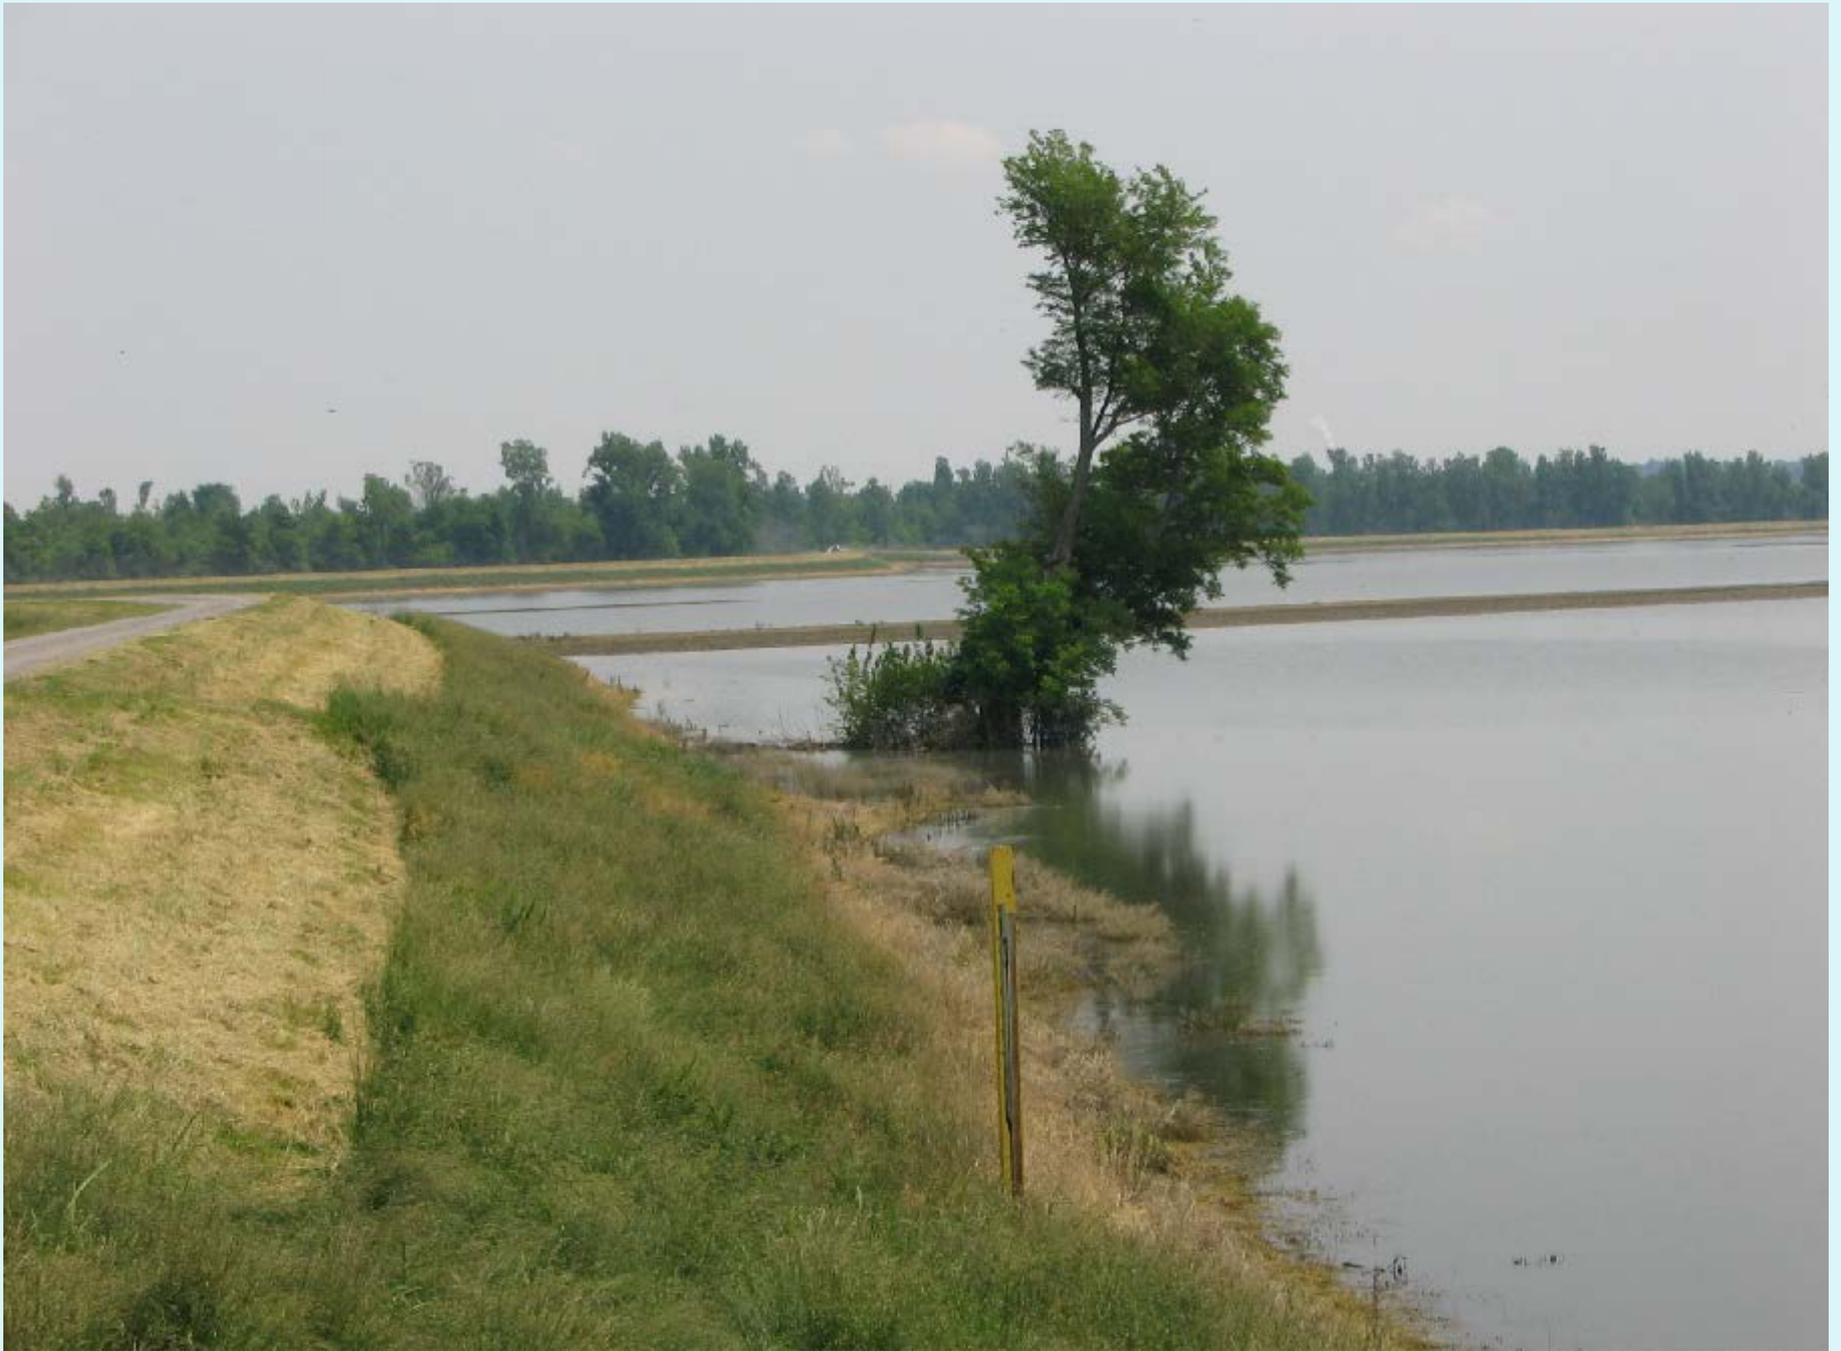
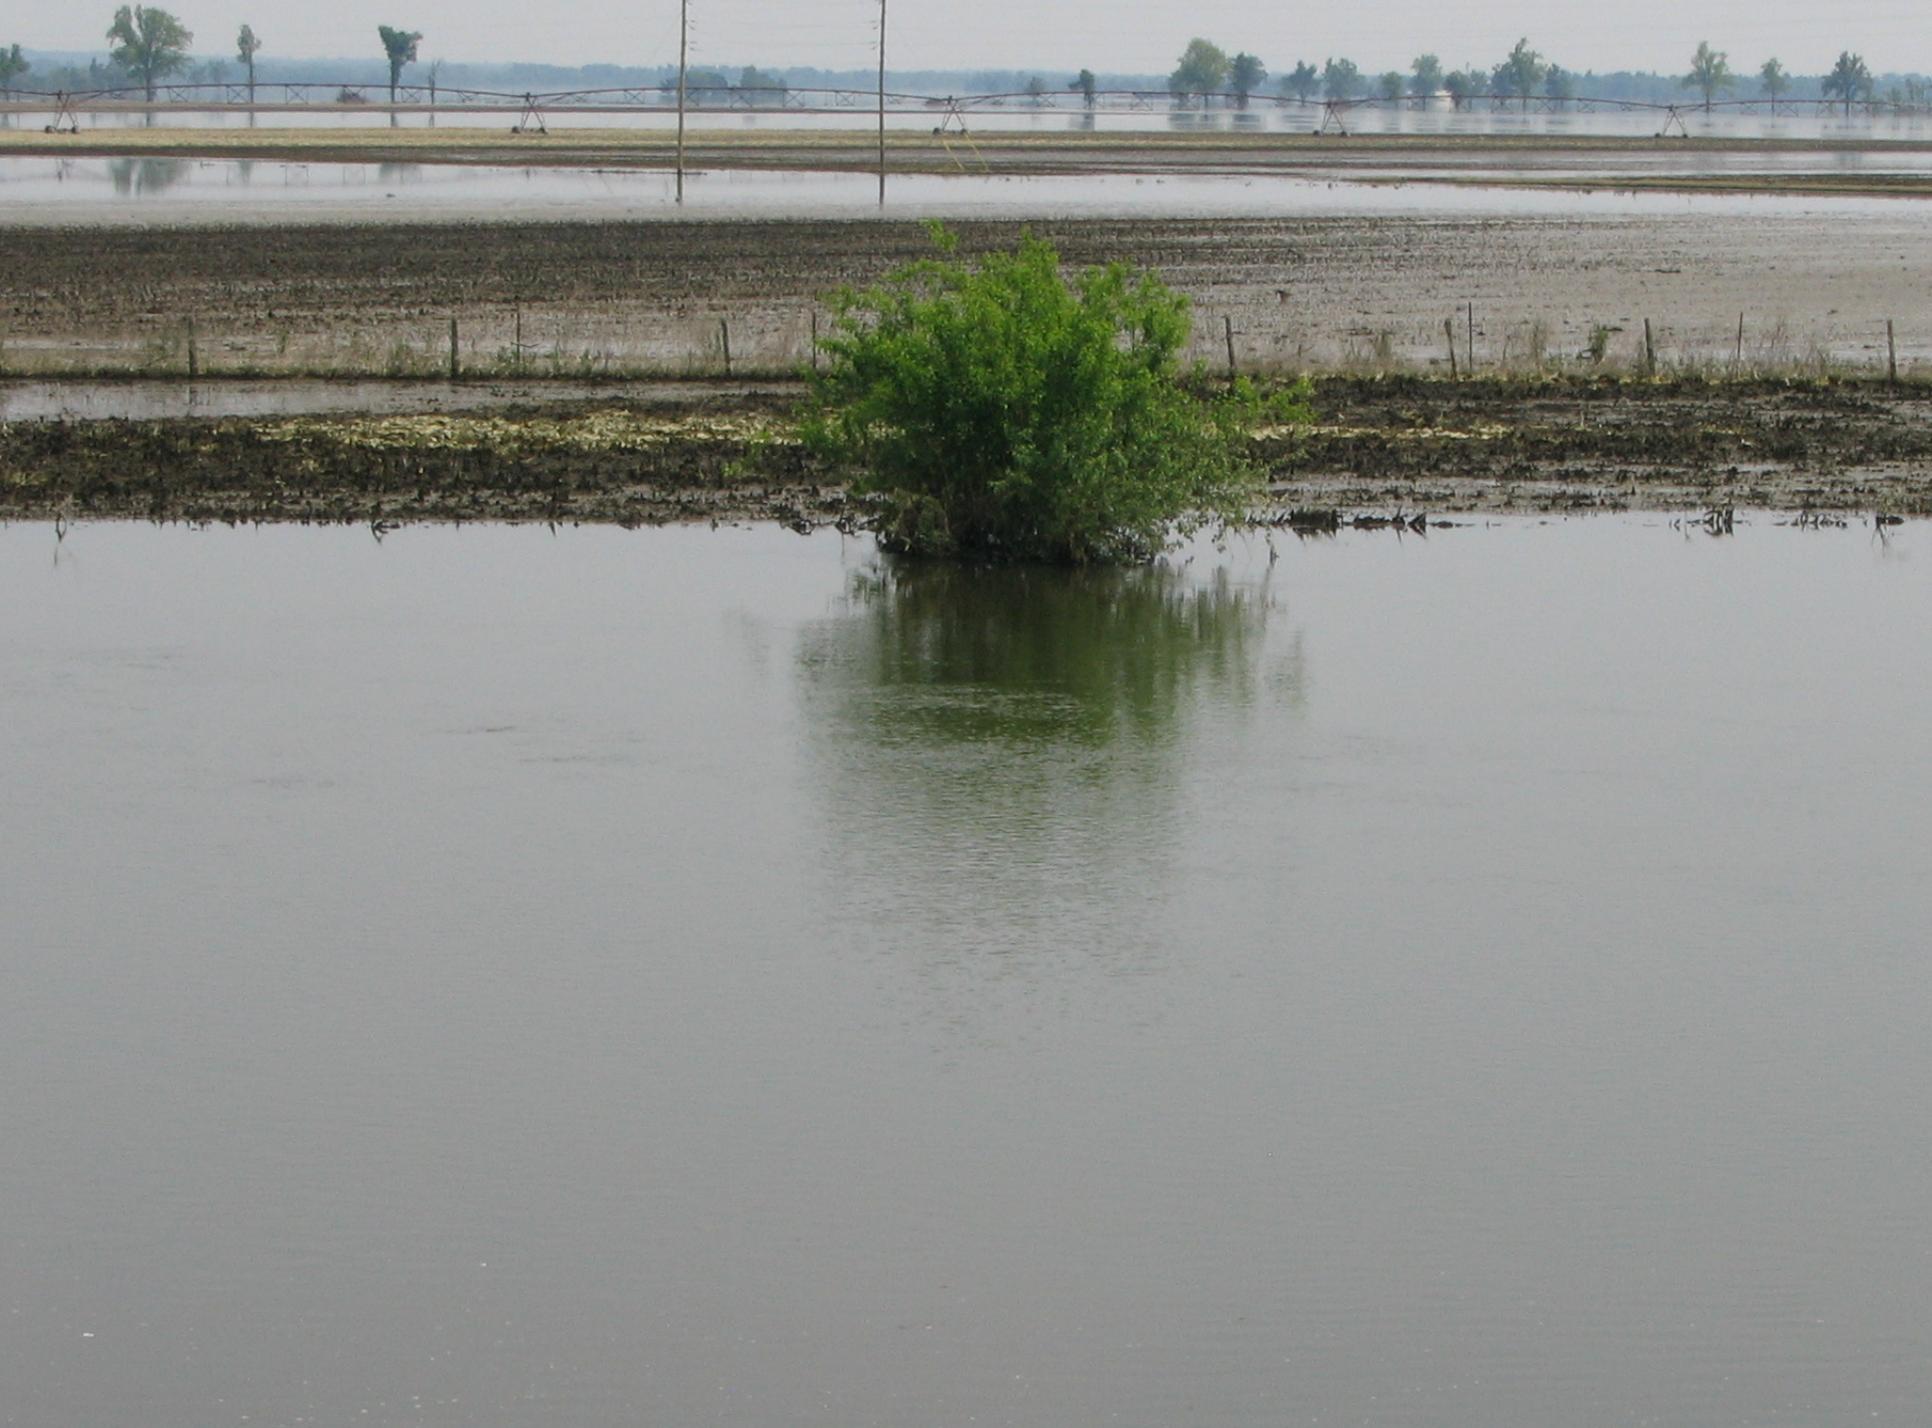
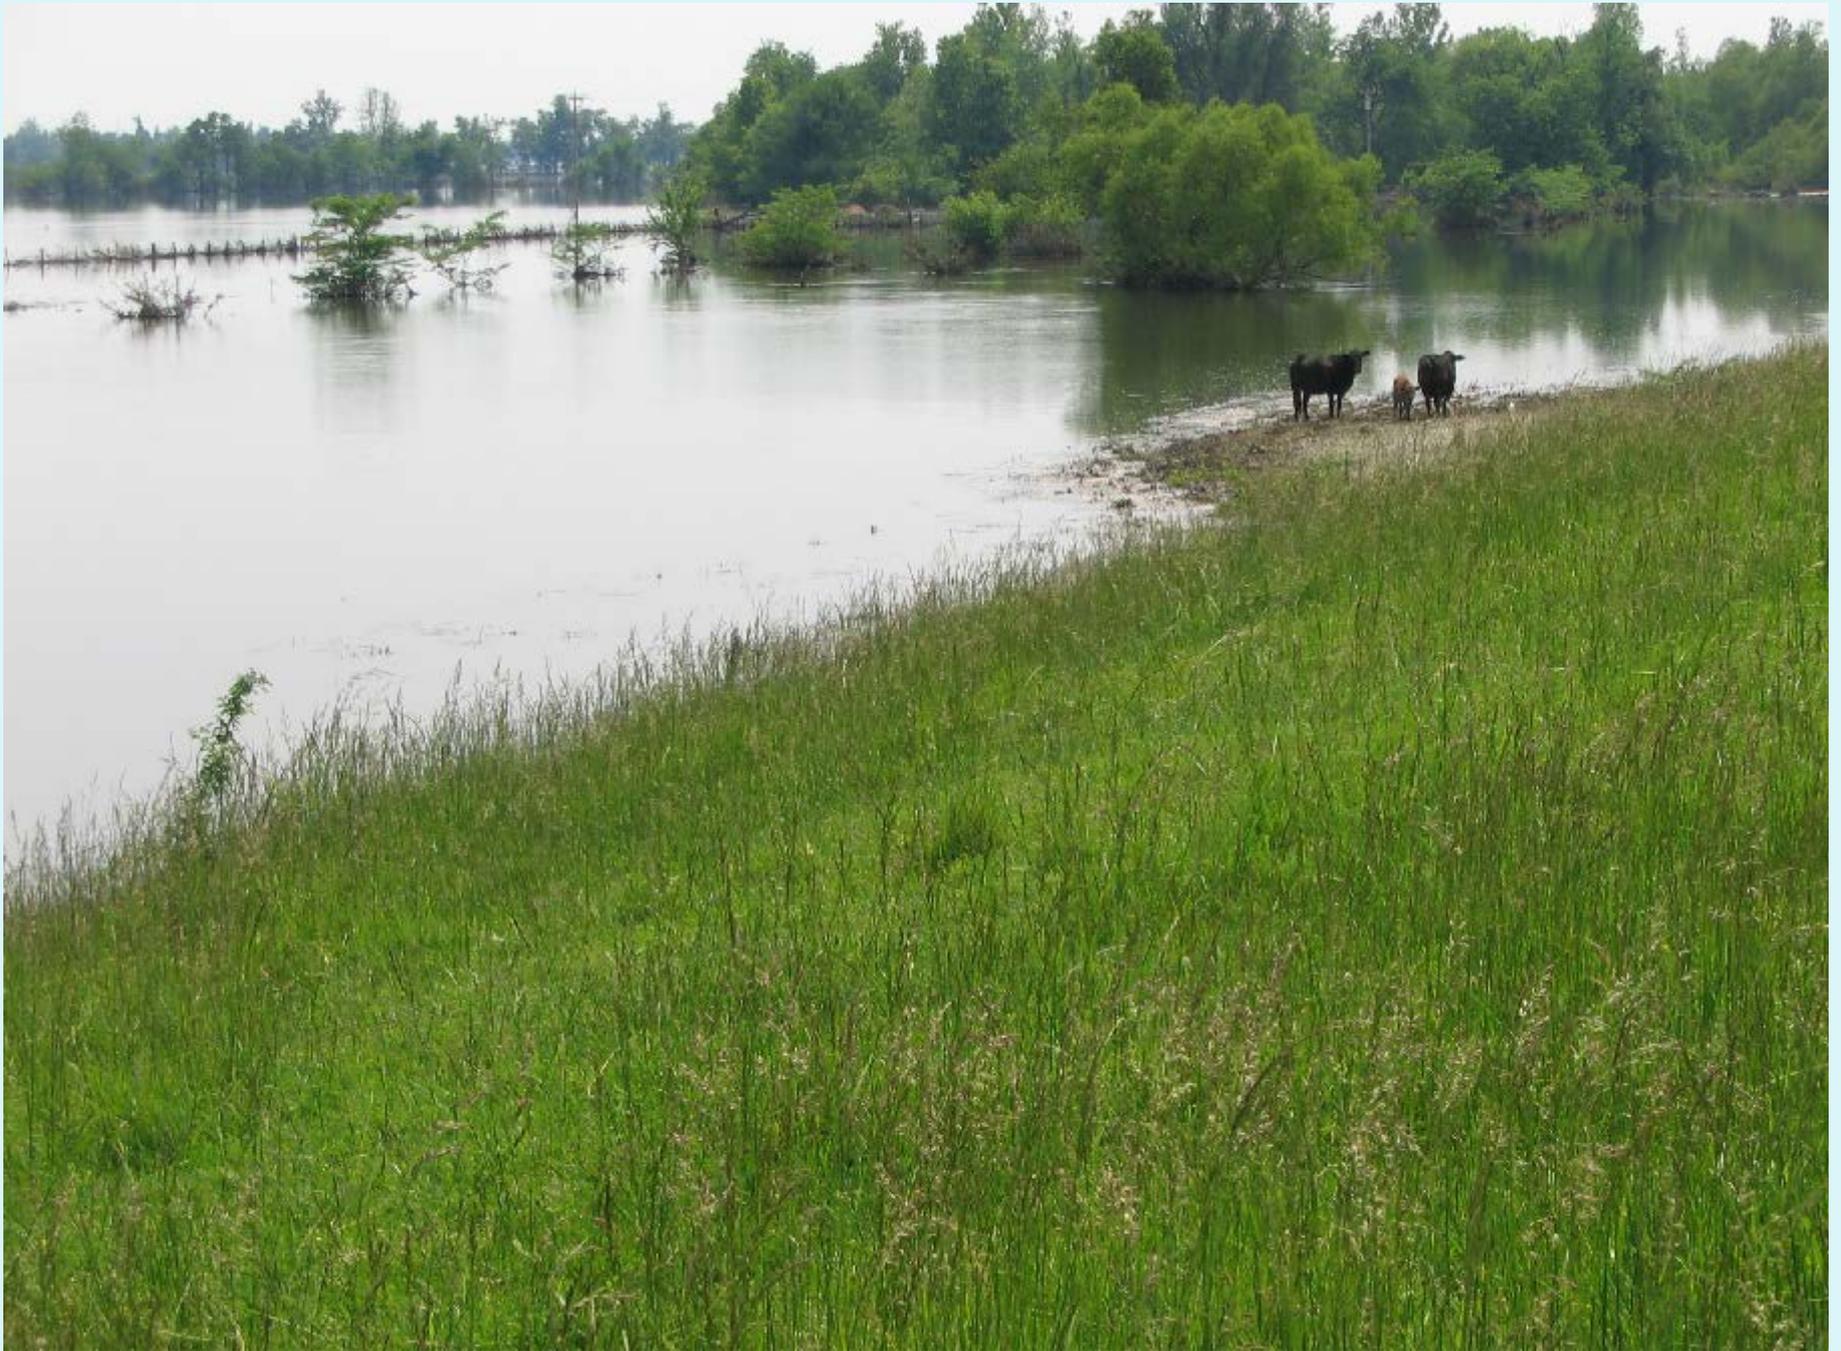
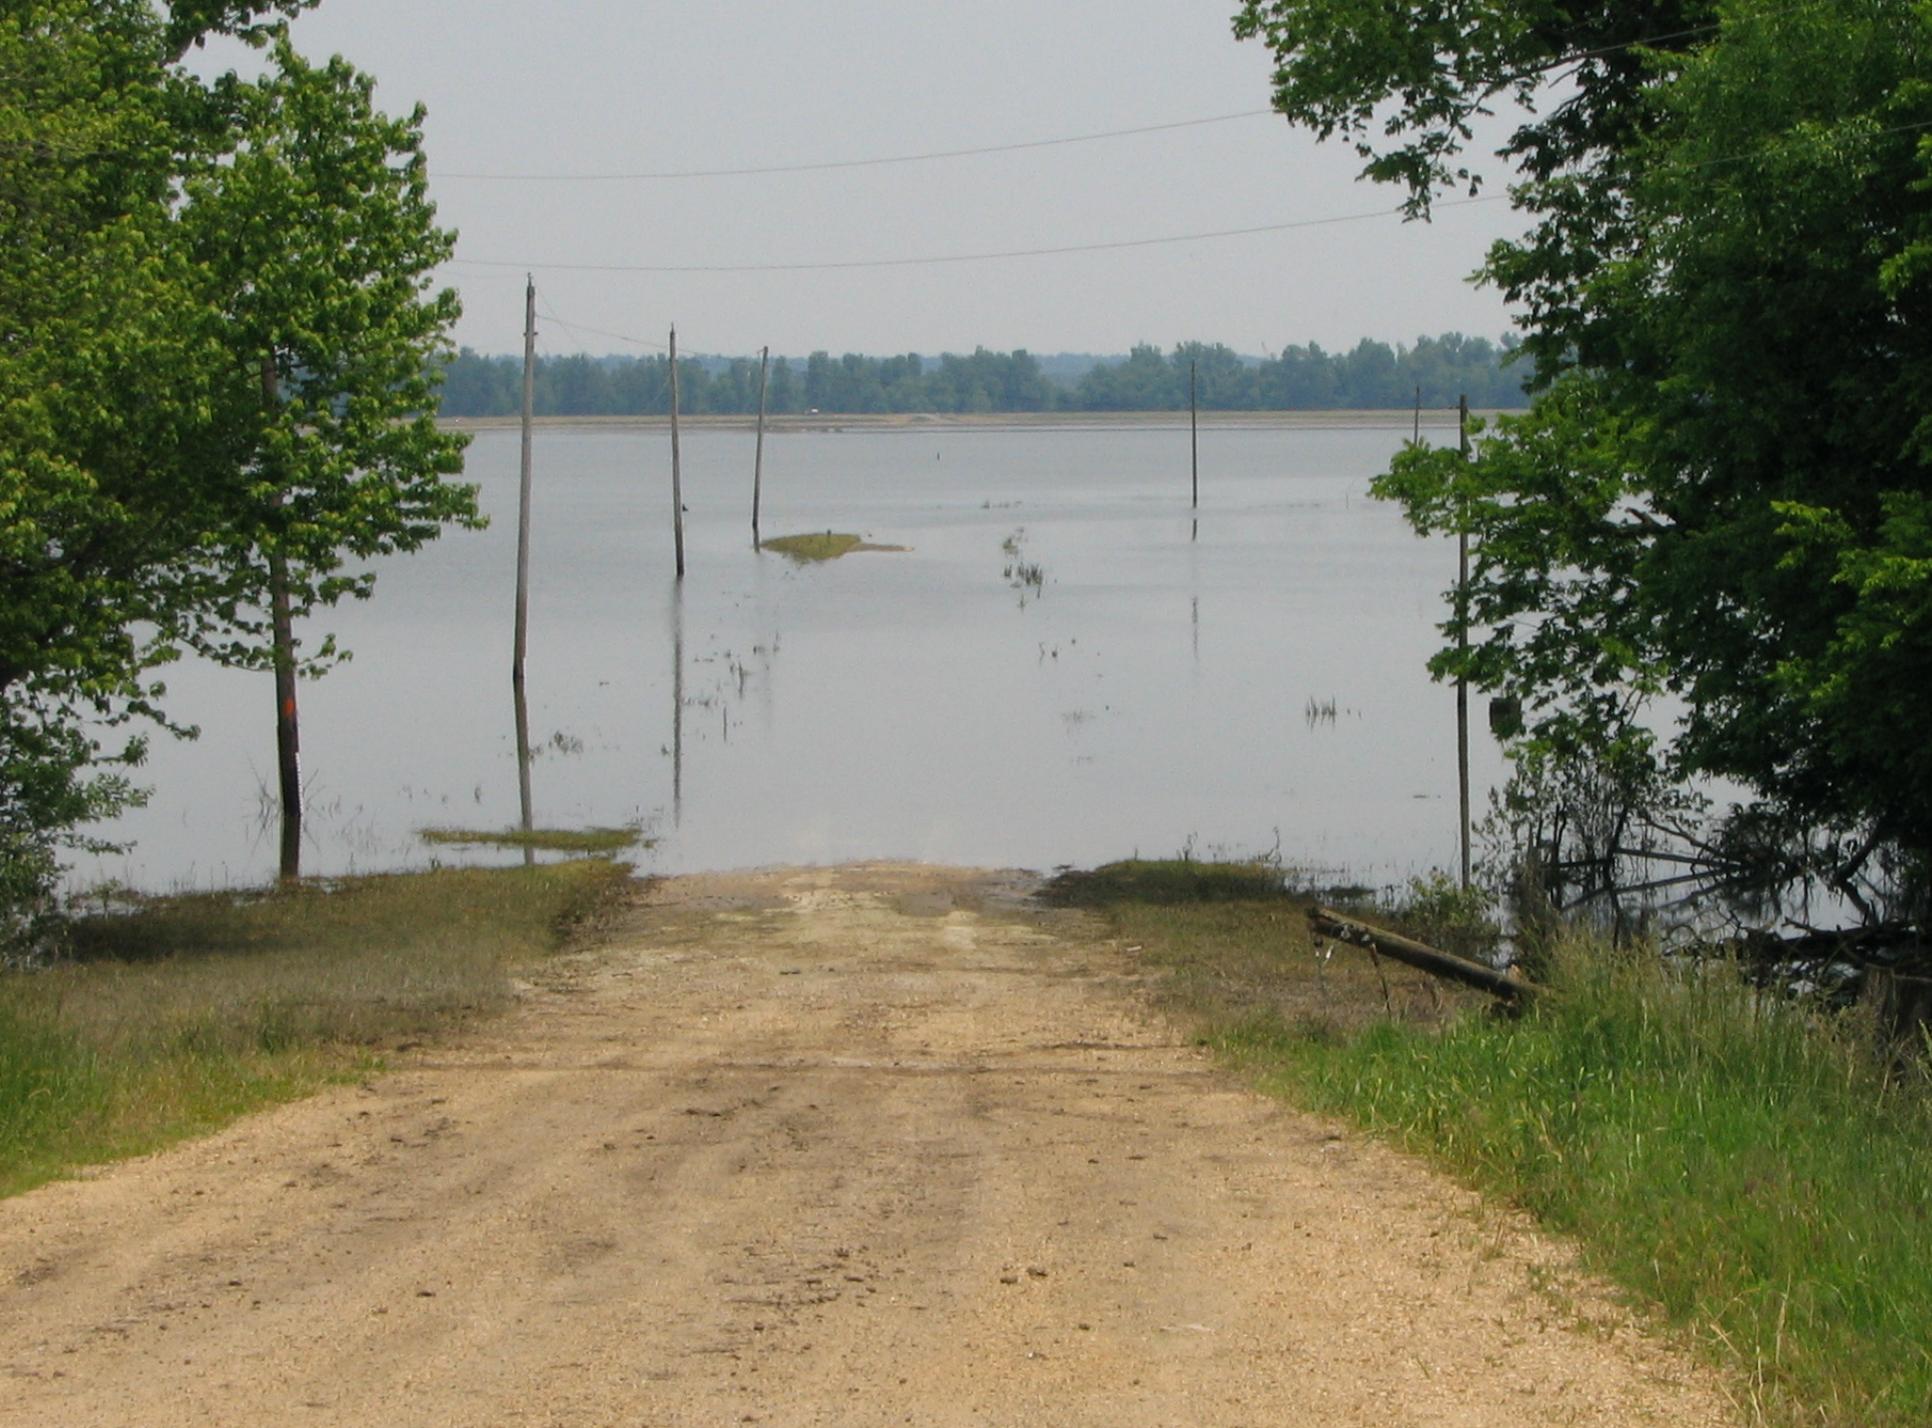
- Six crater lakes were created in agricultural land near the Birds Point and 1.2 miles of the fuse plug and front line levee.
- More than 200 structures, including grain bins, barns, sheds, silos, and residences were damaged by the 10 ft deep water as it entered and surrounded the structures.
- Irrigation equipment was turned over and destroyed.

- The fuse plugs and frontline levee need to be repaired
- The crater lakes filled in.
- The gully fields reclaimed.
