# The Impacts of 2011 Induced Levee Breaches on Agricultural Lands of Mississippi River Valley

- By Kenneth R. Olson, Professor of Soil Science, NRES, ACES, UIUC and Lois Wright Morton, Professor of Sociology

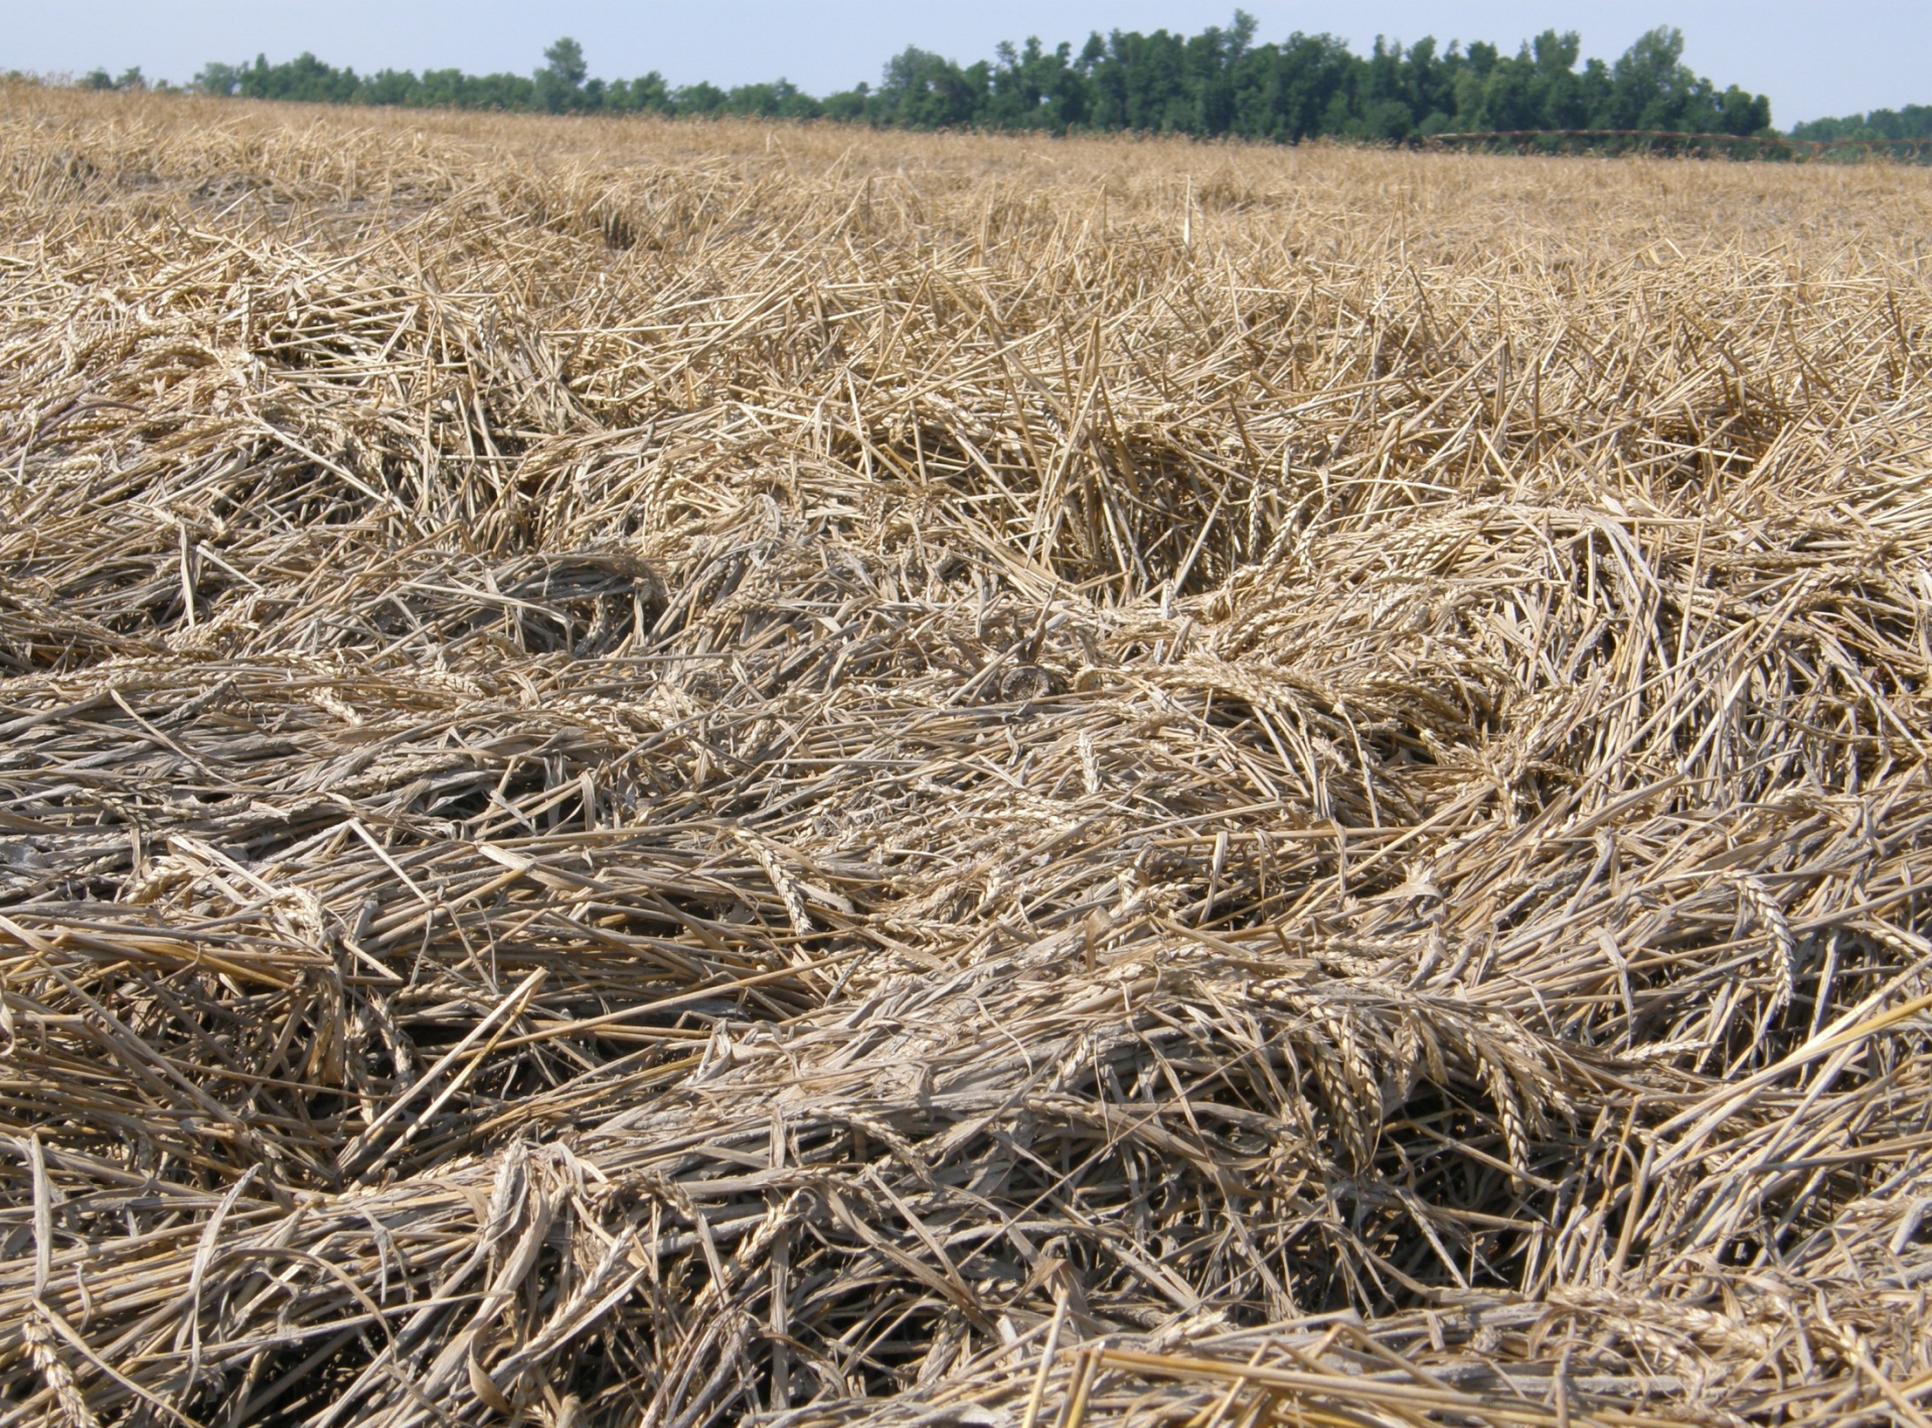
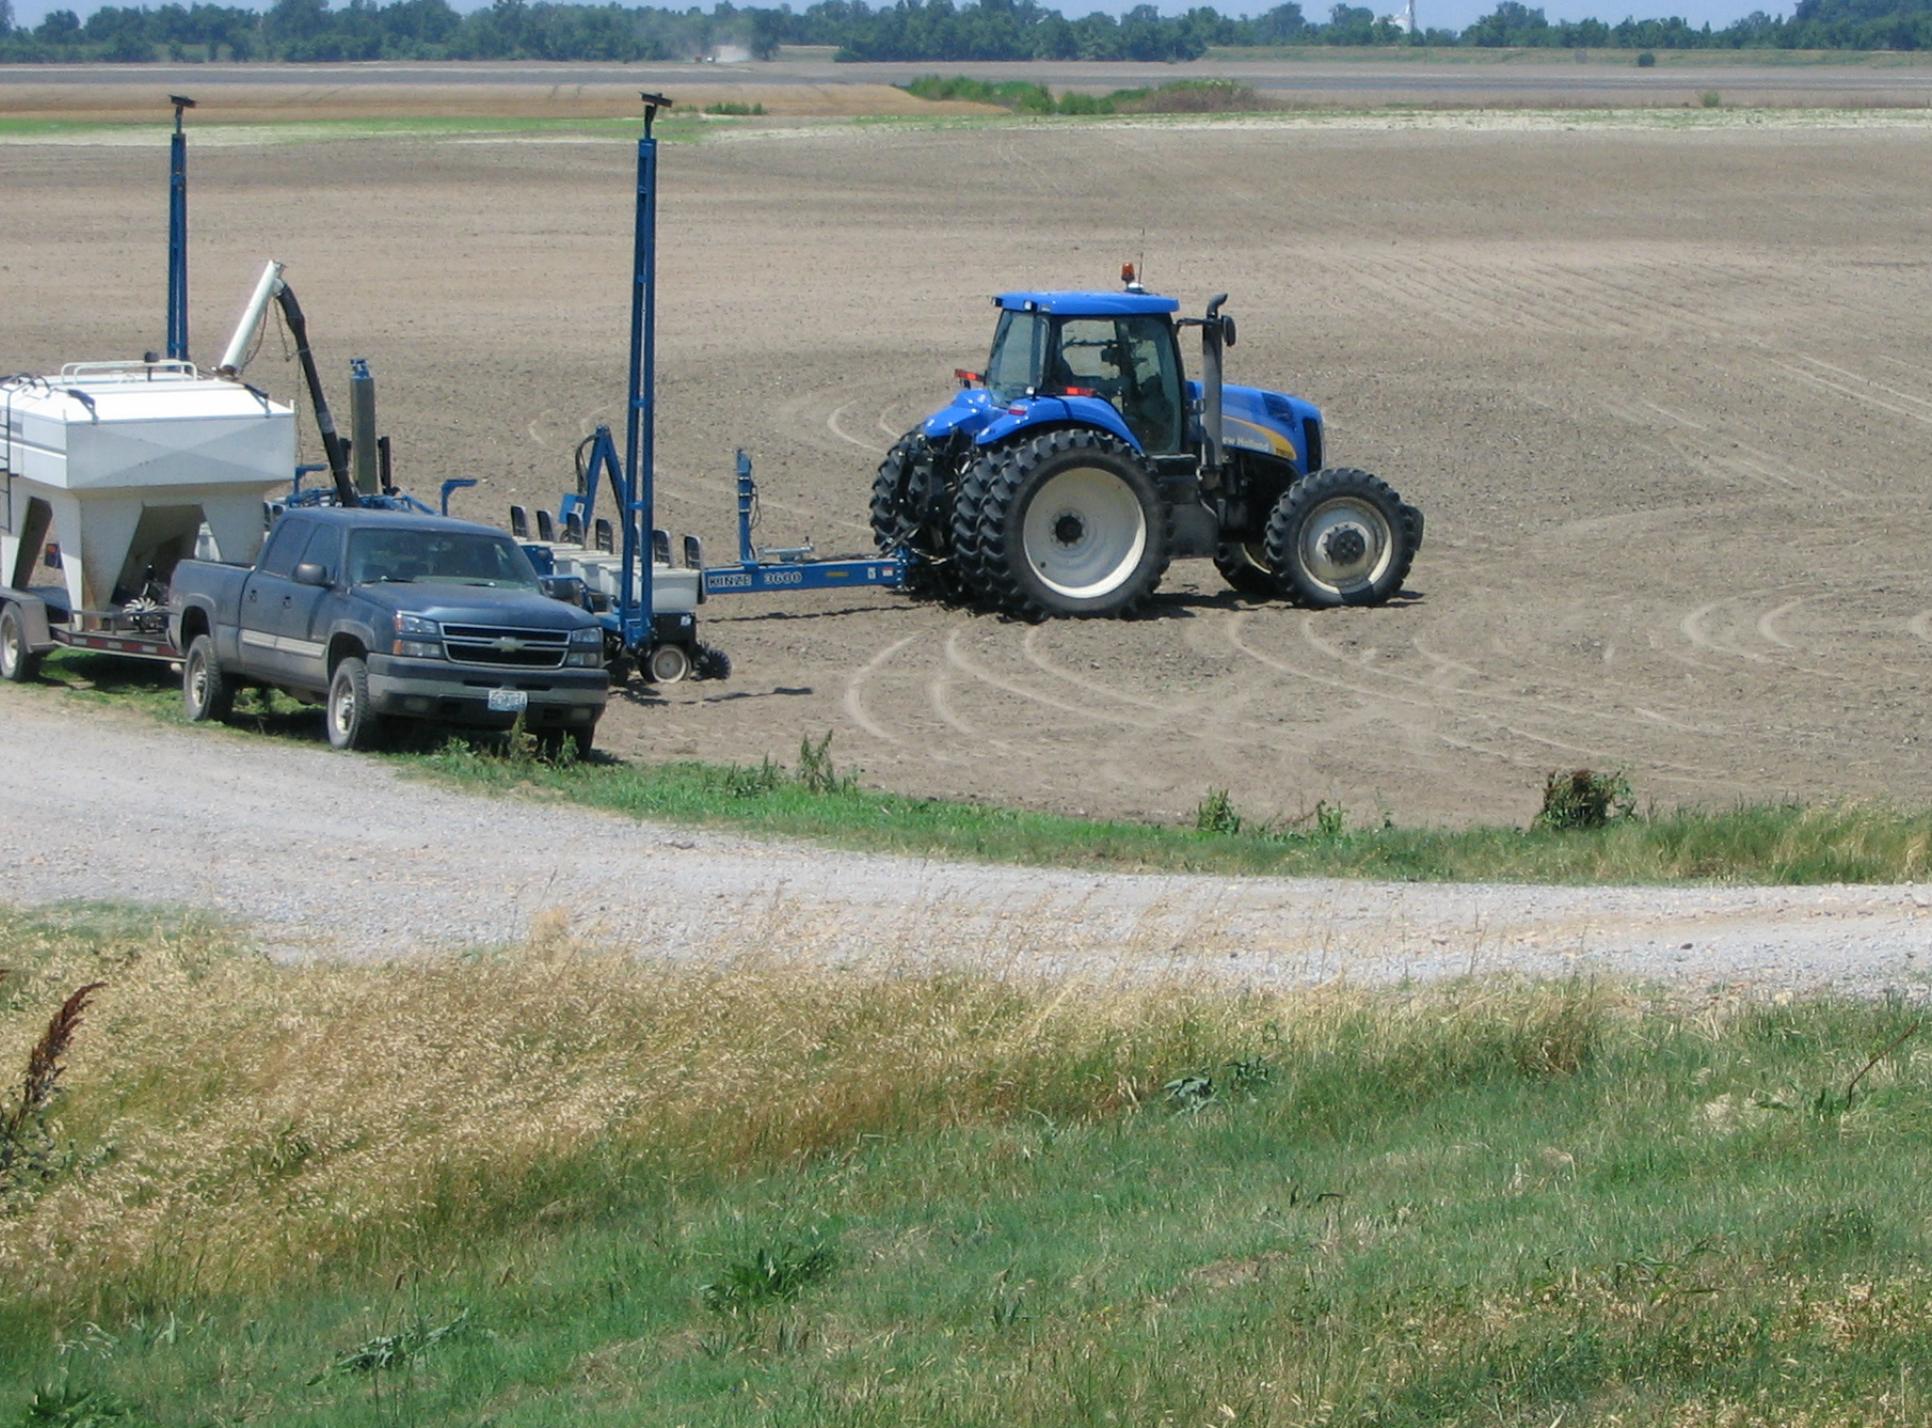
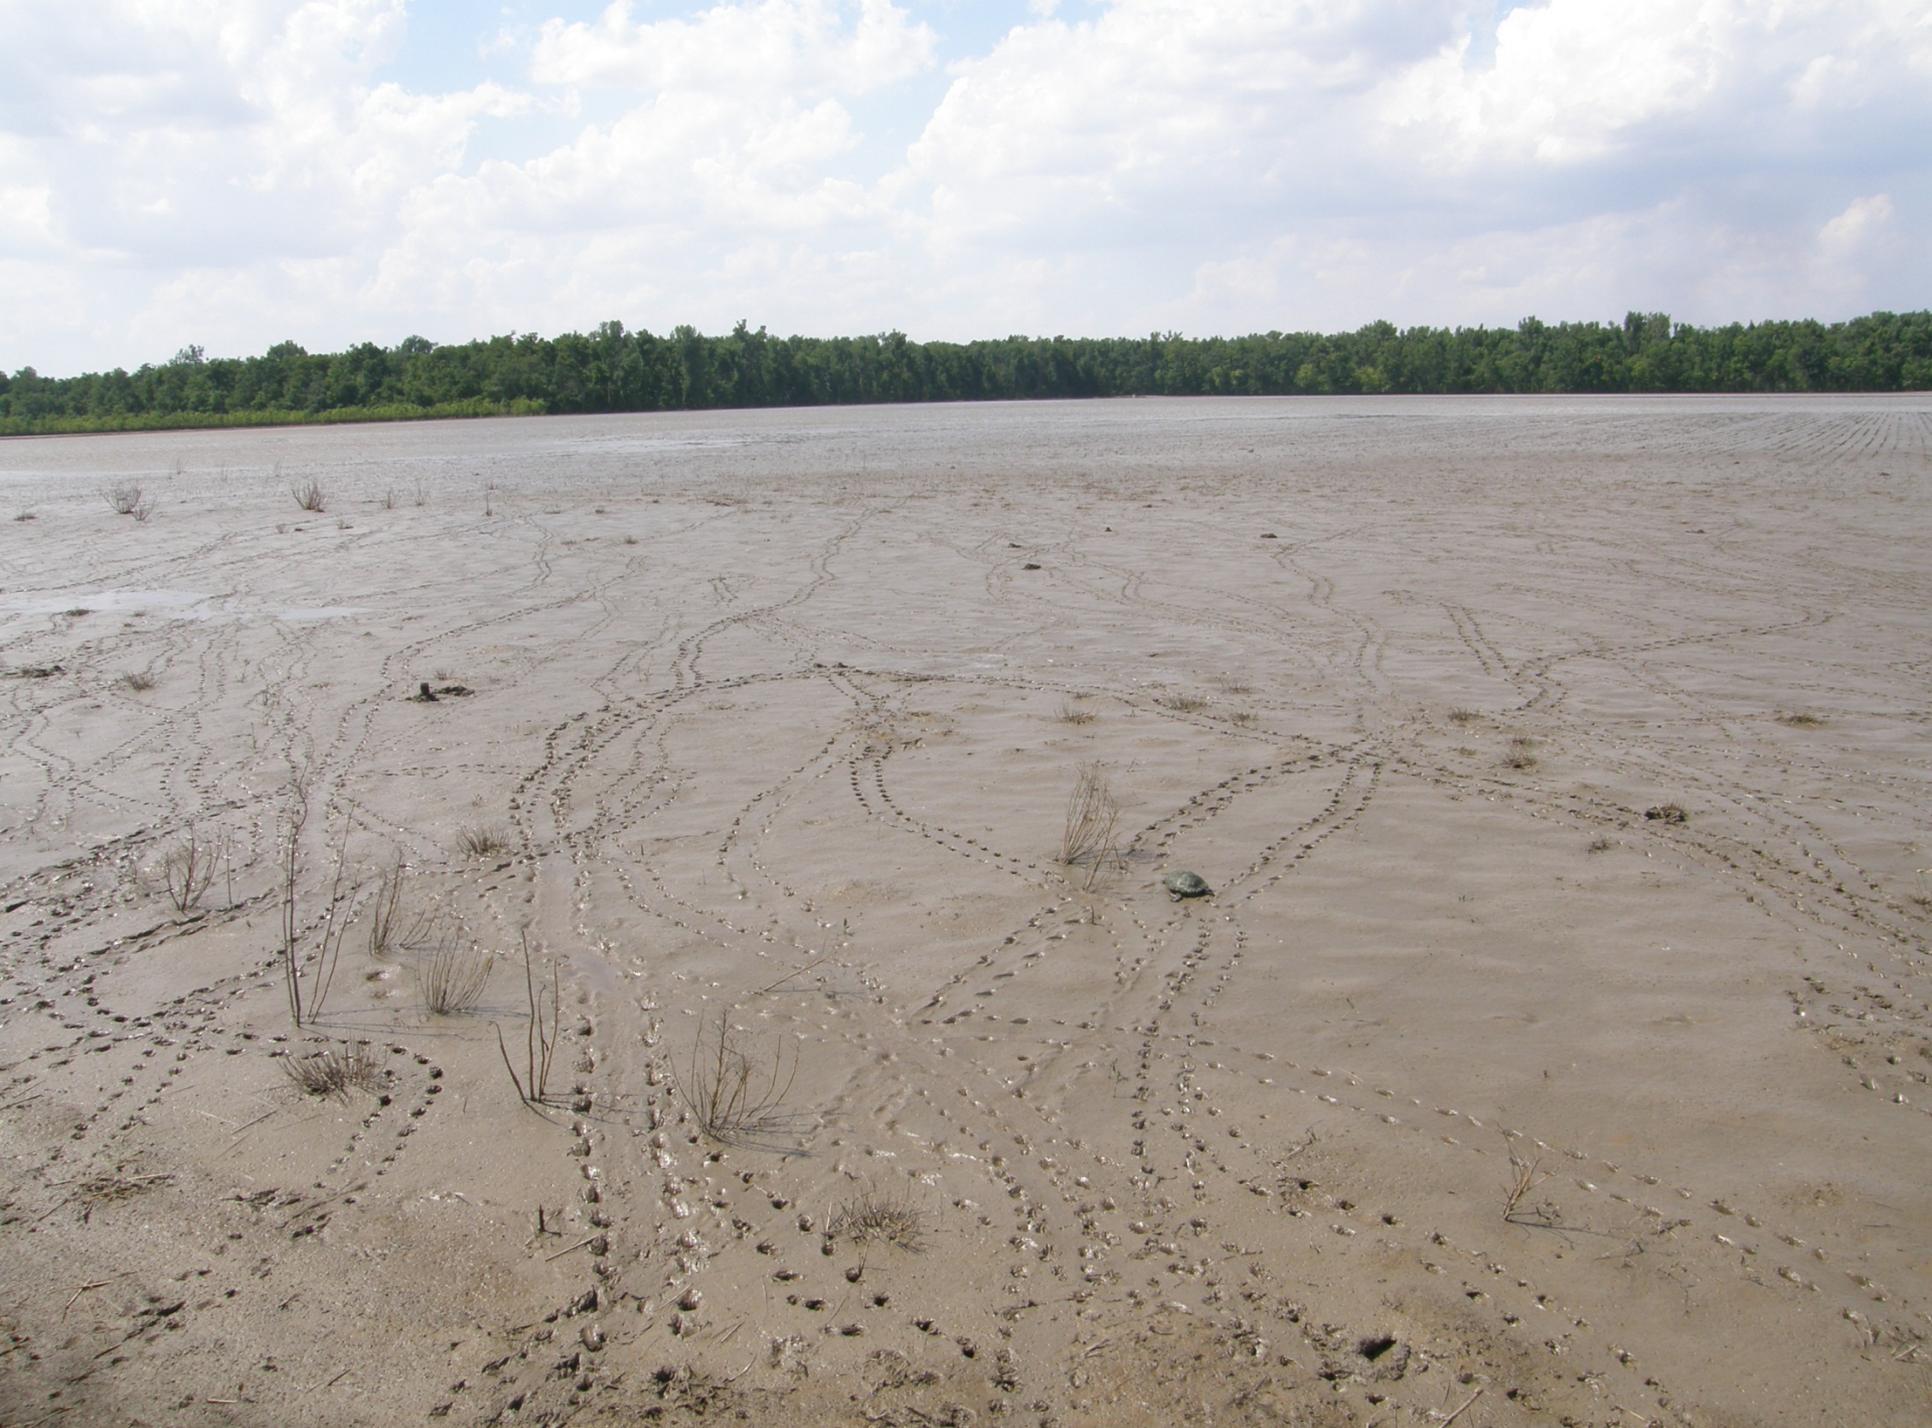
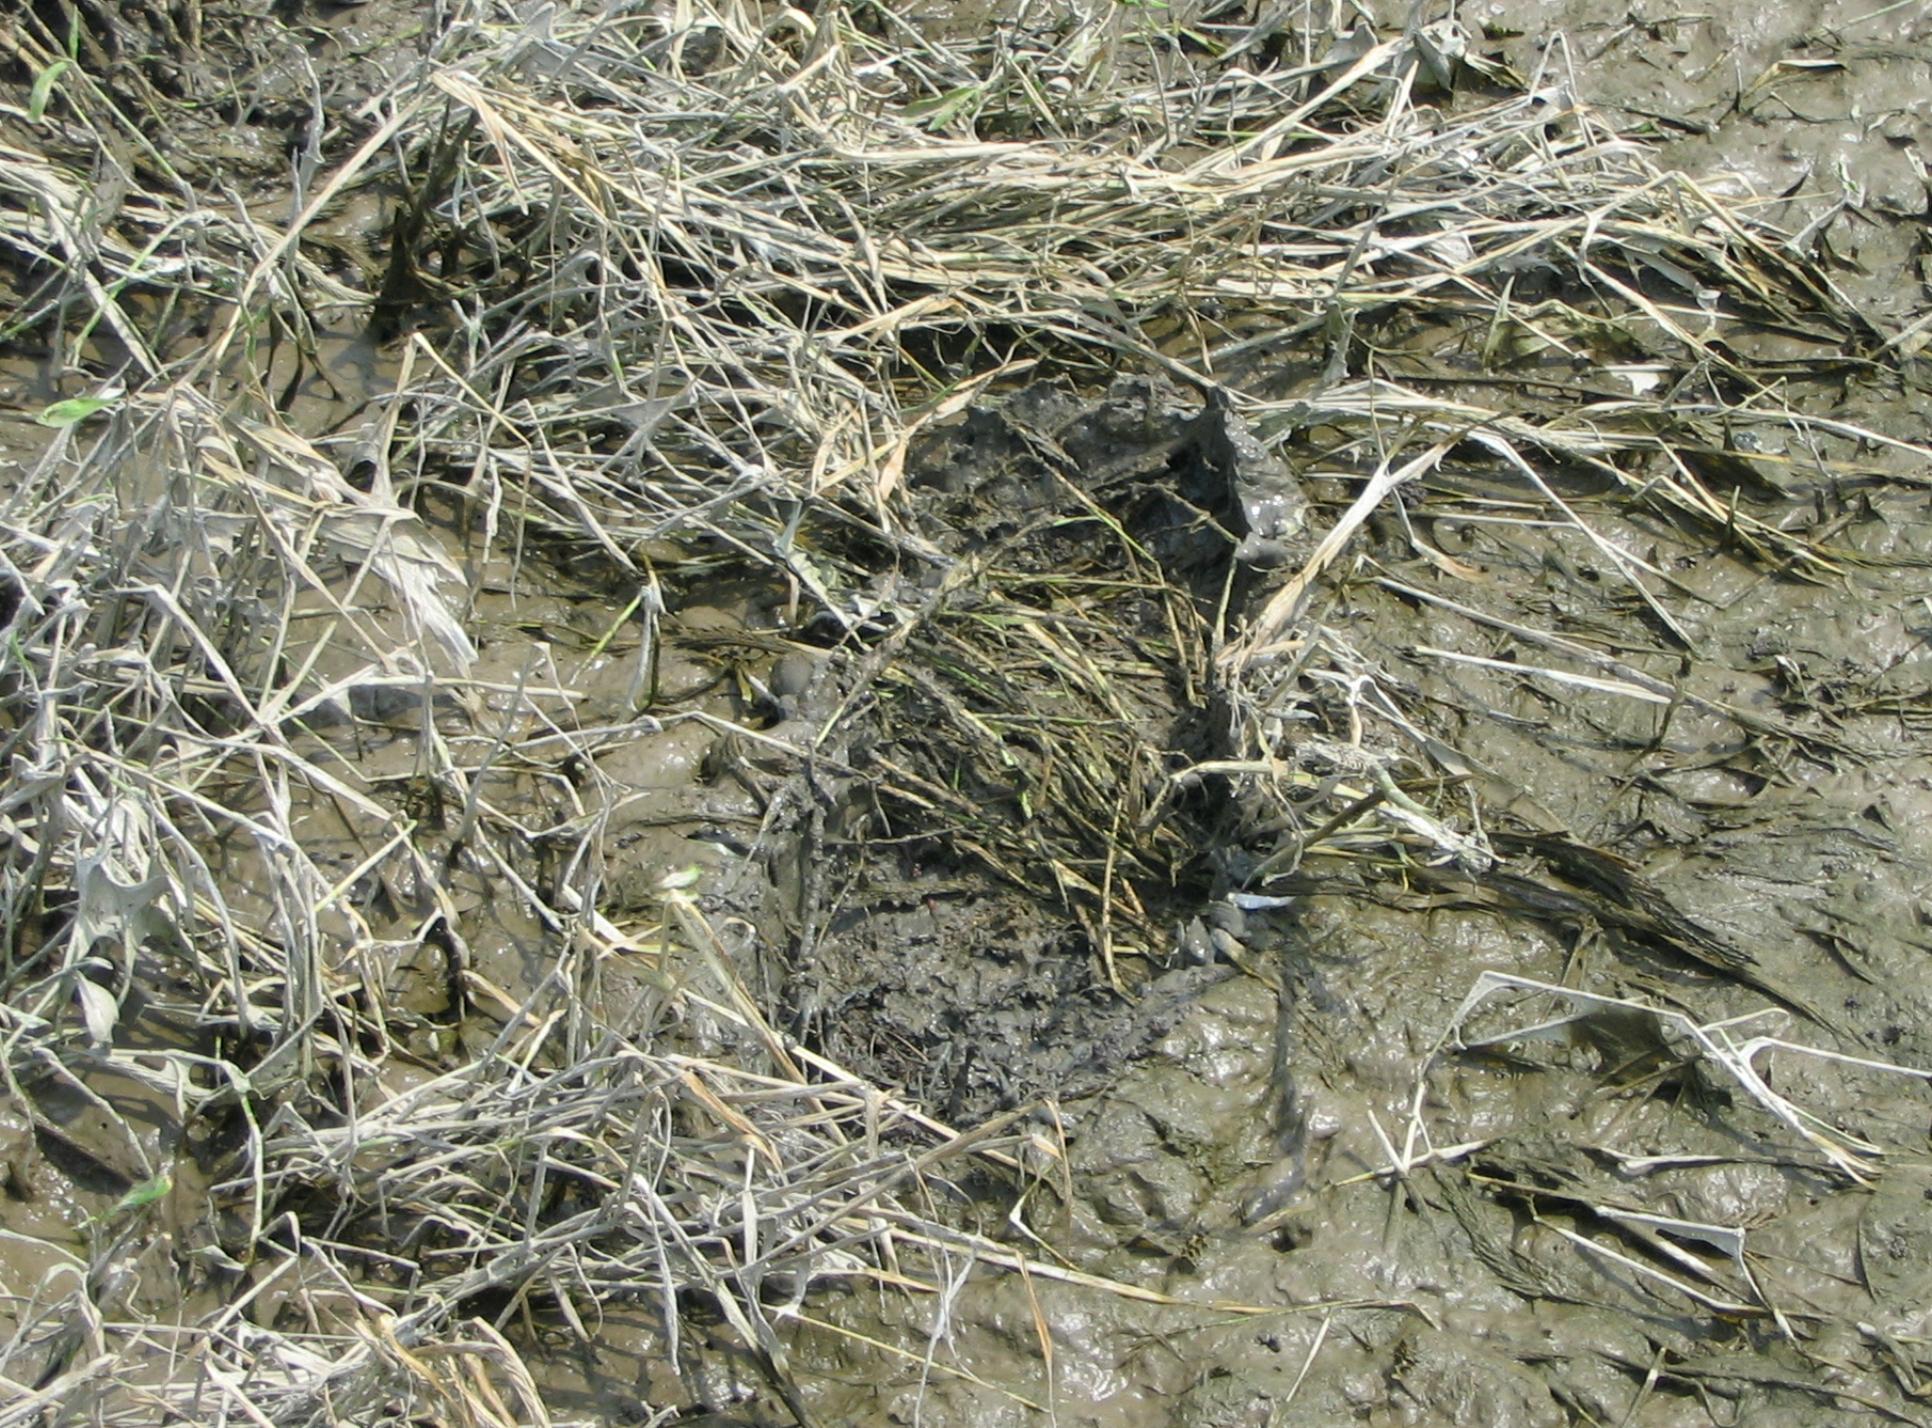
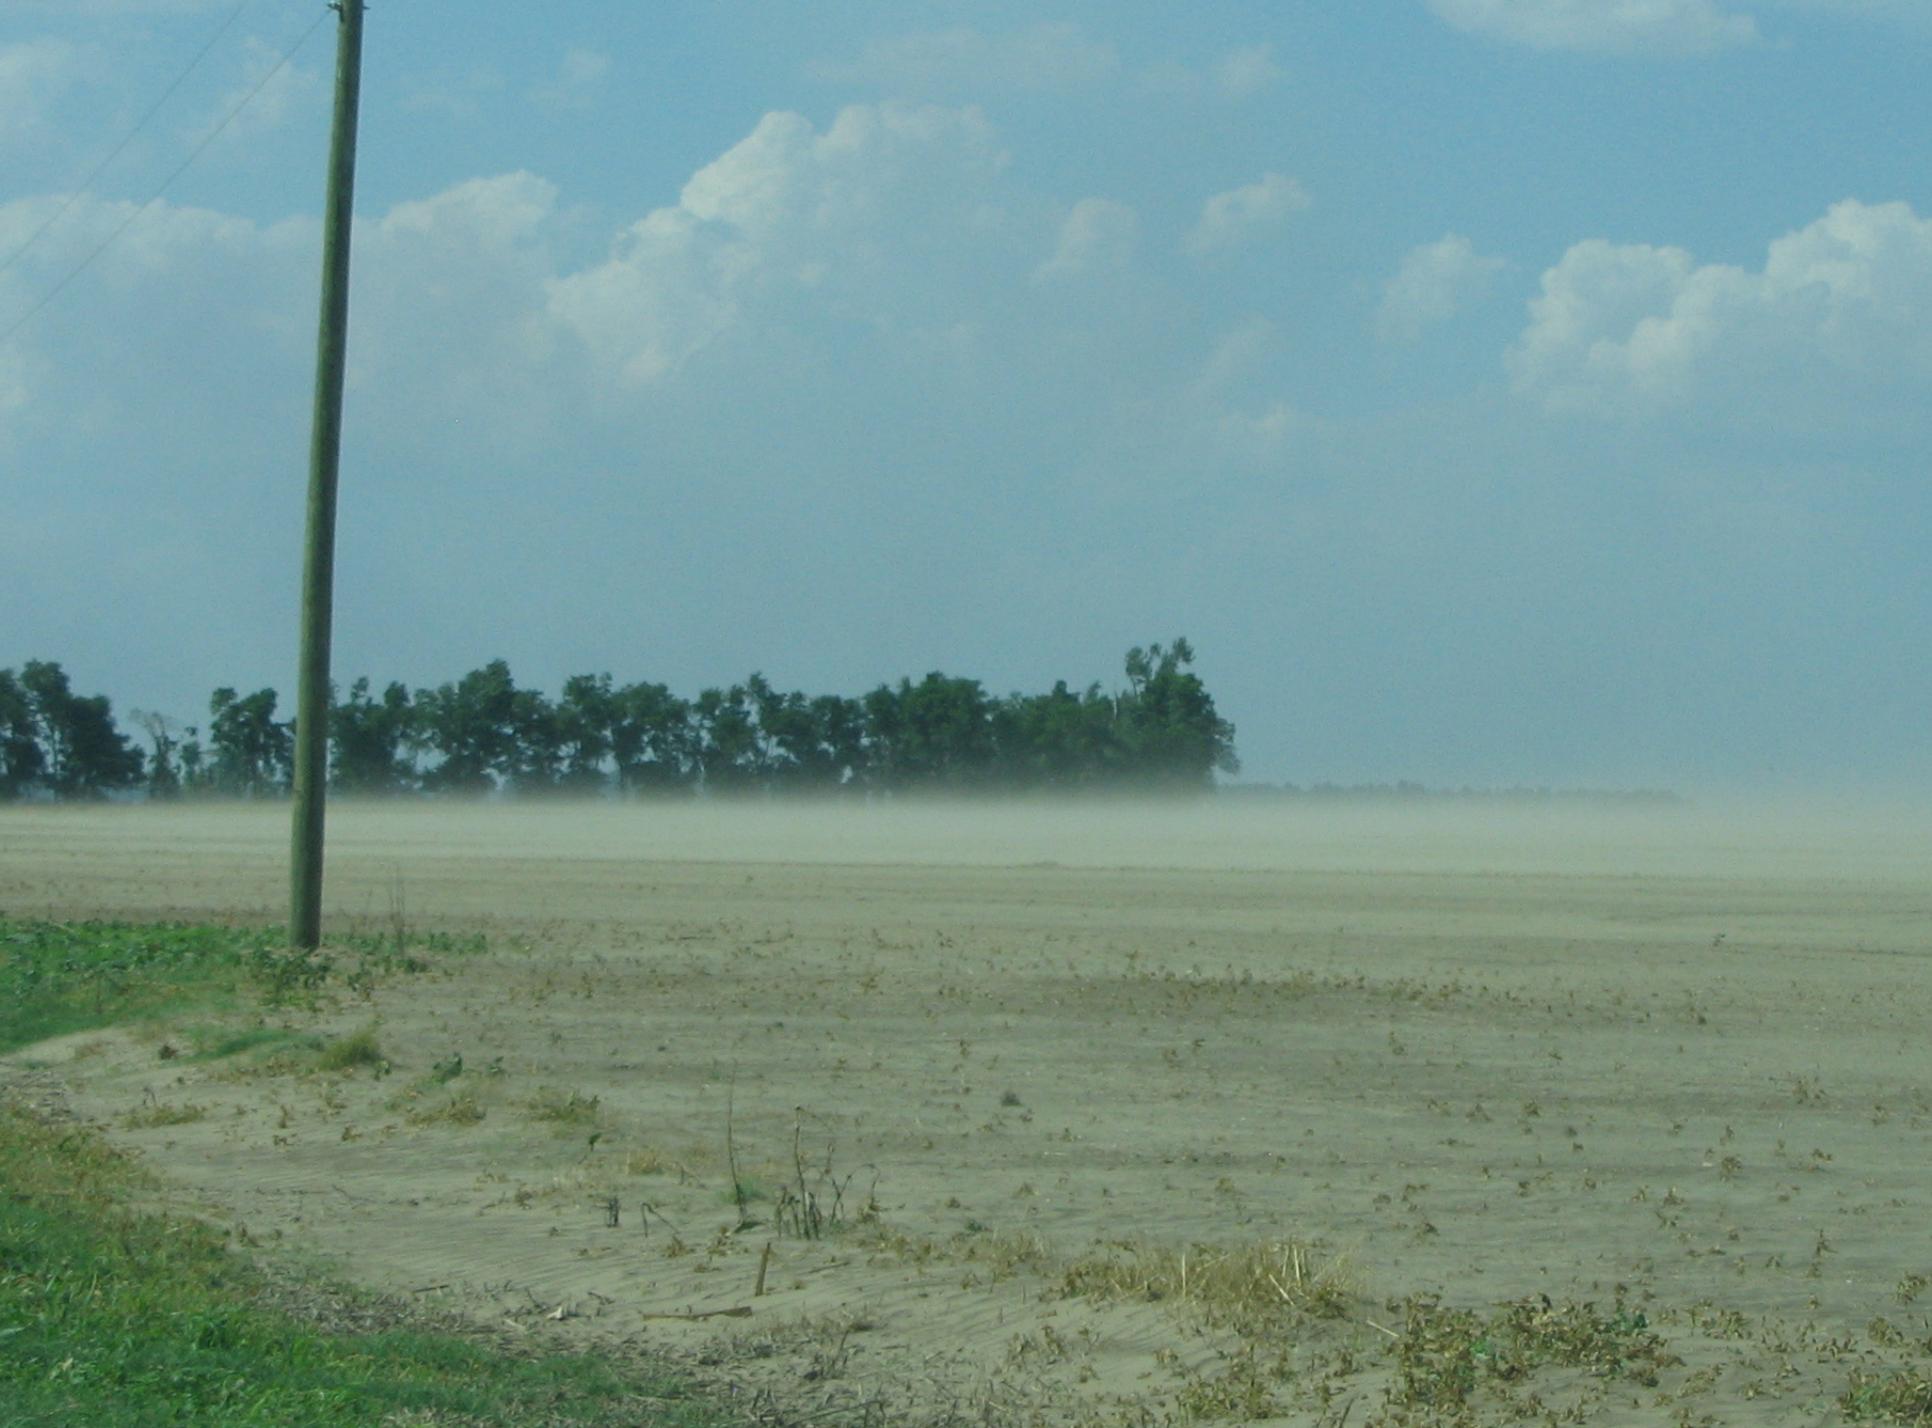
# Damages

- Loss of farm income which was partially offset by Crop Insurance.
- The man-induced breaches were considered a natural flooding event in a federal declaration and a total of \$50 million was paid for the loss of the 2011 wheat, and the damaged areas adjacent to the levees that could not be planted in 2011 and the cropland too wet for crop production in 2011.
