# The Impacts of 2011 Induced Levee Breaches on Agricultural Lands of Mississippi River Valley

- By Kenneth R. Olson, Professor of Soil Science, NRES, ACES, UIUC and Lois Wright Morton, Professor of Sociology

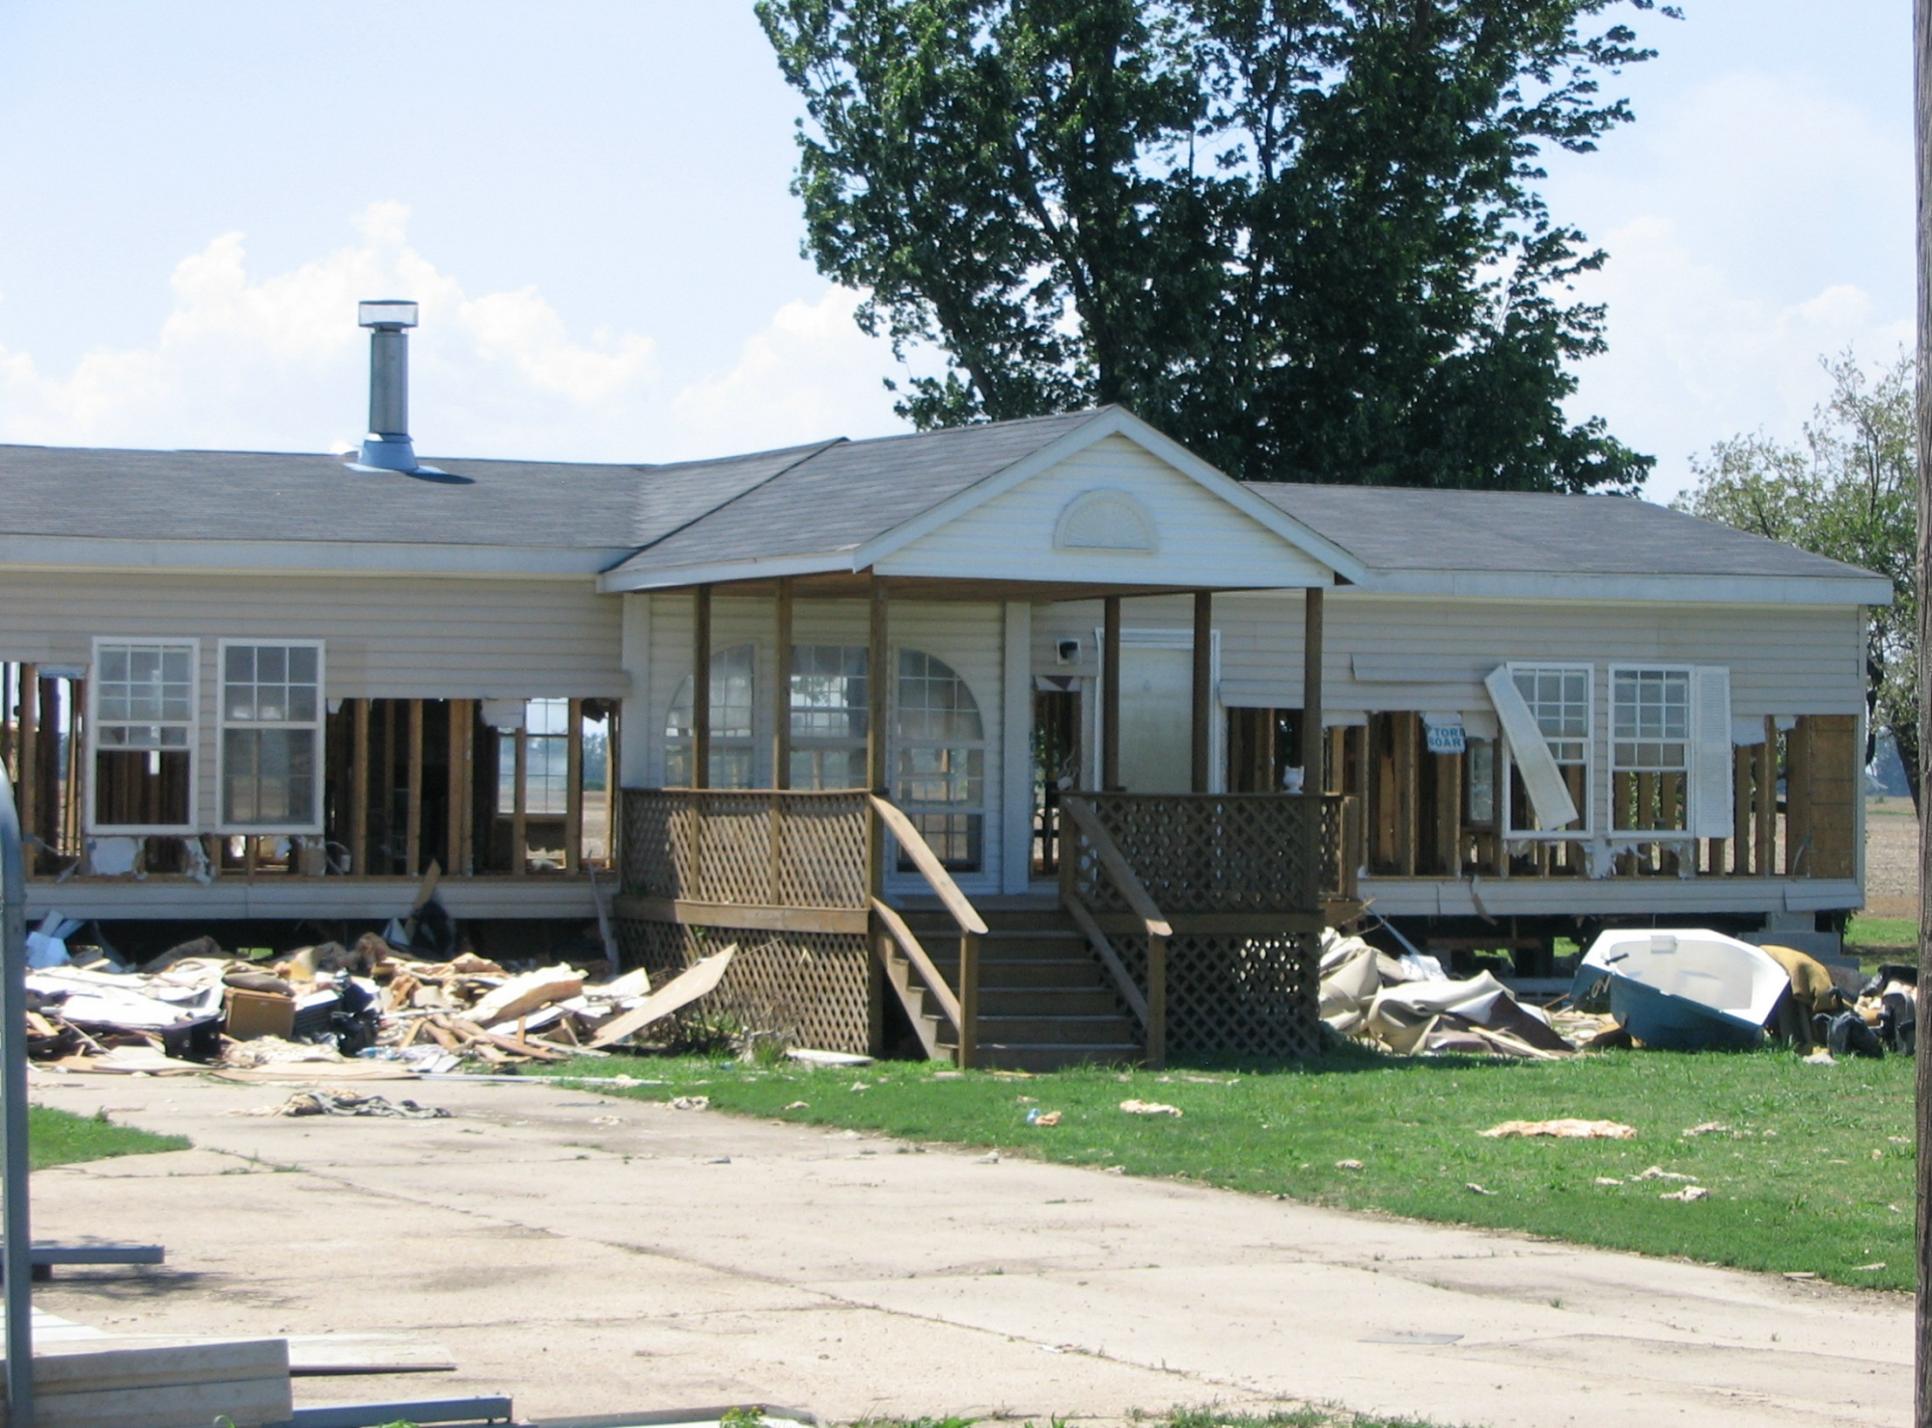
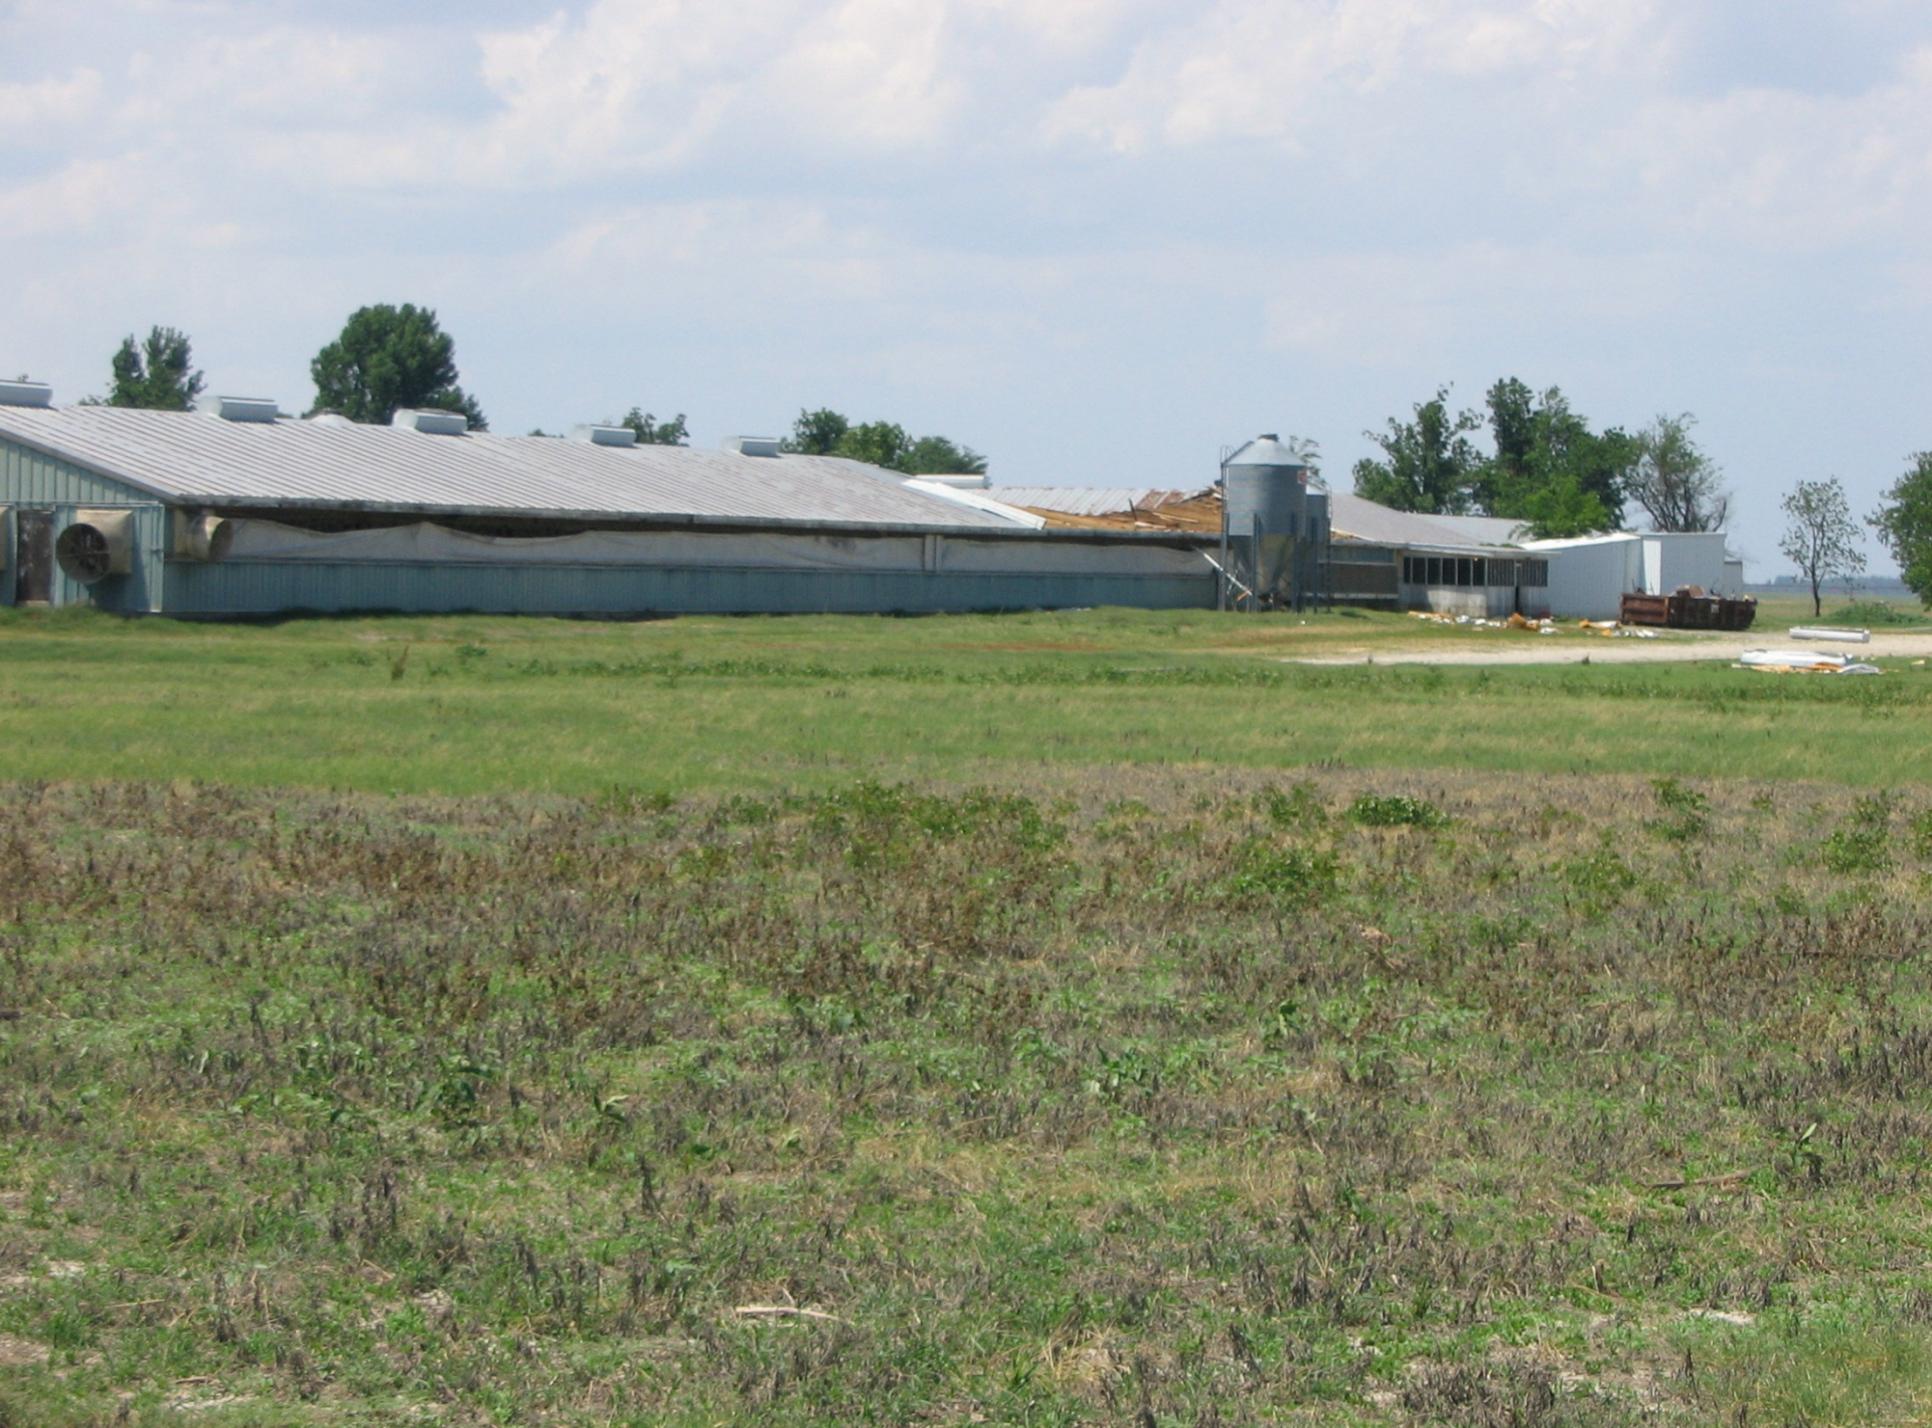
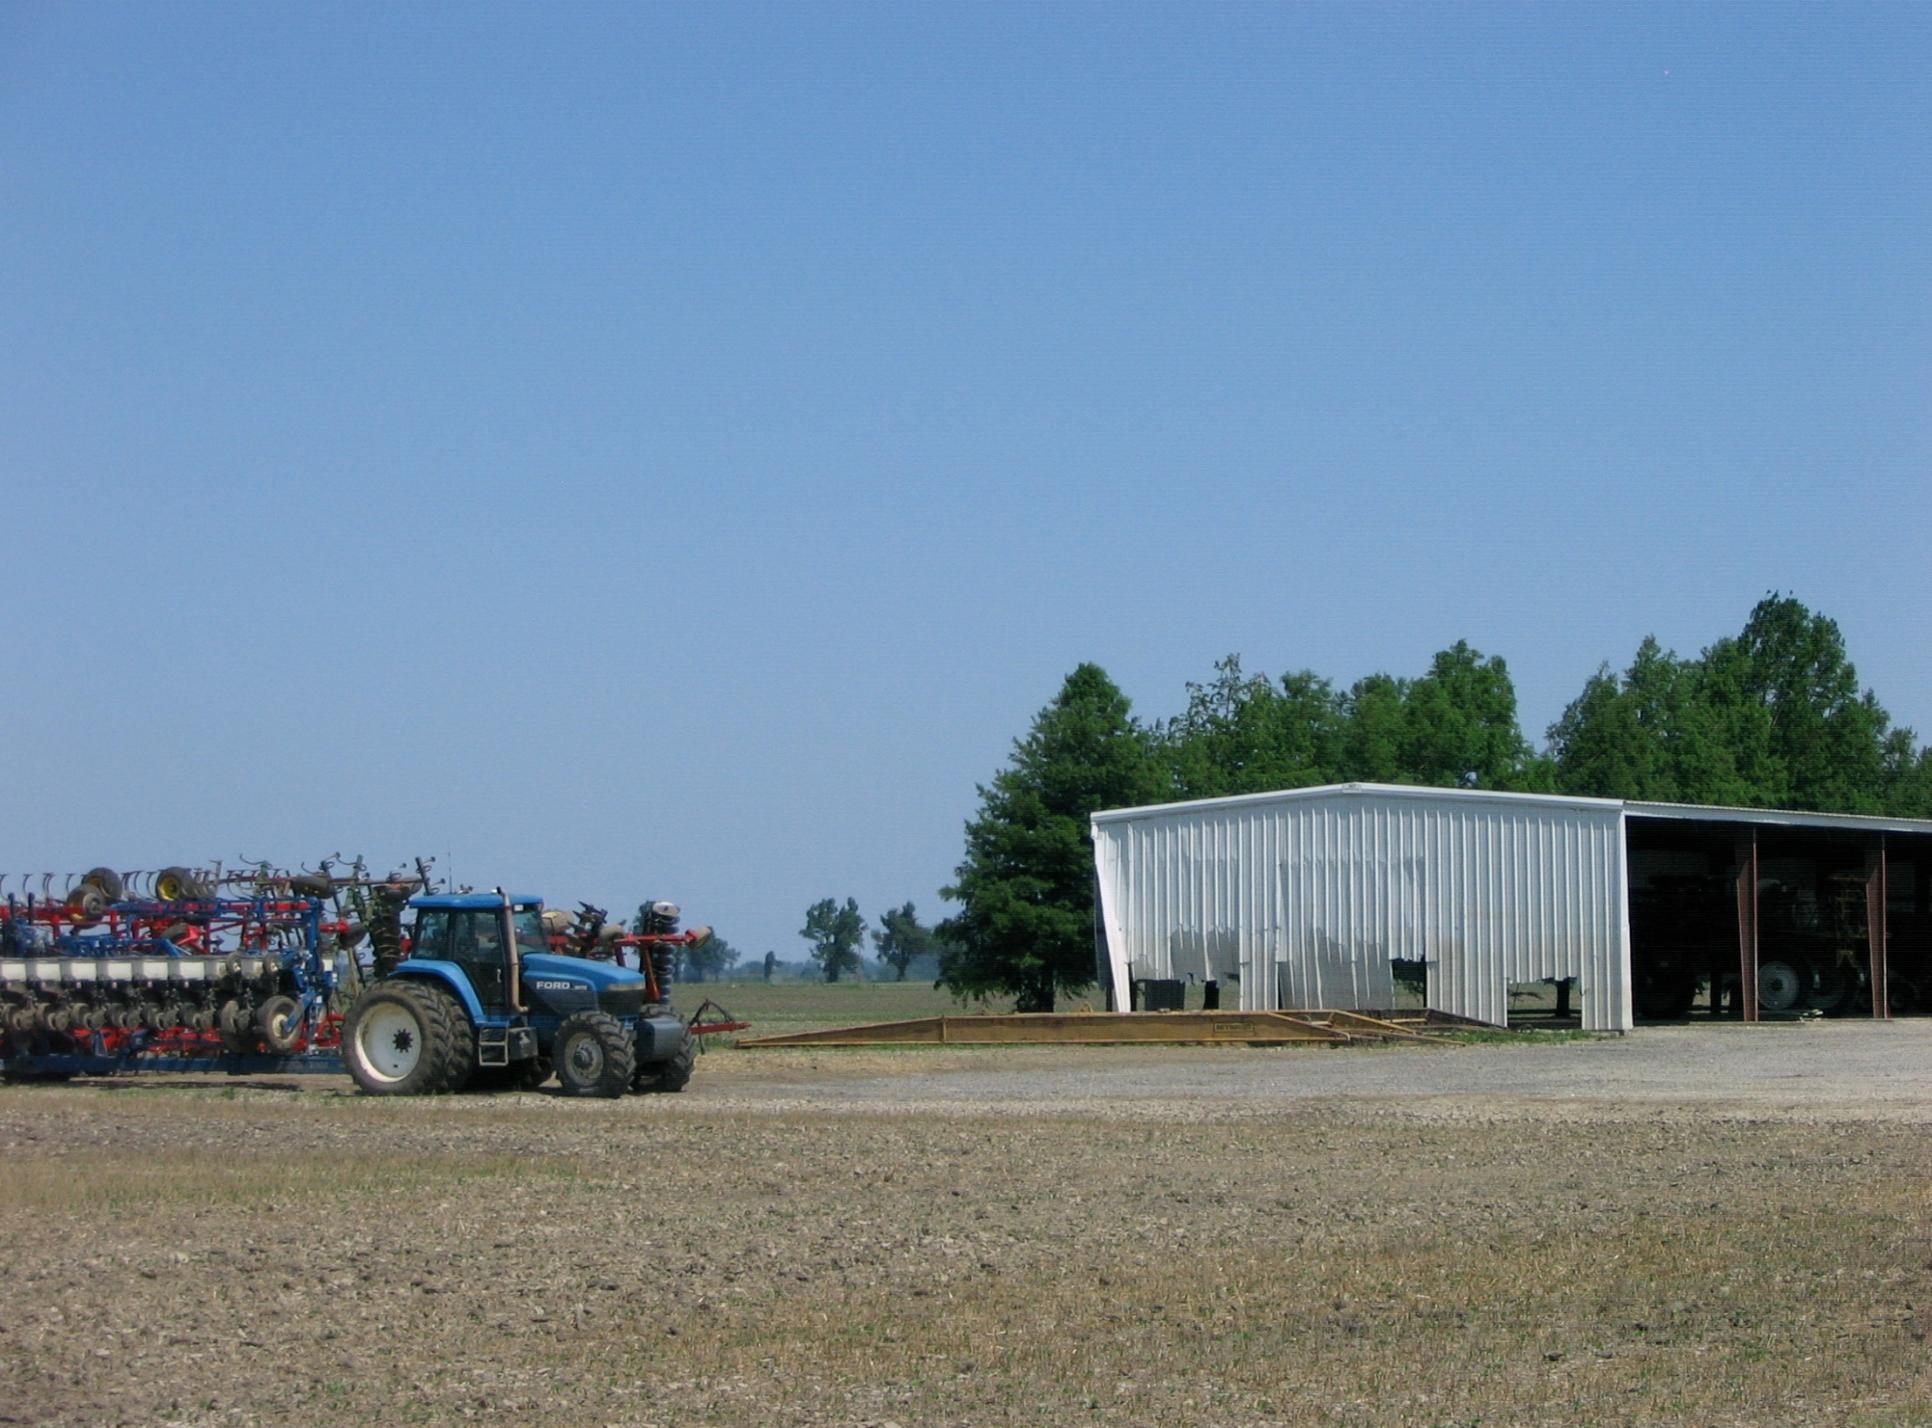
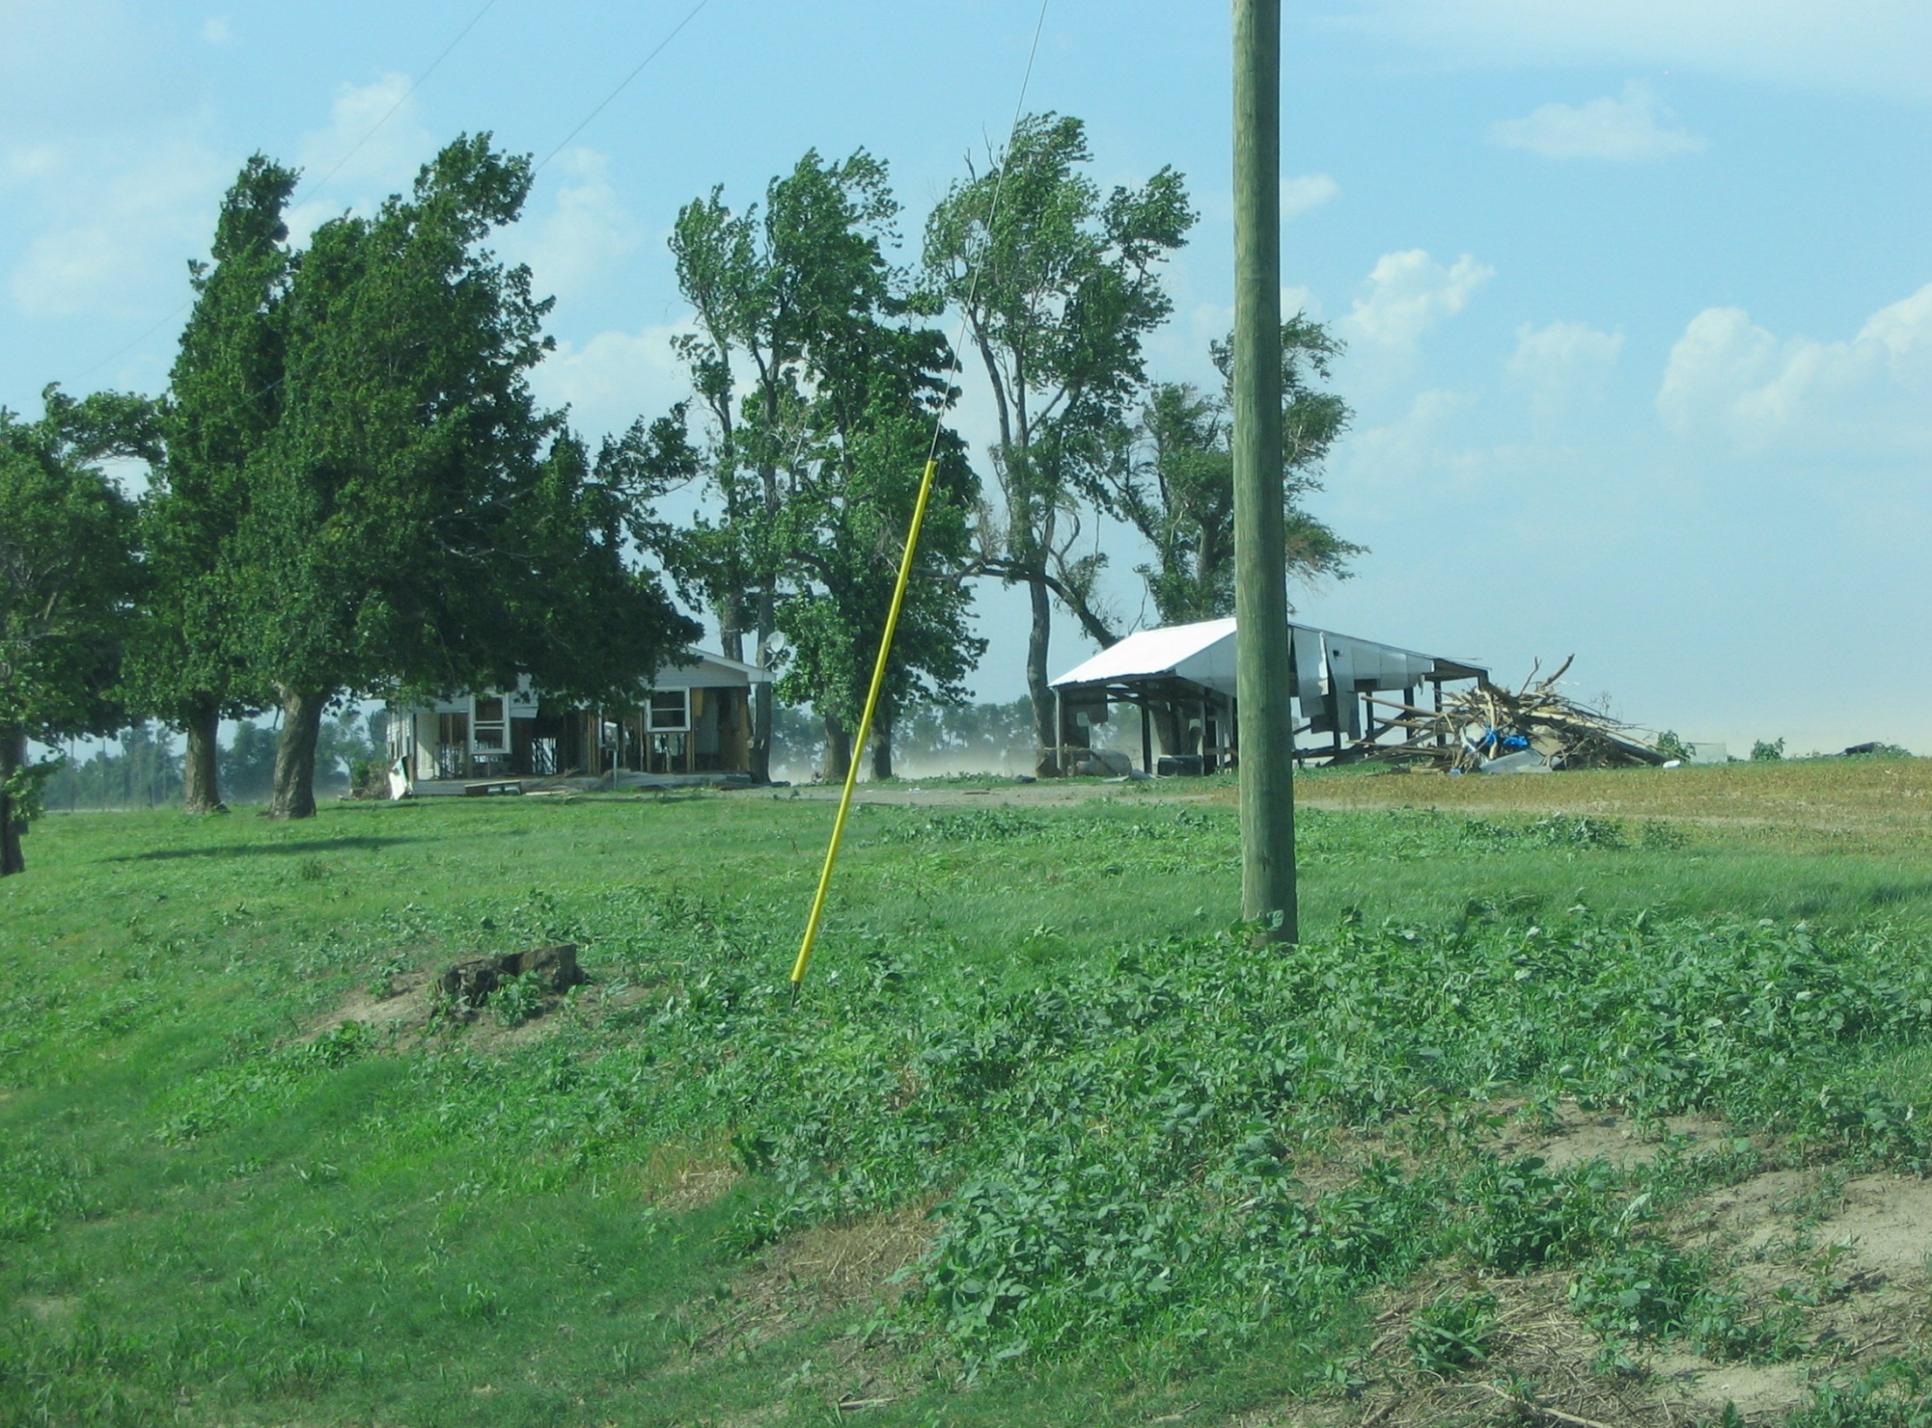
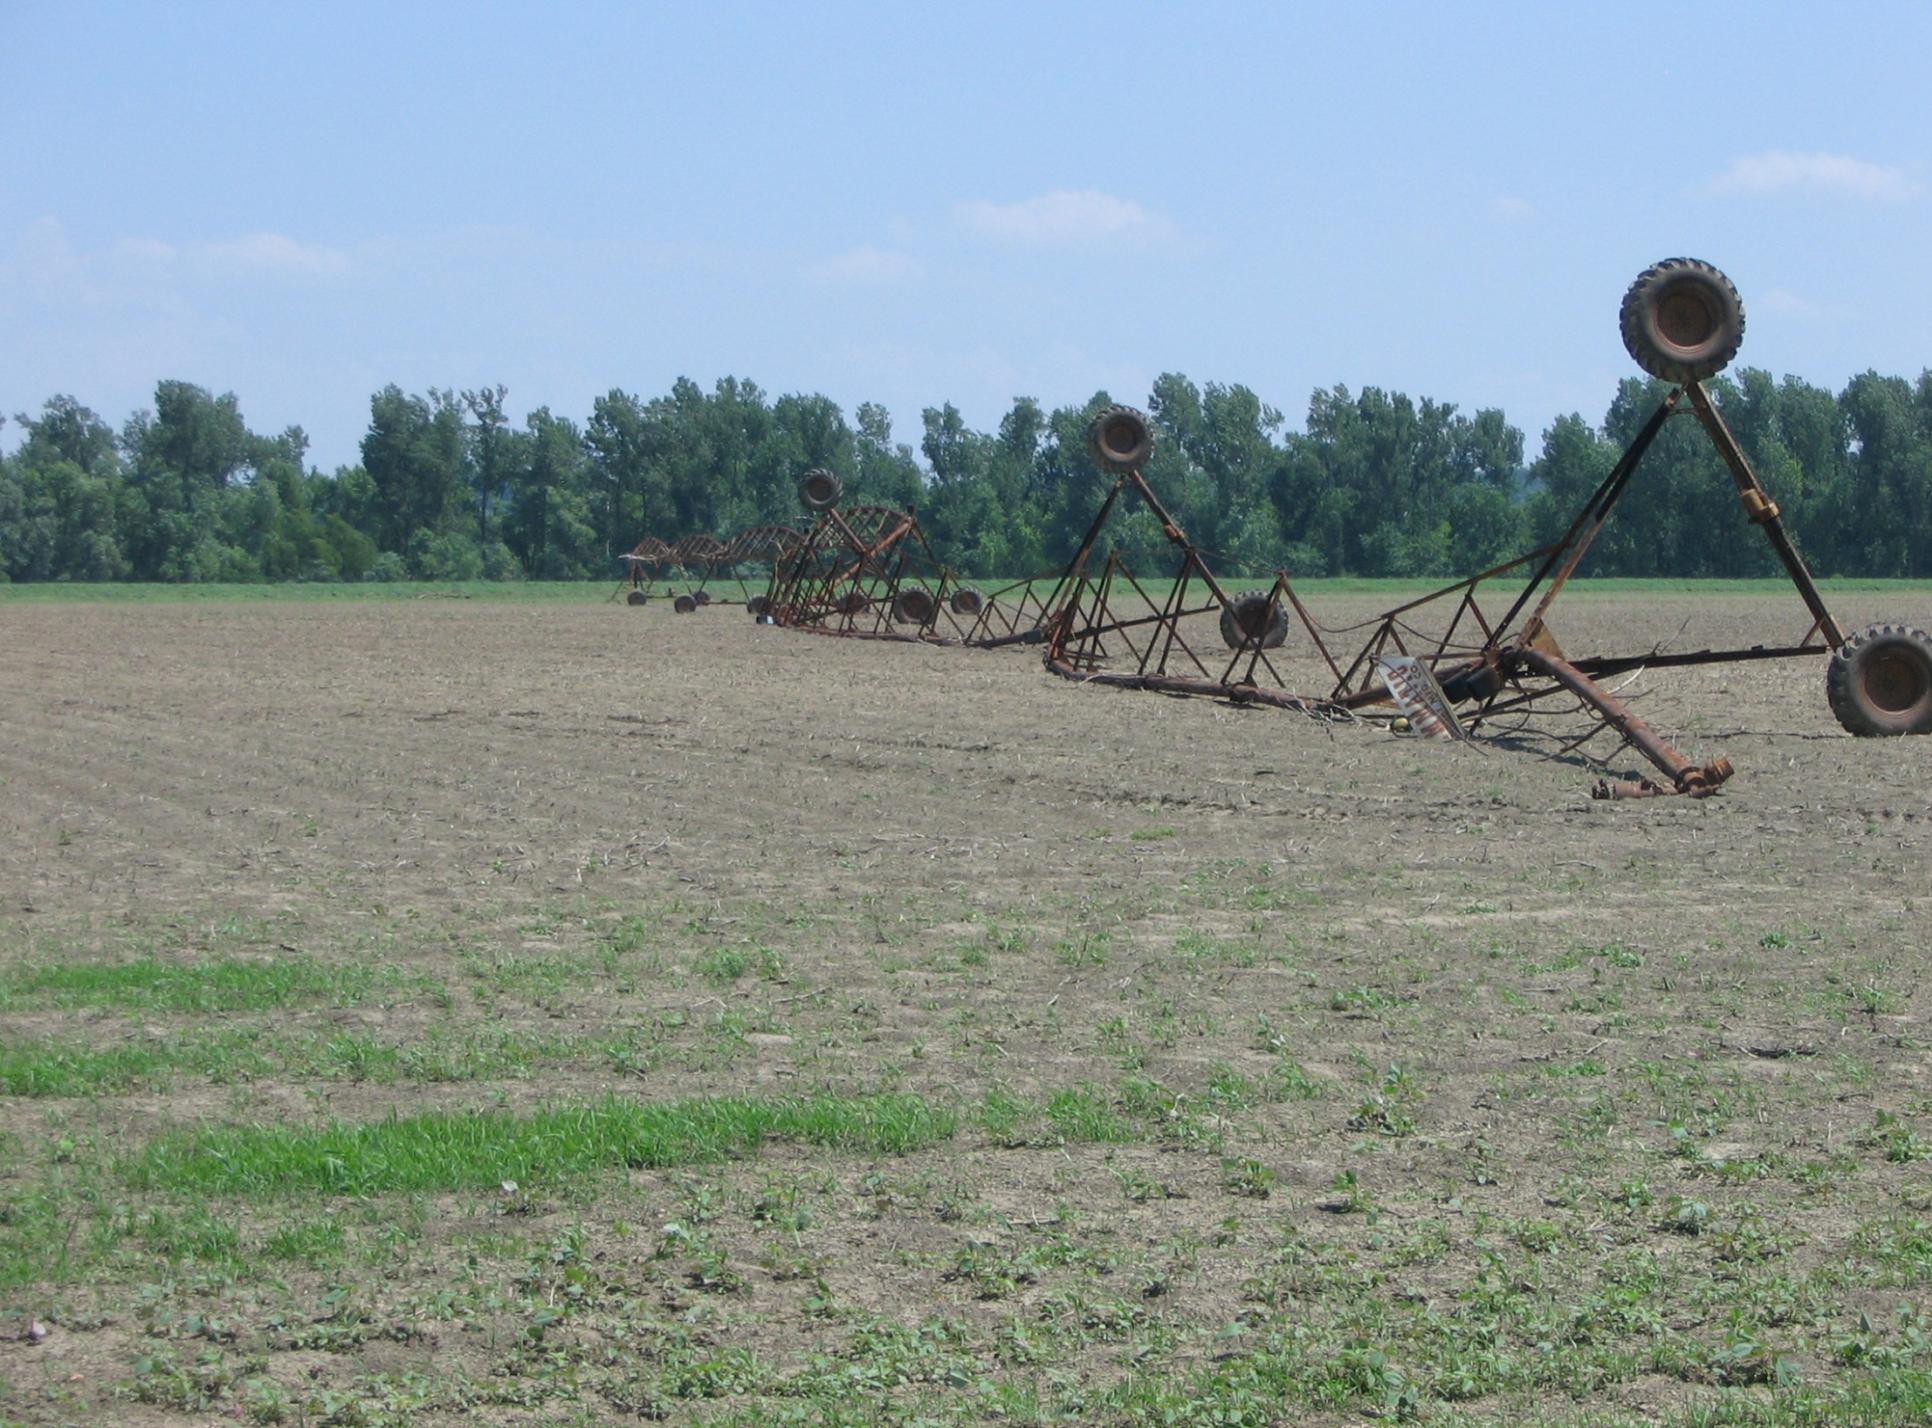
- There were approximately 200 structures damaged by flooding including the rapidly moving water and water retained in the Floodway.
- The floodway was capable of 10 to 12 ft of floodwaters or 1.3 to 1.6 million acre-ft.
-
