# The Impacts of 2011 Induced Levee Breaches on Agricultural Lands of Mississippi River Valley

- By Kenneth R. Olson, Professor of Soil Science, NRES, ACES, UIUC and Lois Wright Morton, Professor of Sociology

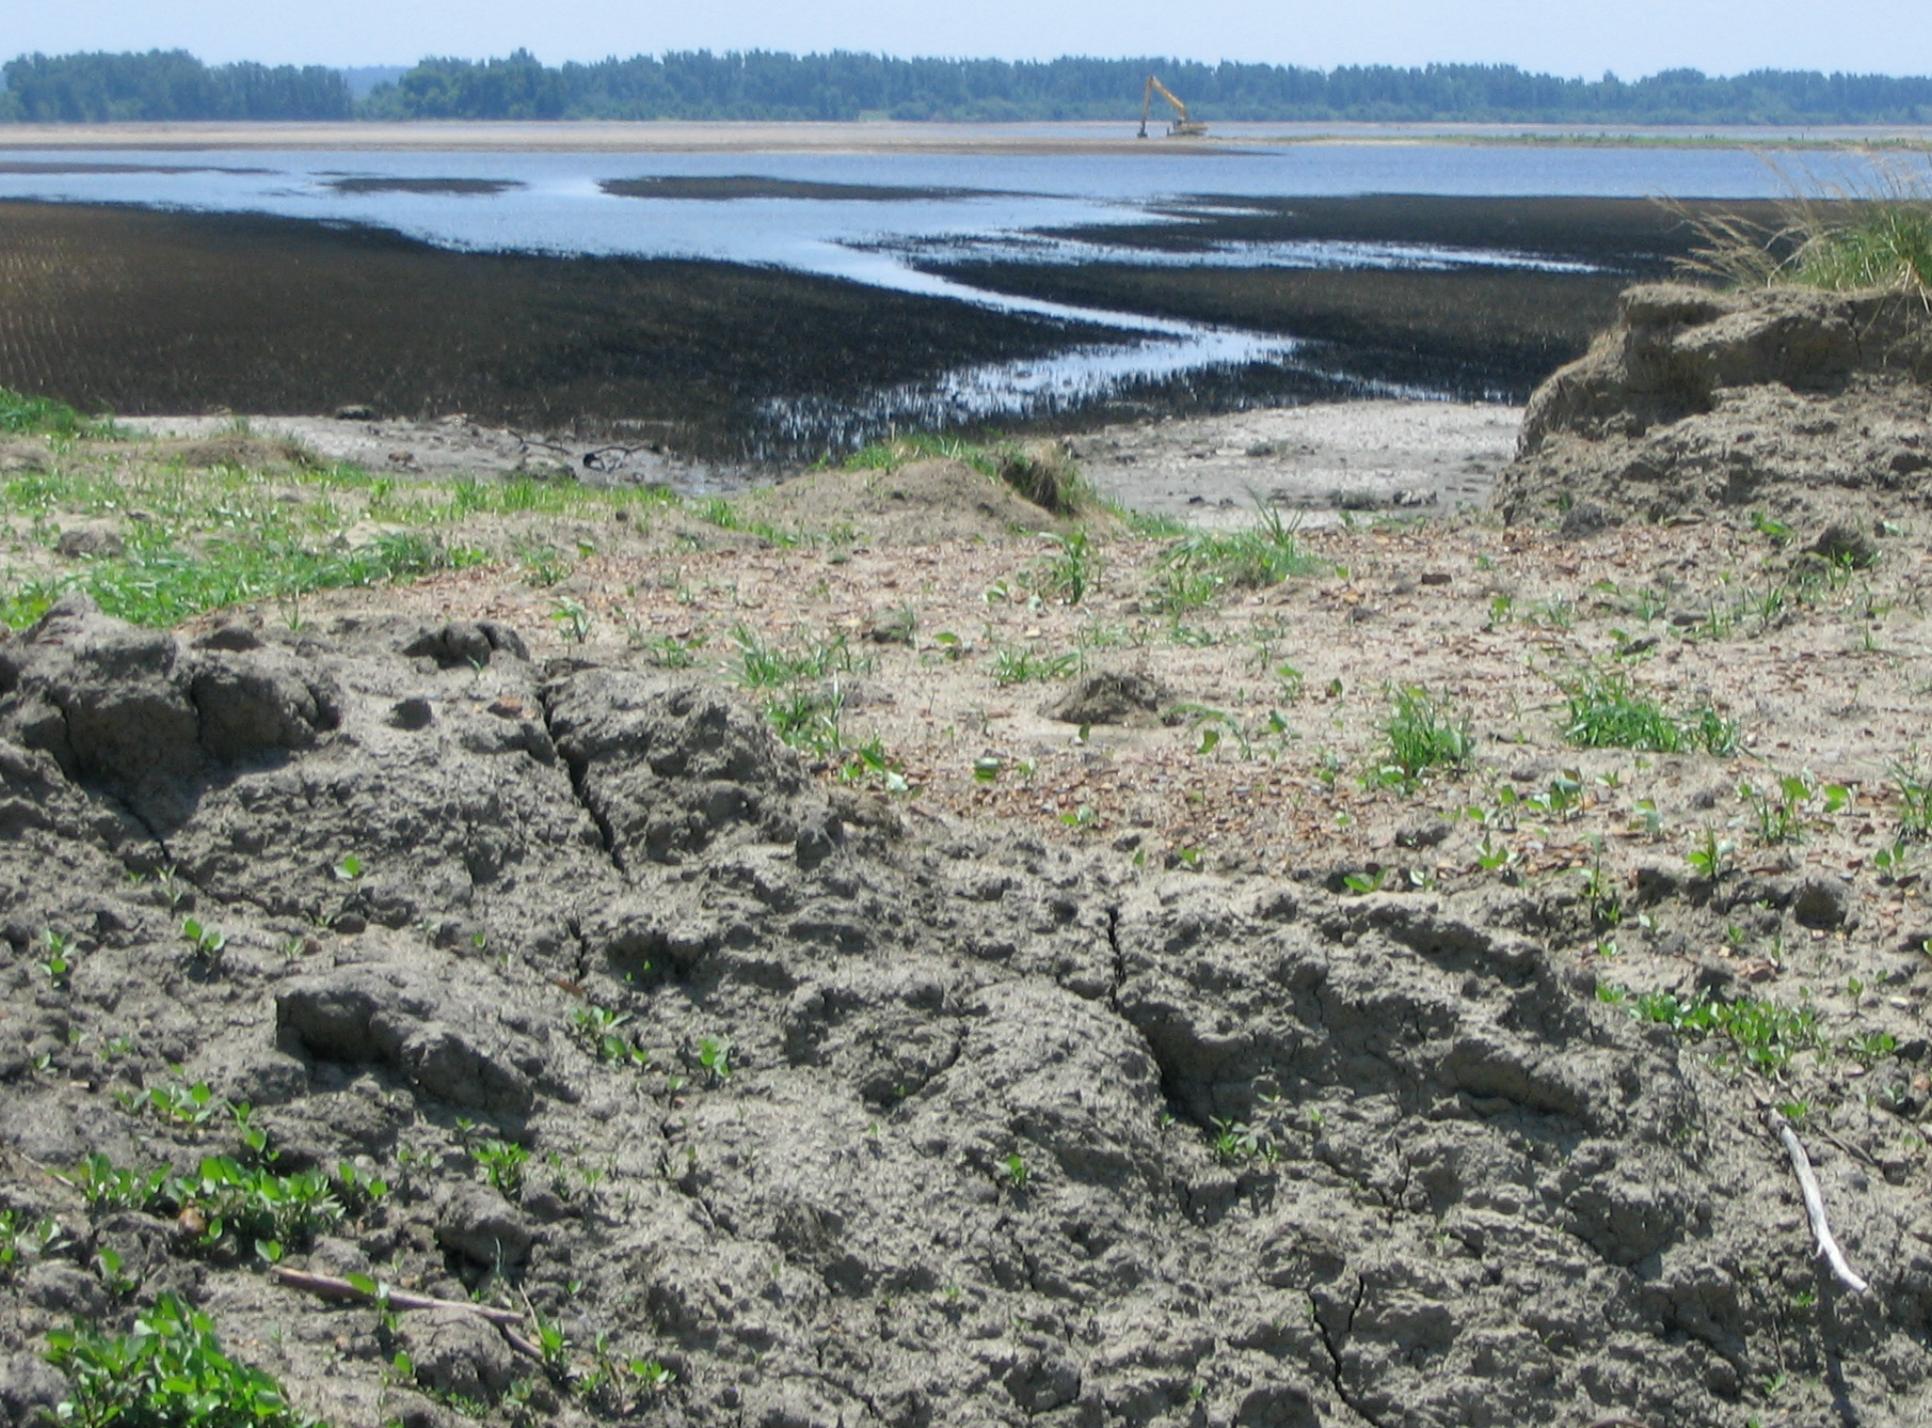
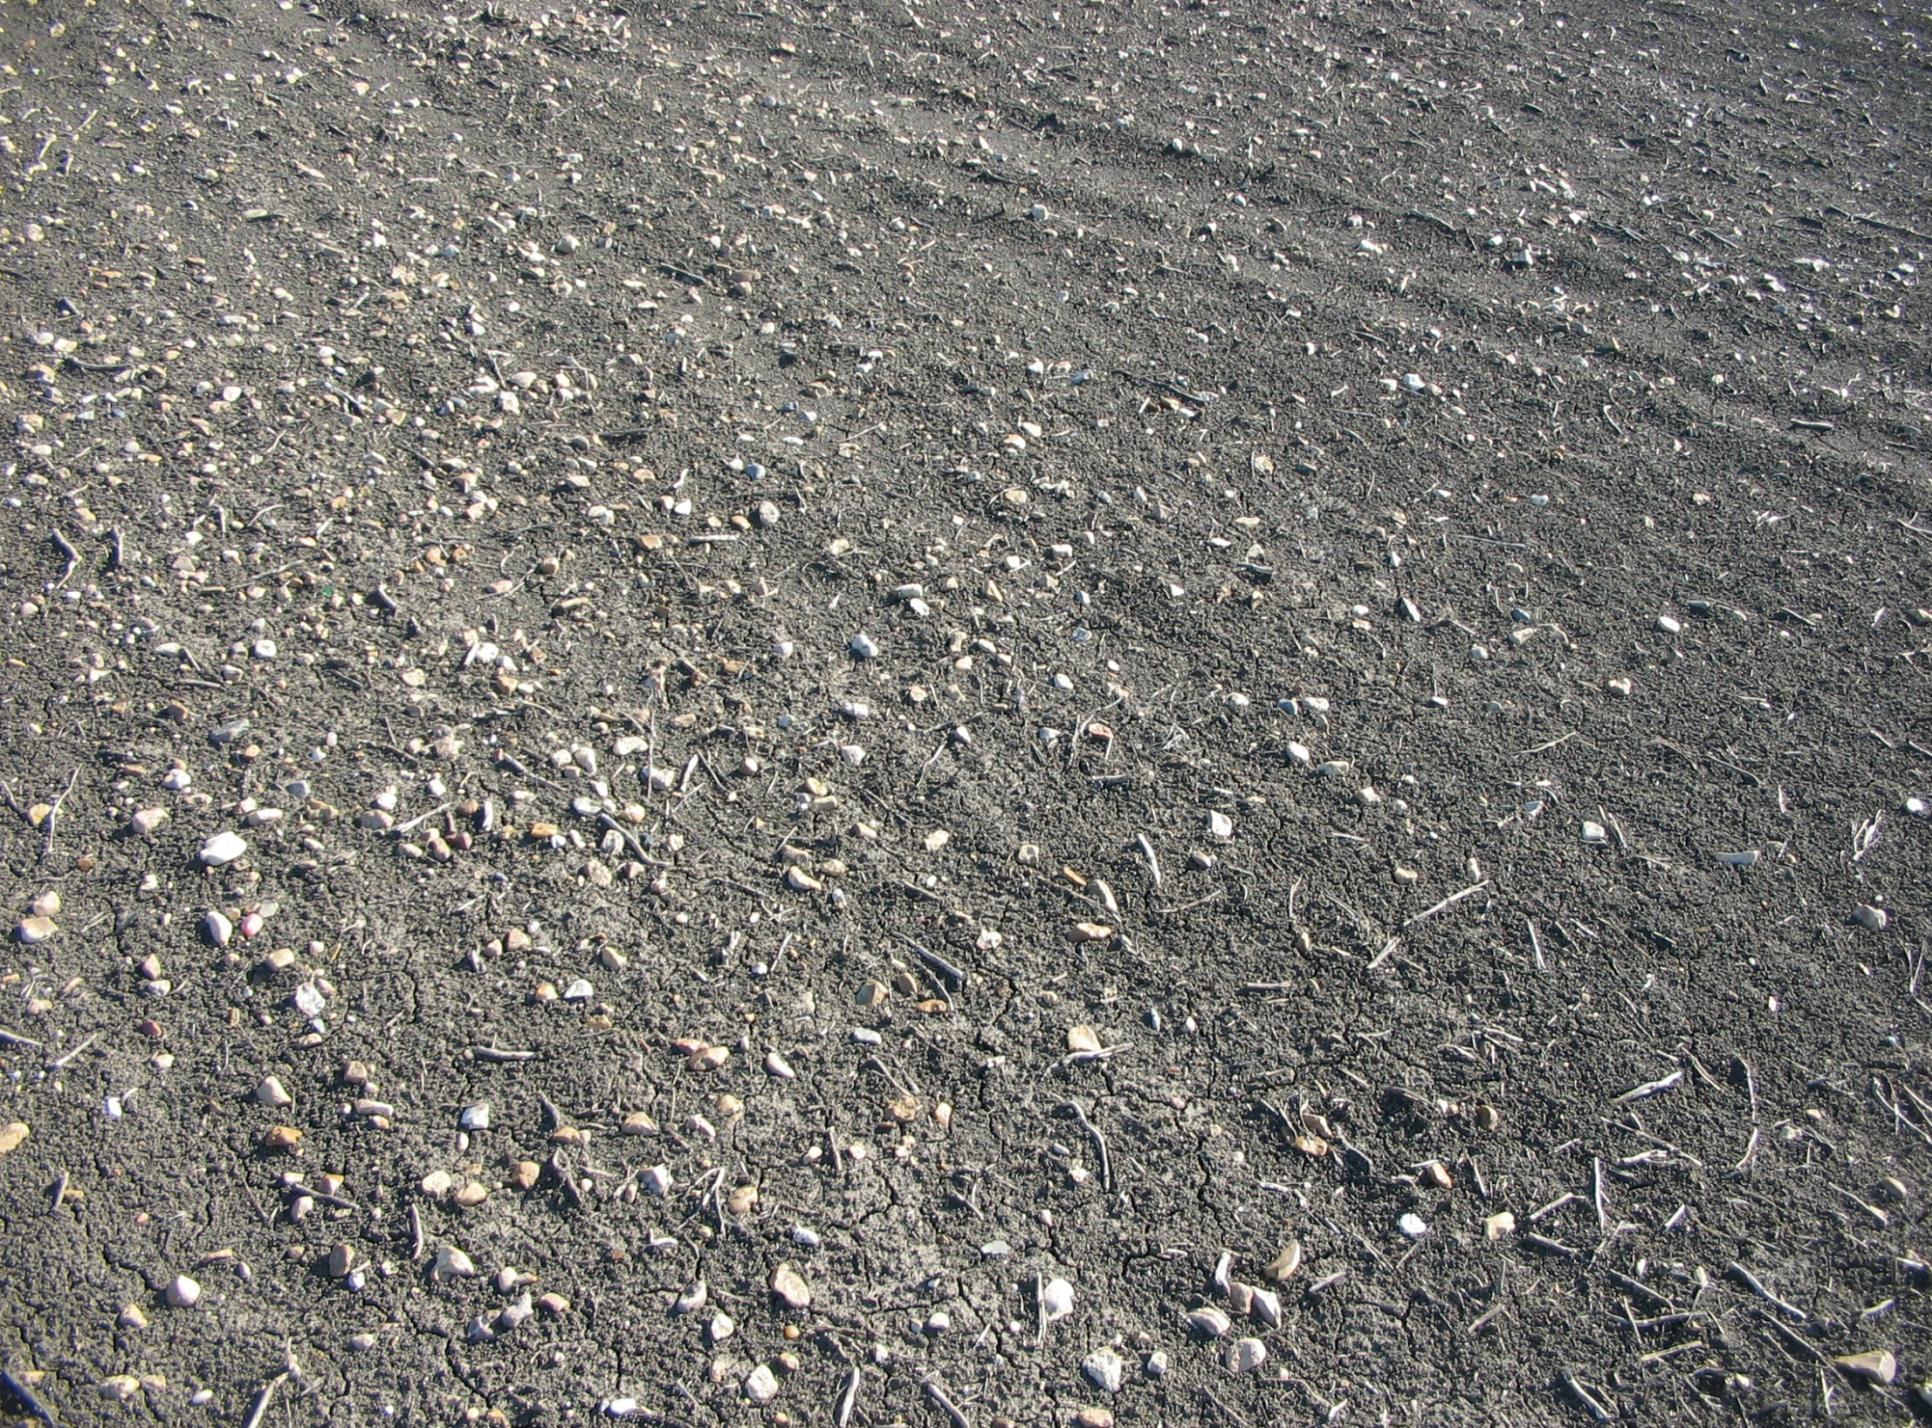
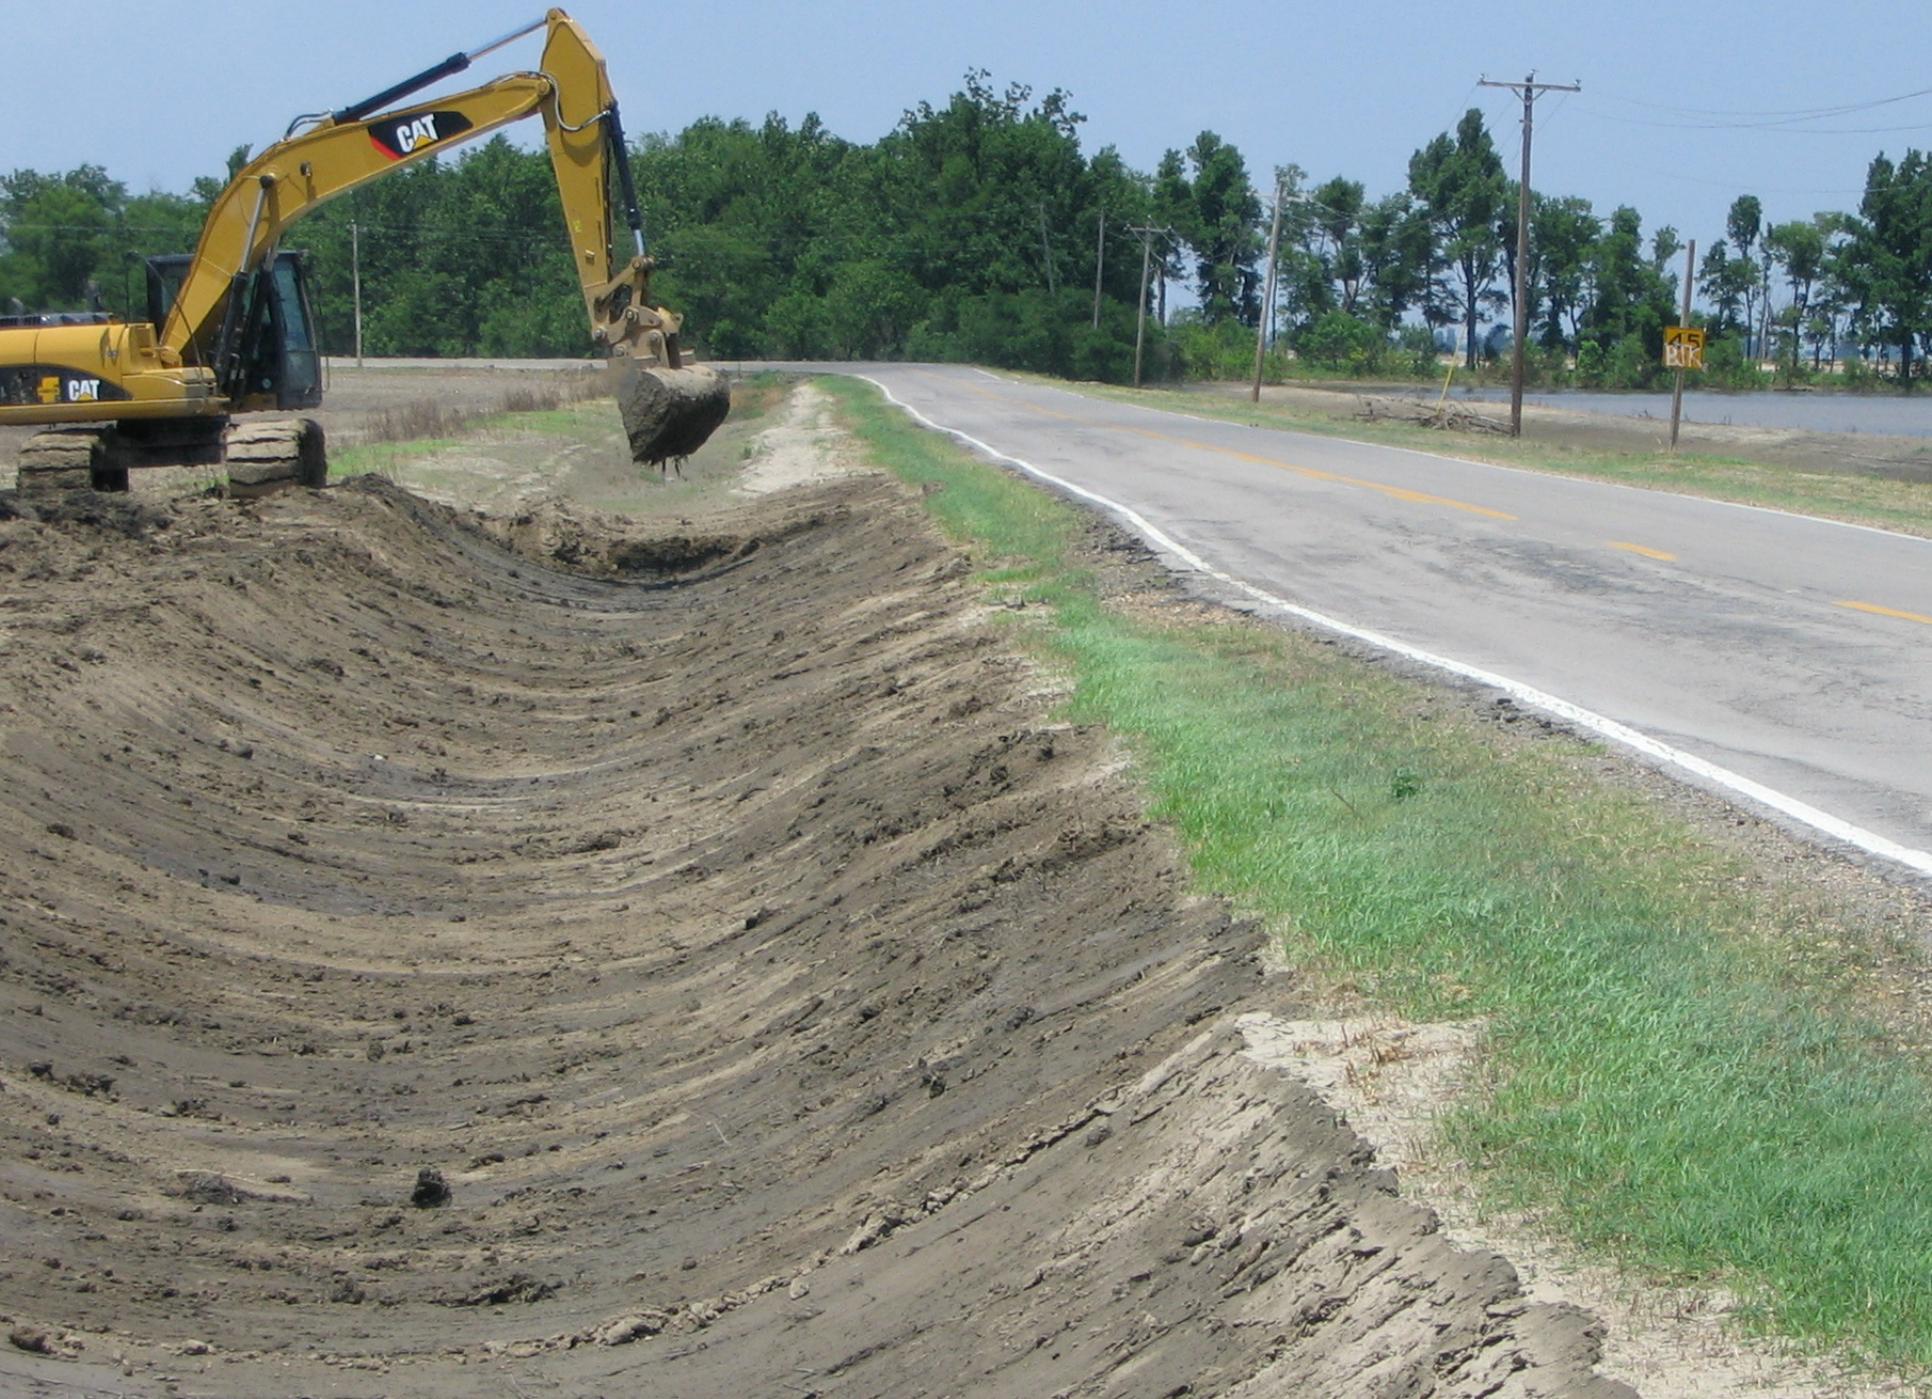
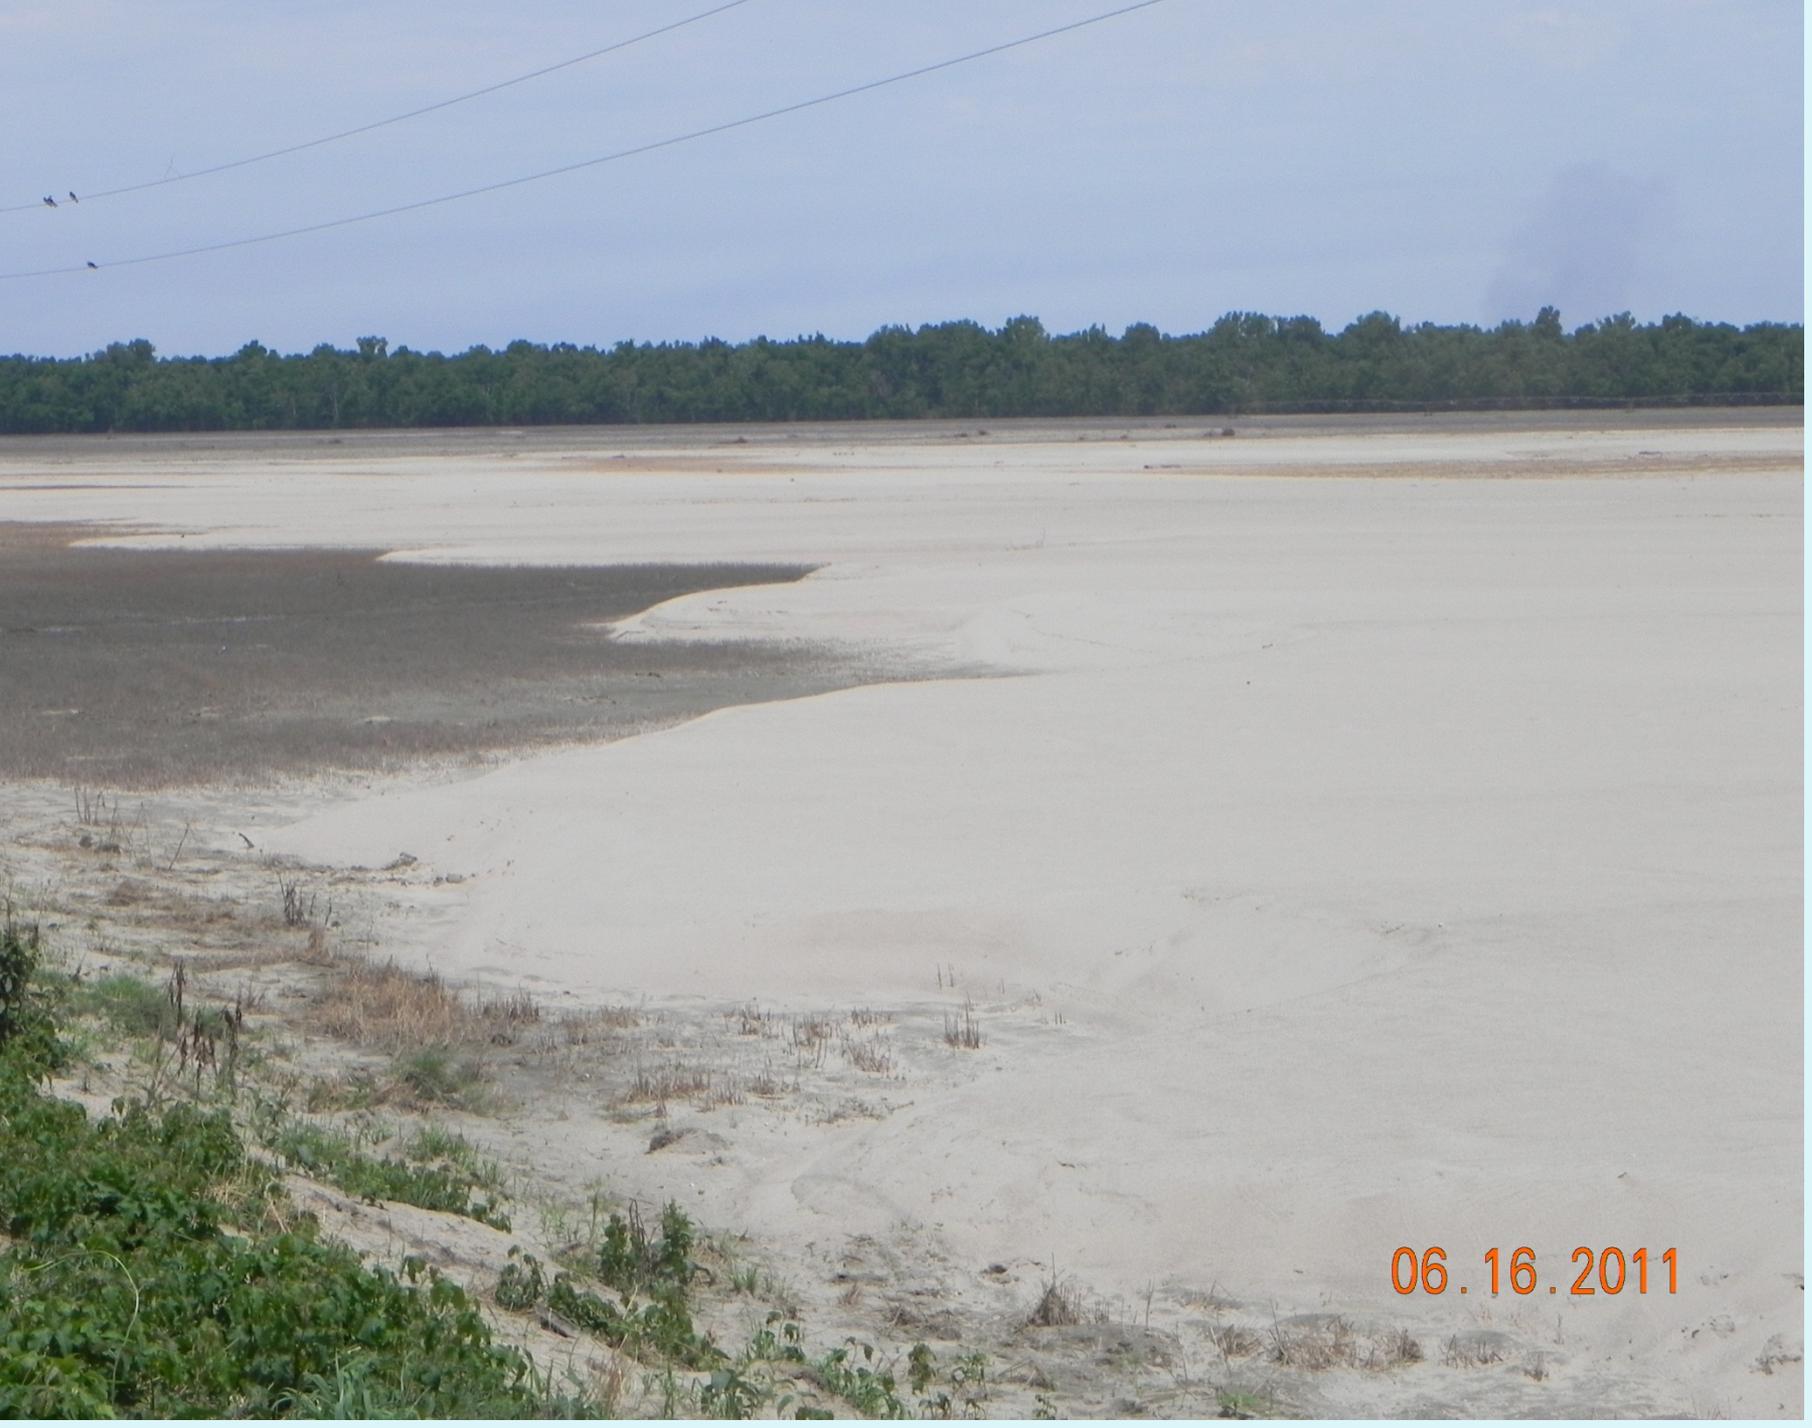
- All of the drainage ditches were filled with sediment and 30 excavators were required to open the channels and drainage ditches.
- Hundreds of acres of sand deltas were created with the largest being near Big Oak Tree State Park and the site of the frontline levee blast.

- The fuse plugs and frontline levee need to be repaired
- The crater lakes filled in.
- The gully fields reclaimed.
