# The Impacts of 2011 Induced Levee Breaches on Agricultural Lands of Mississippi River Valley

- By Kenneth R. Olson, Professor of Soil Science, NRES, ACES, UIUC and Lois Wright Morton, Professor of Sociology

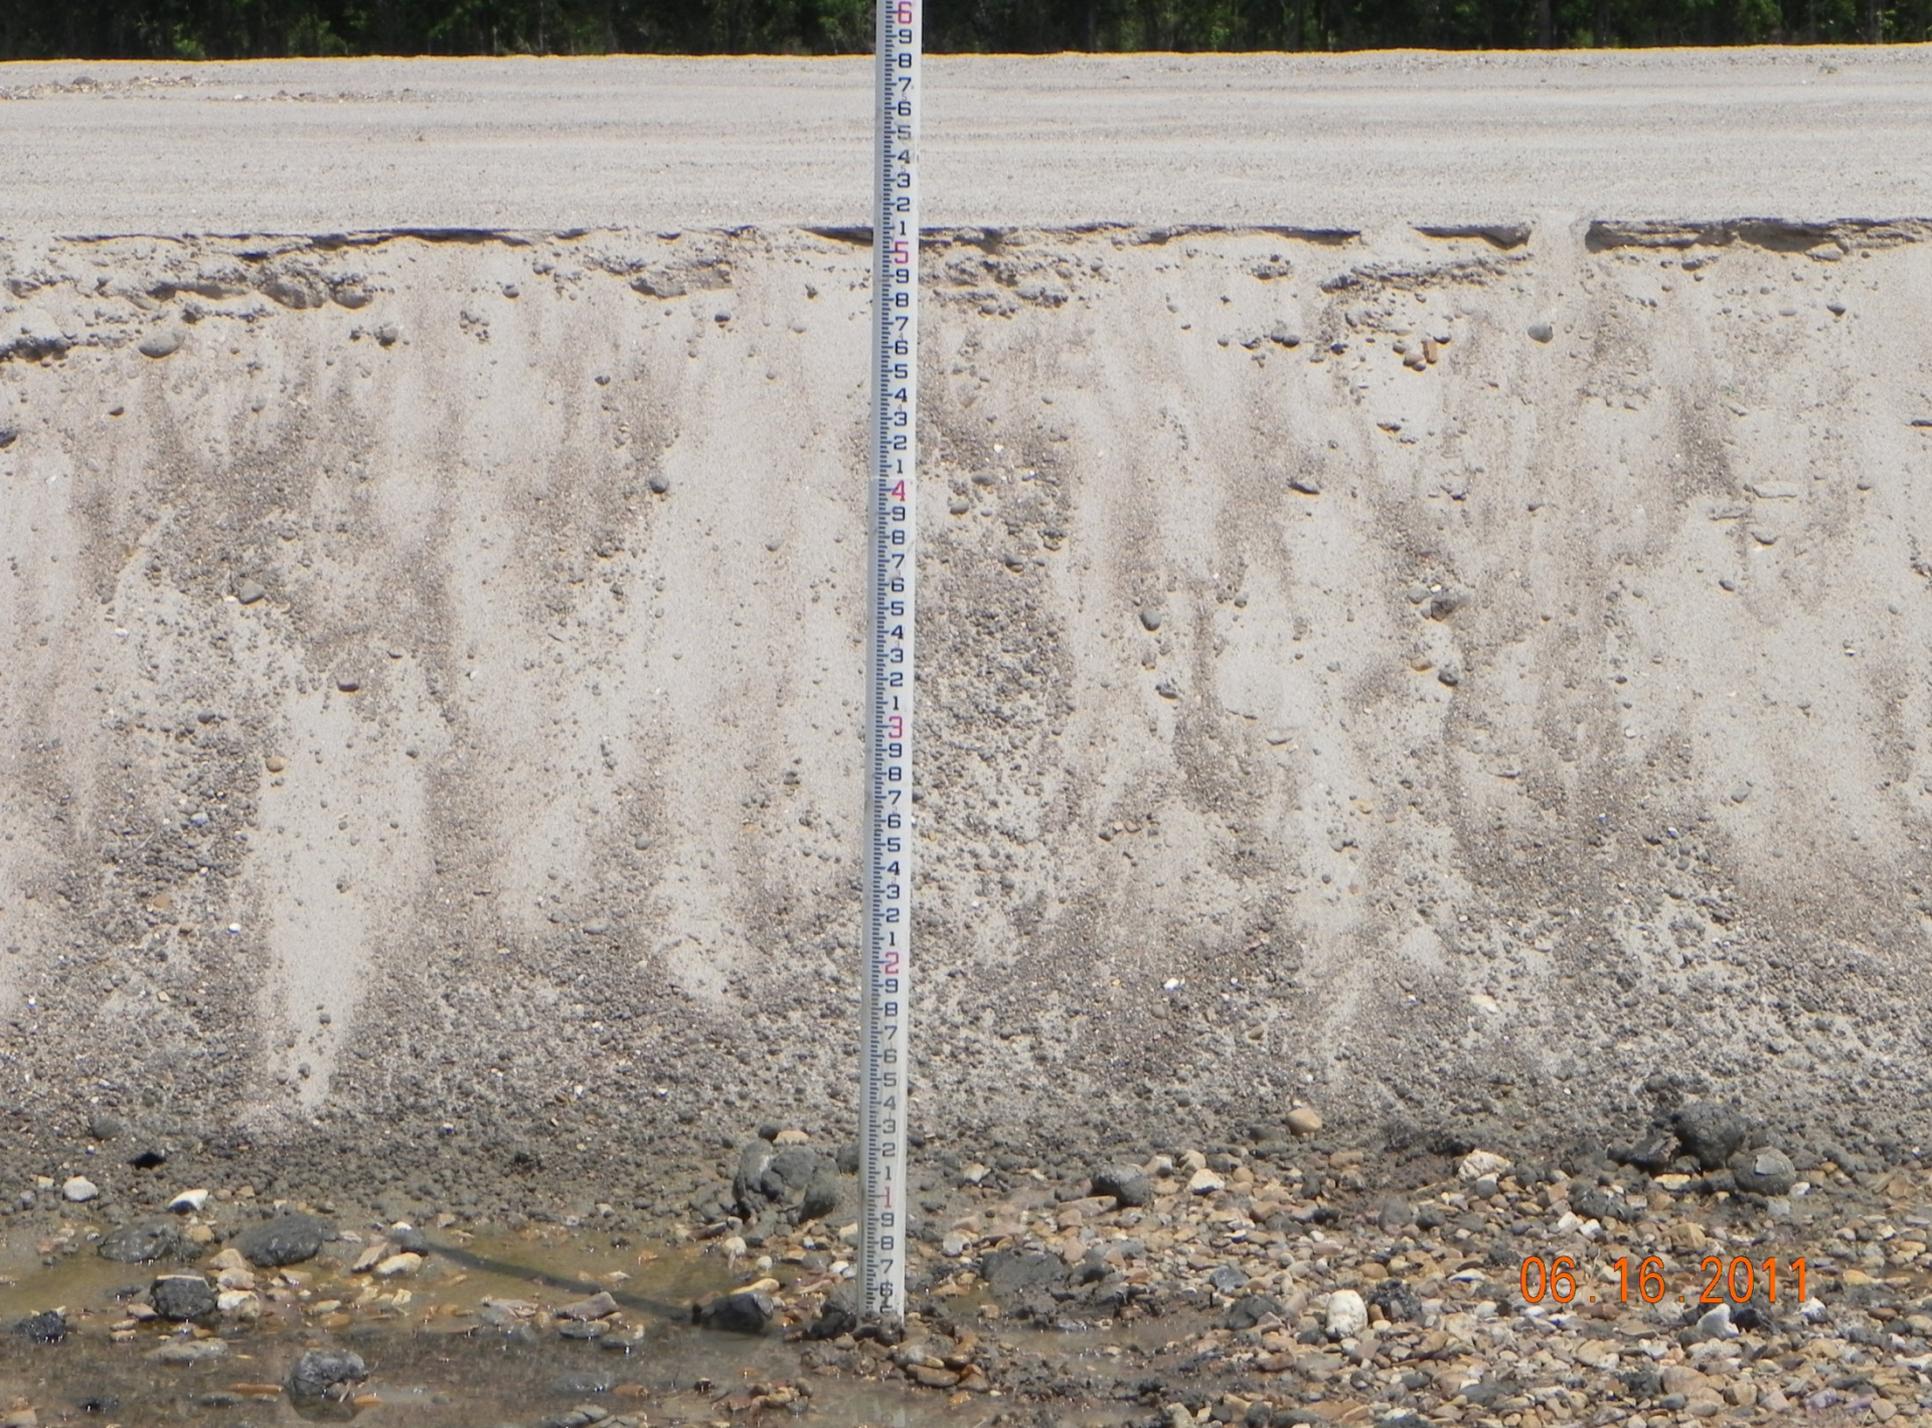
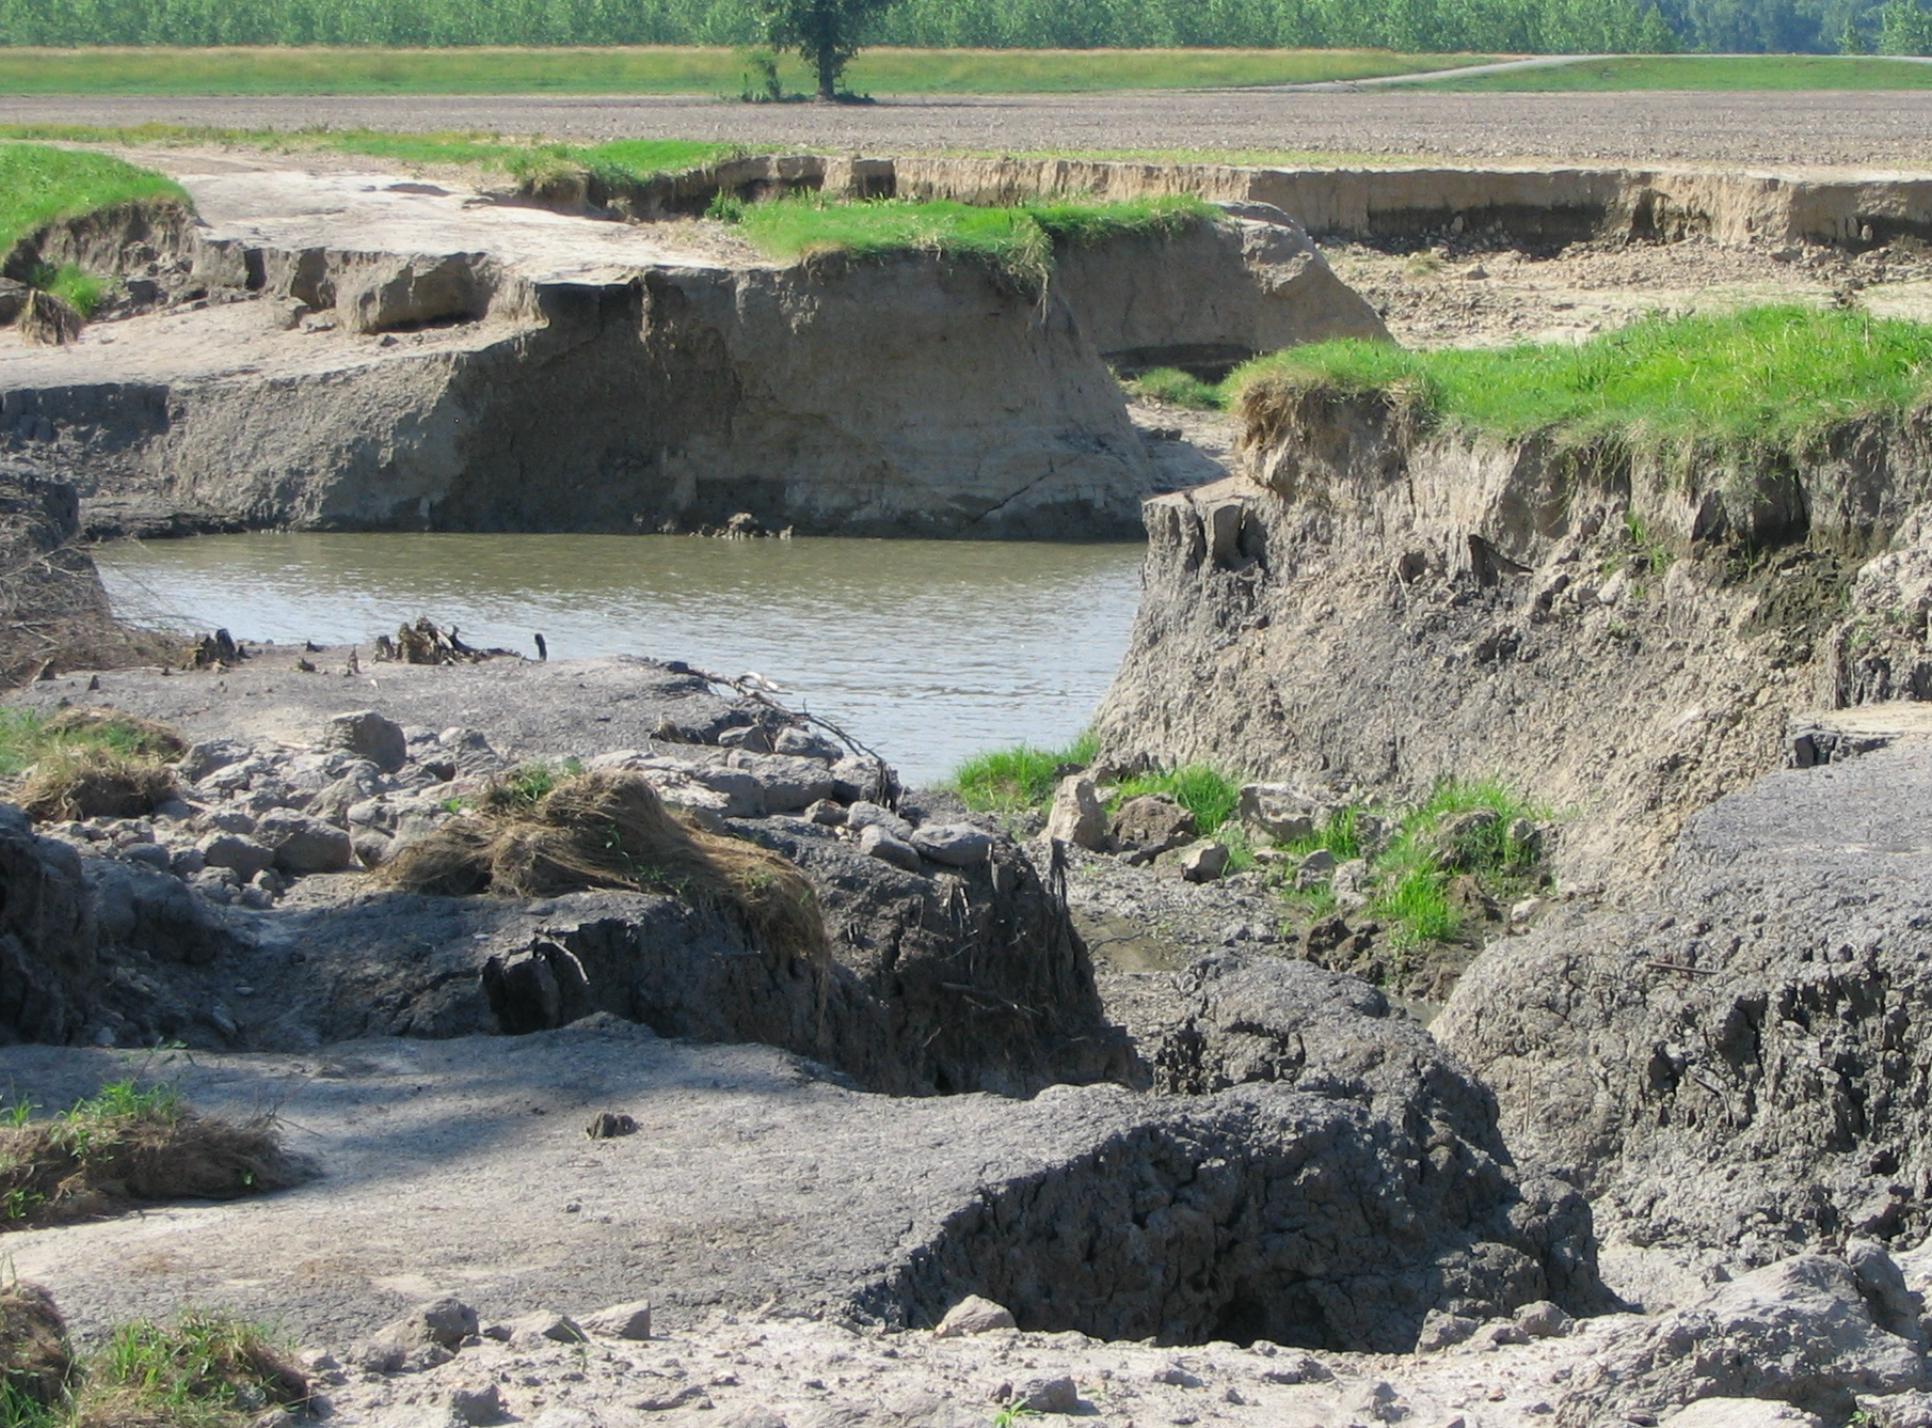
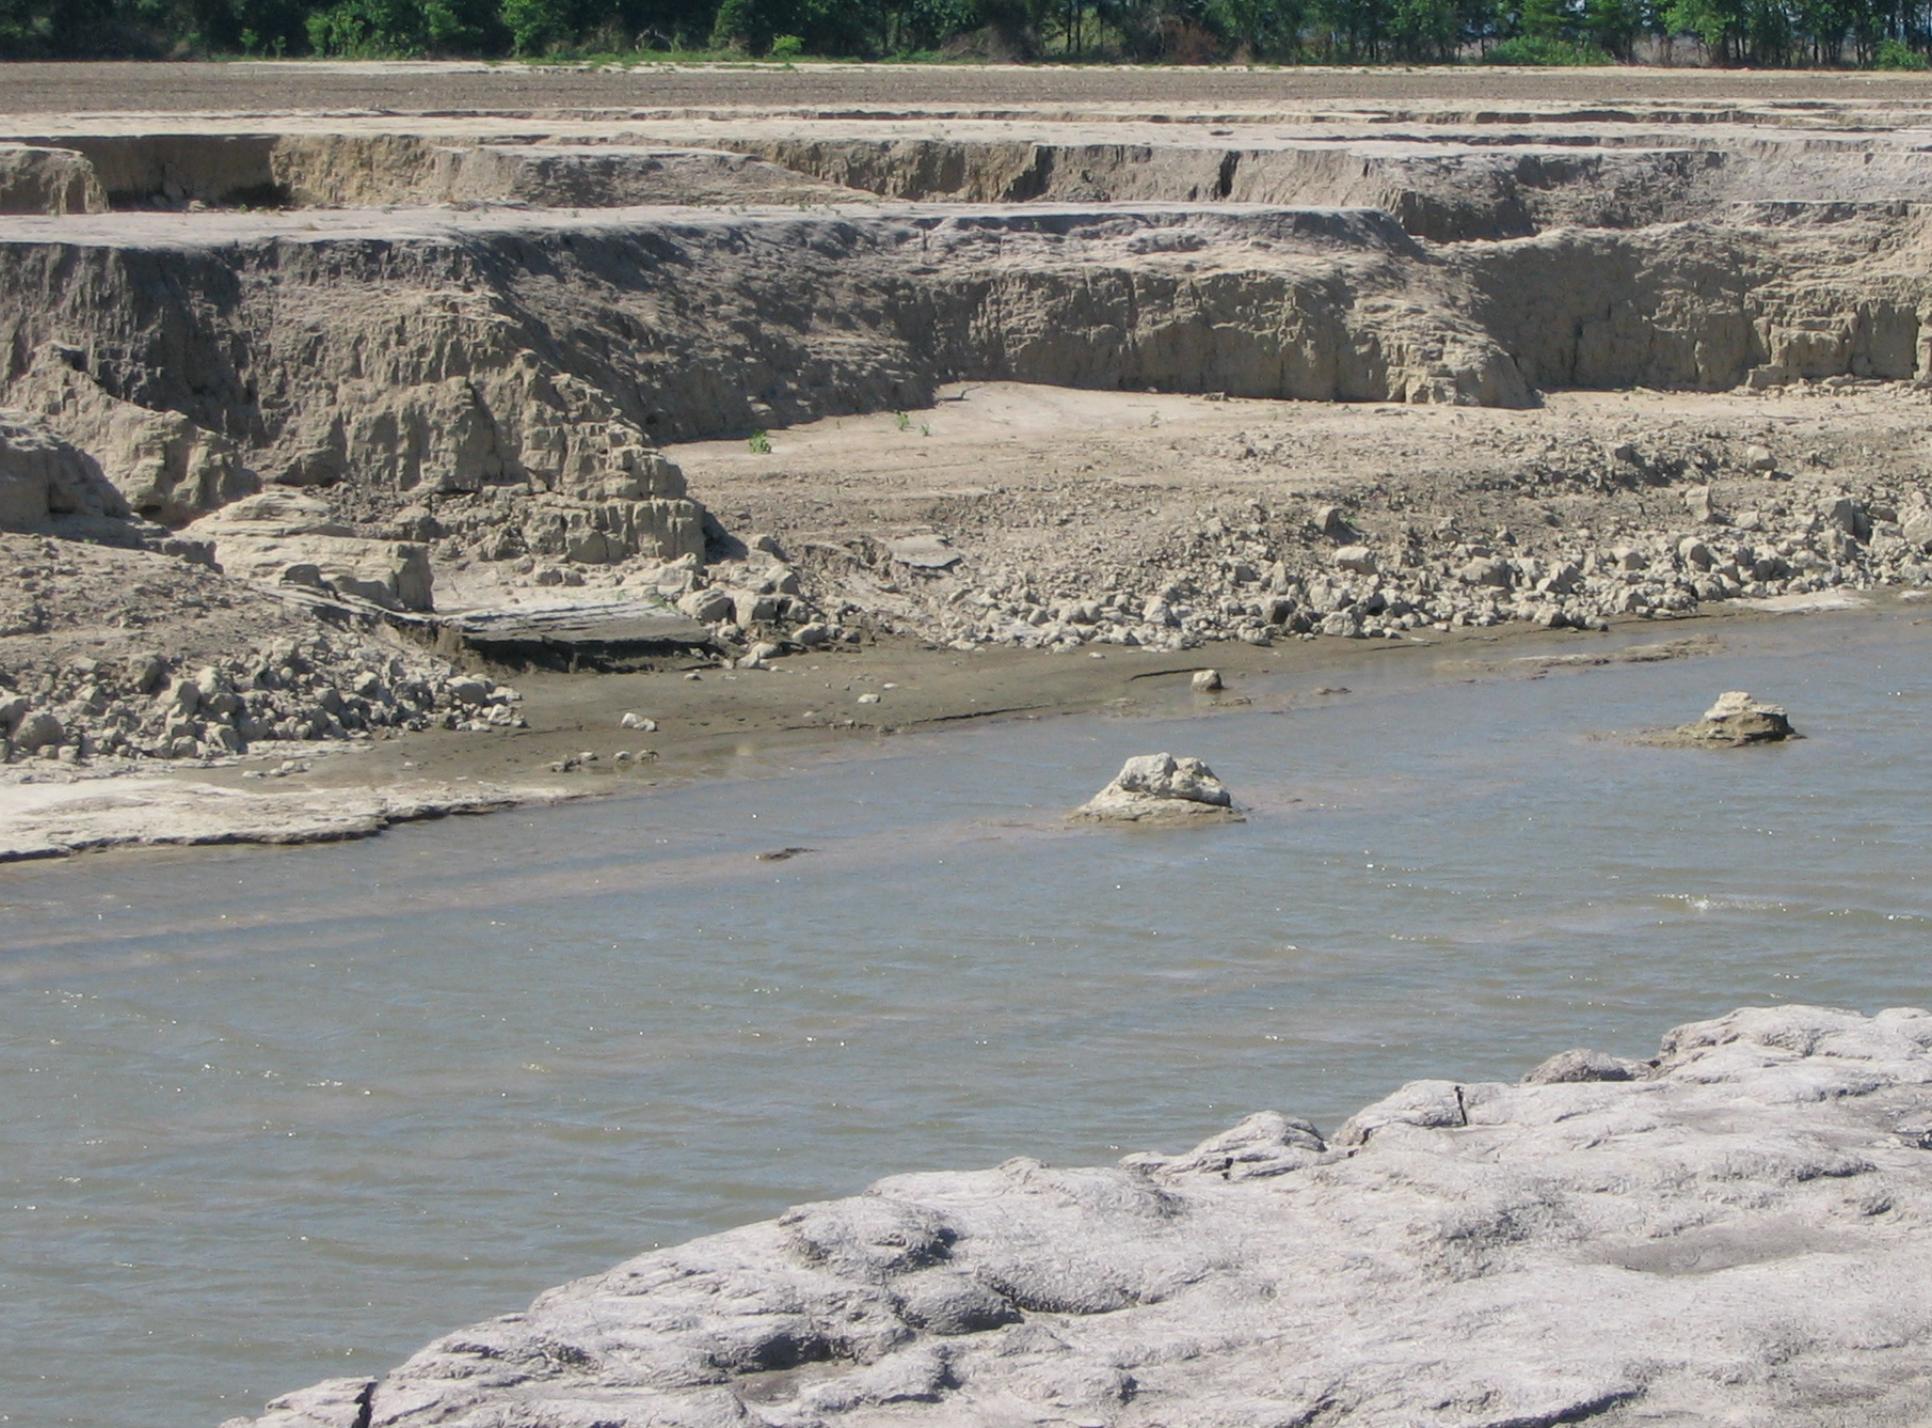
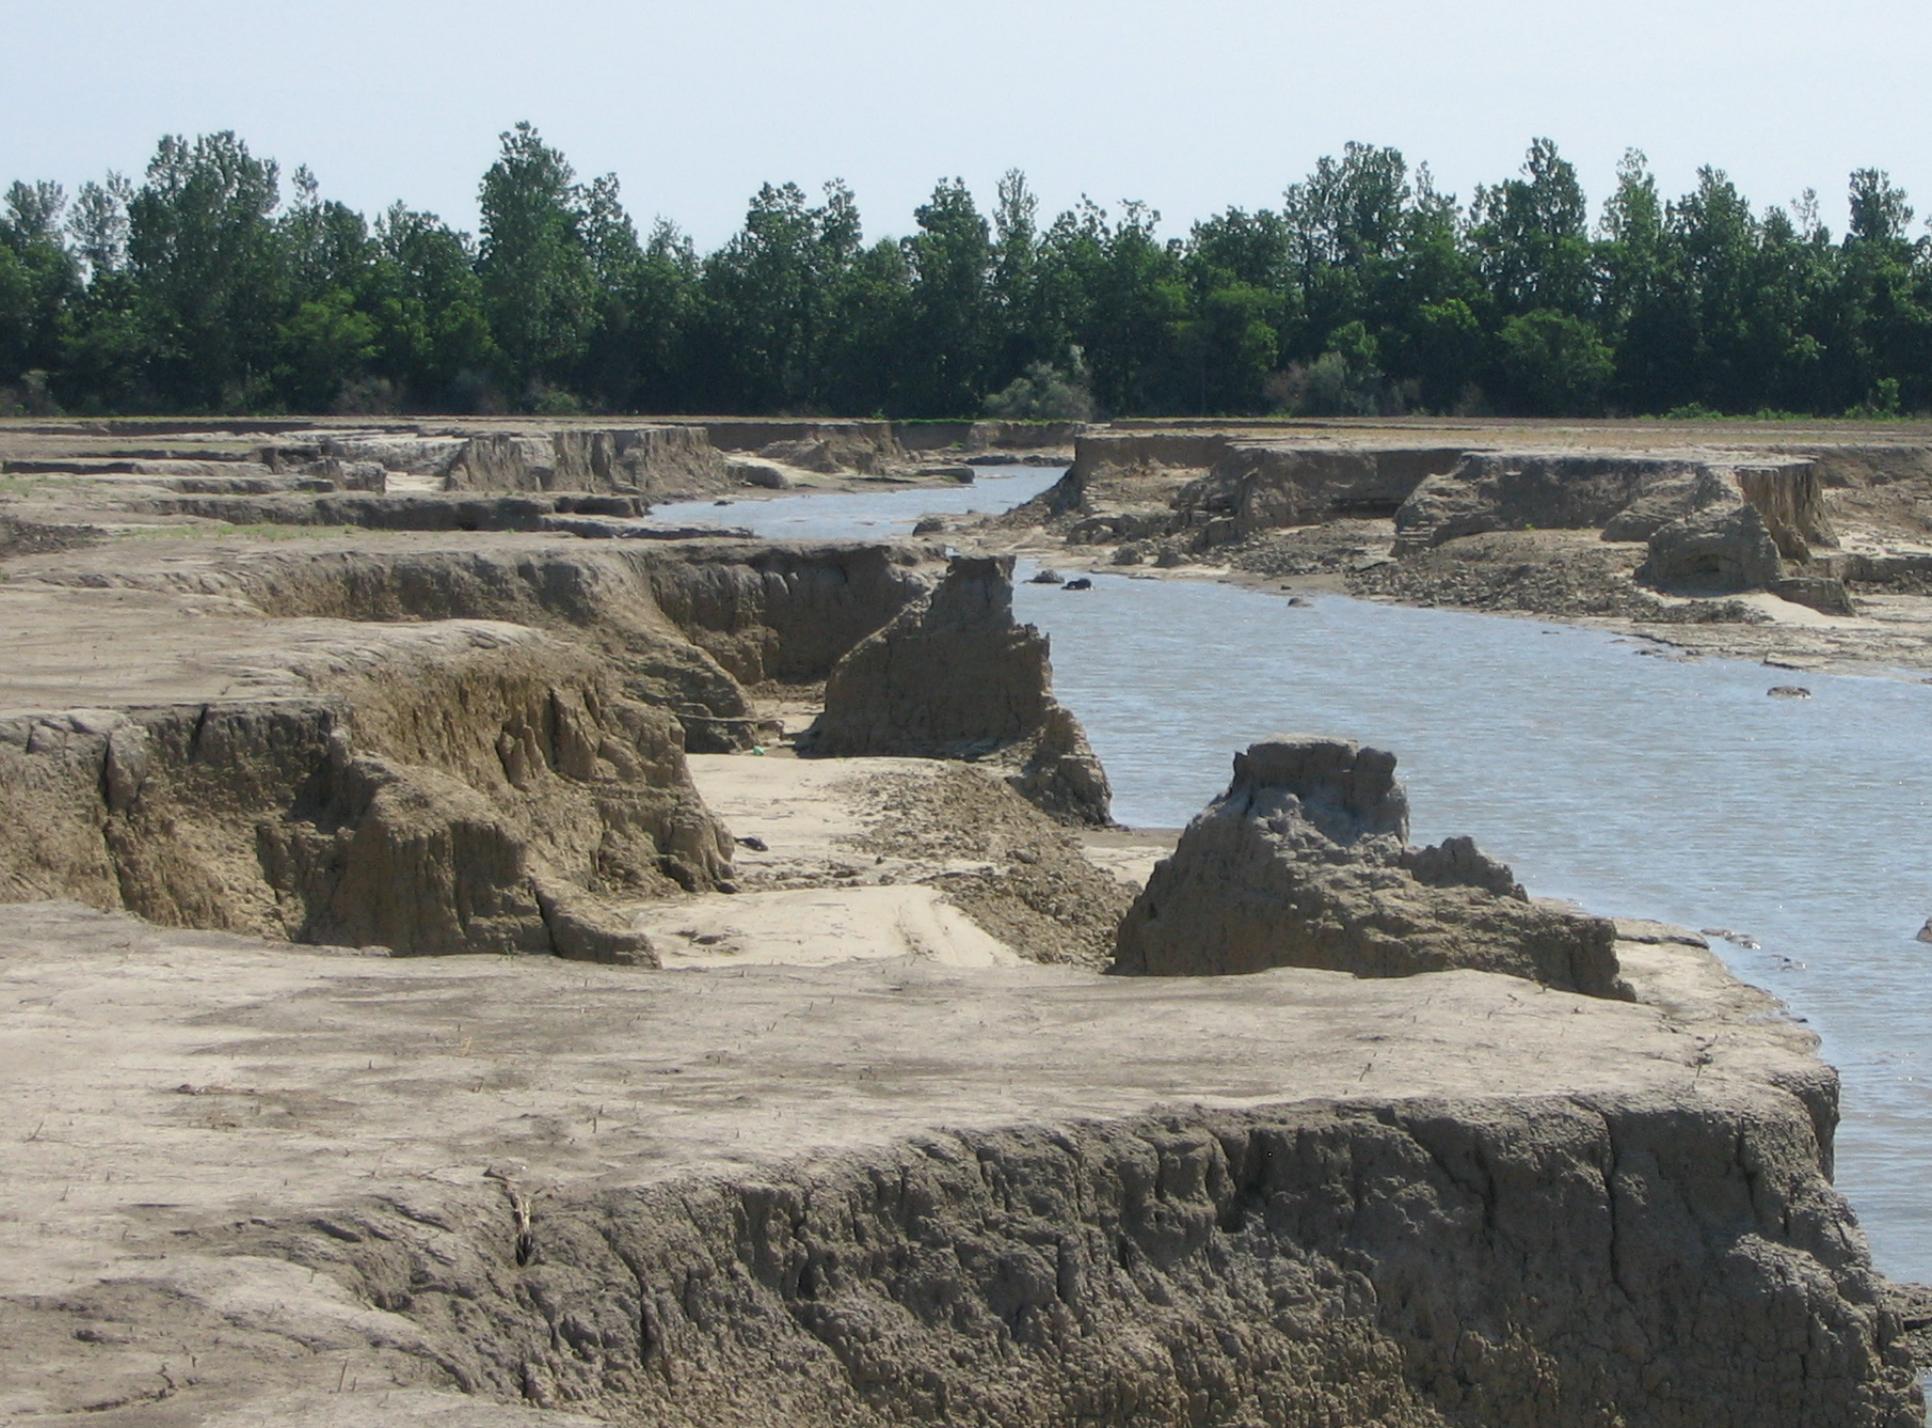
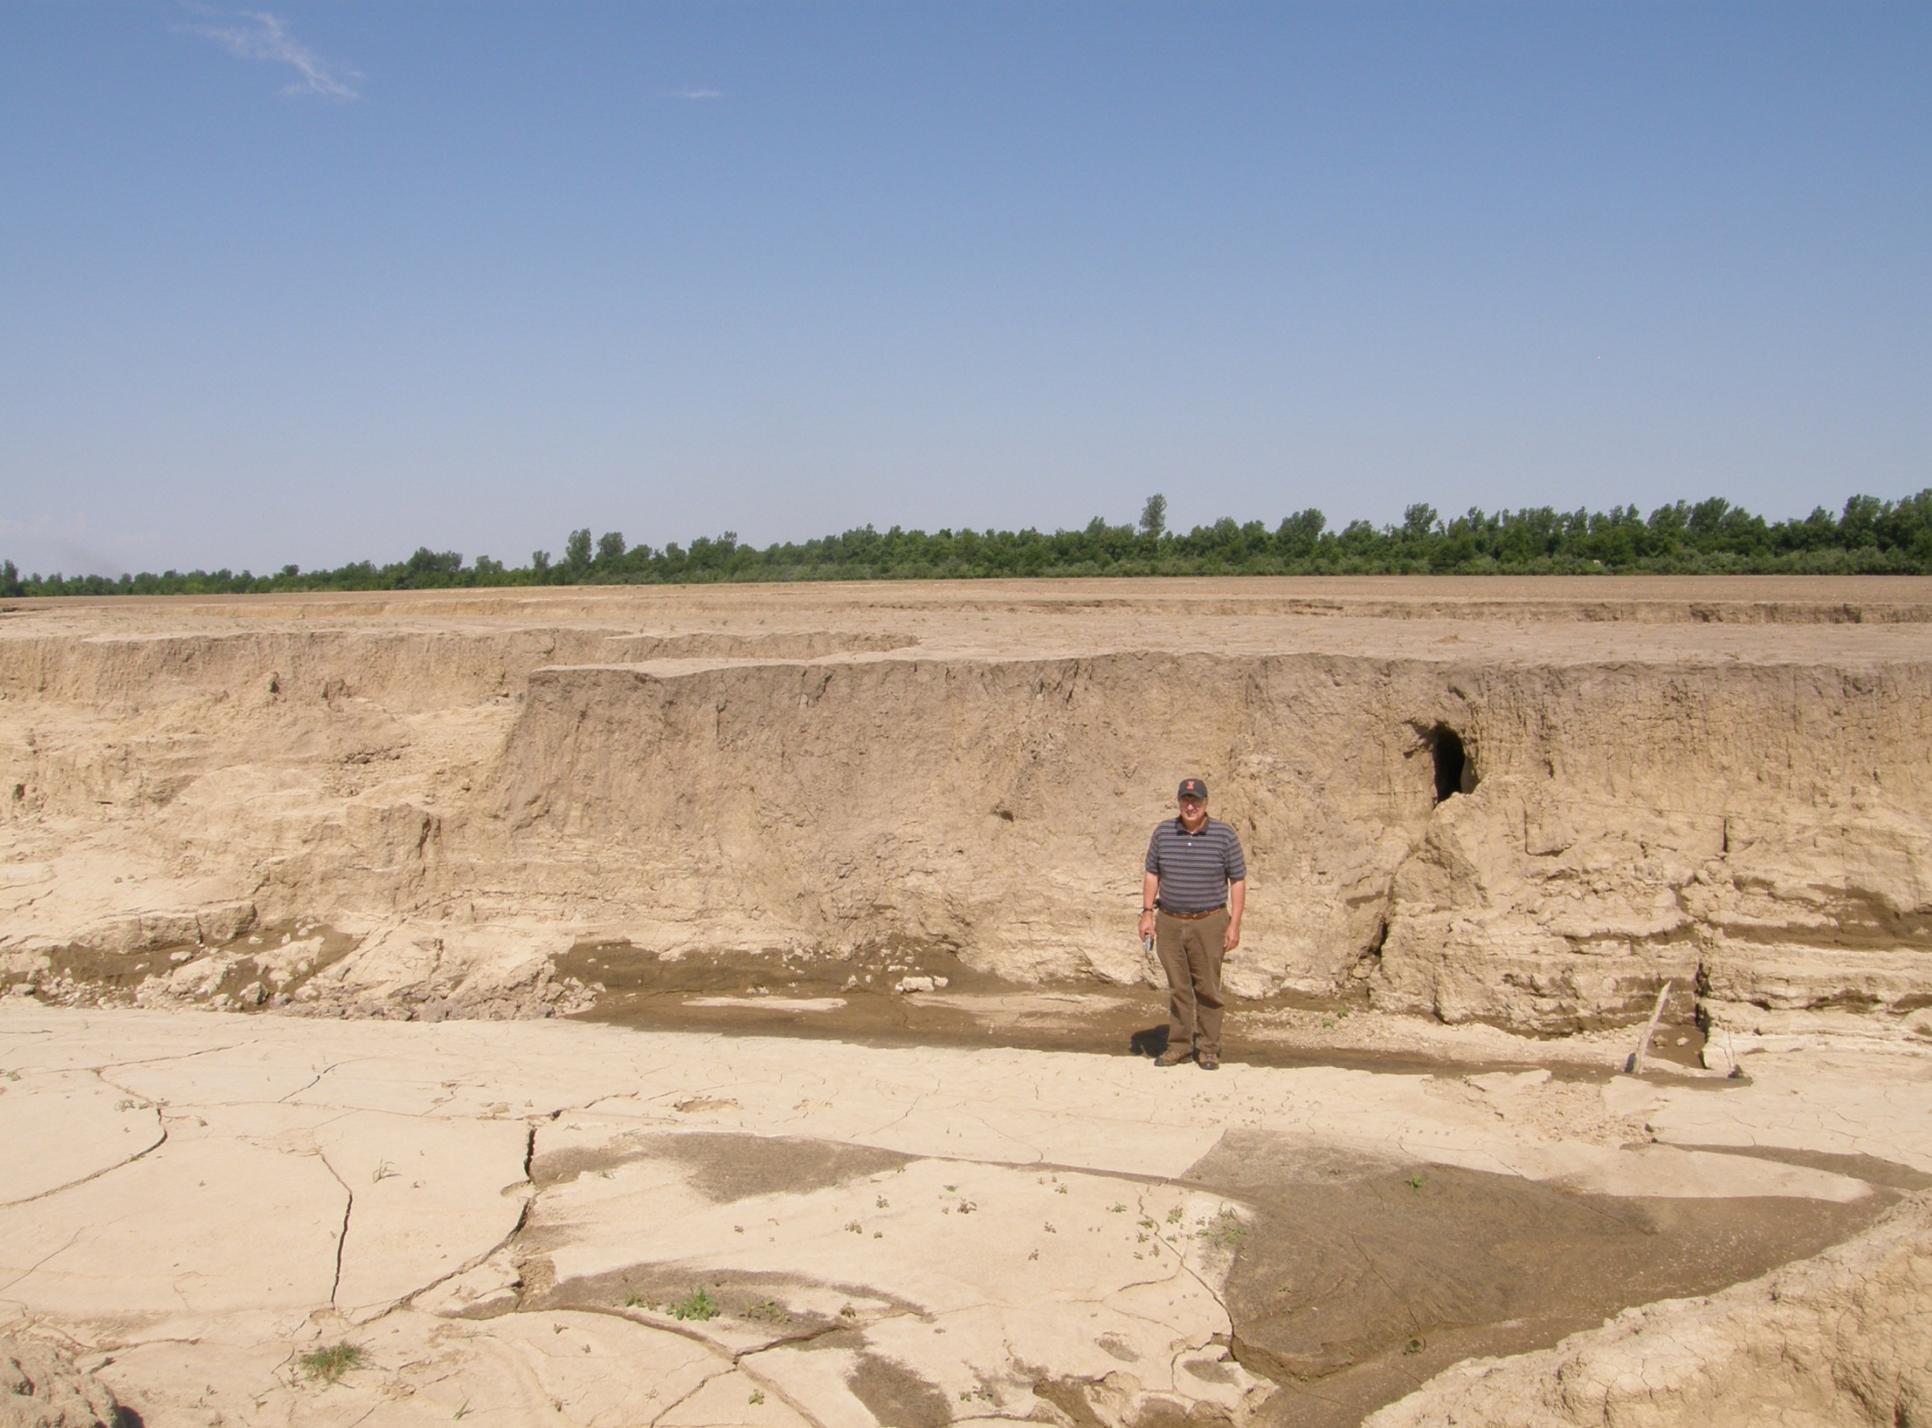
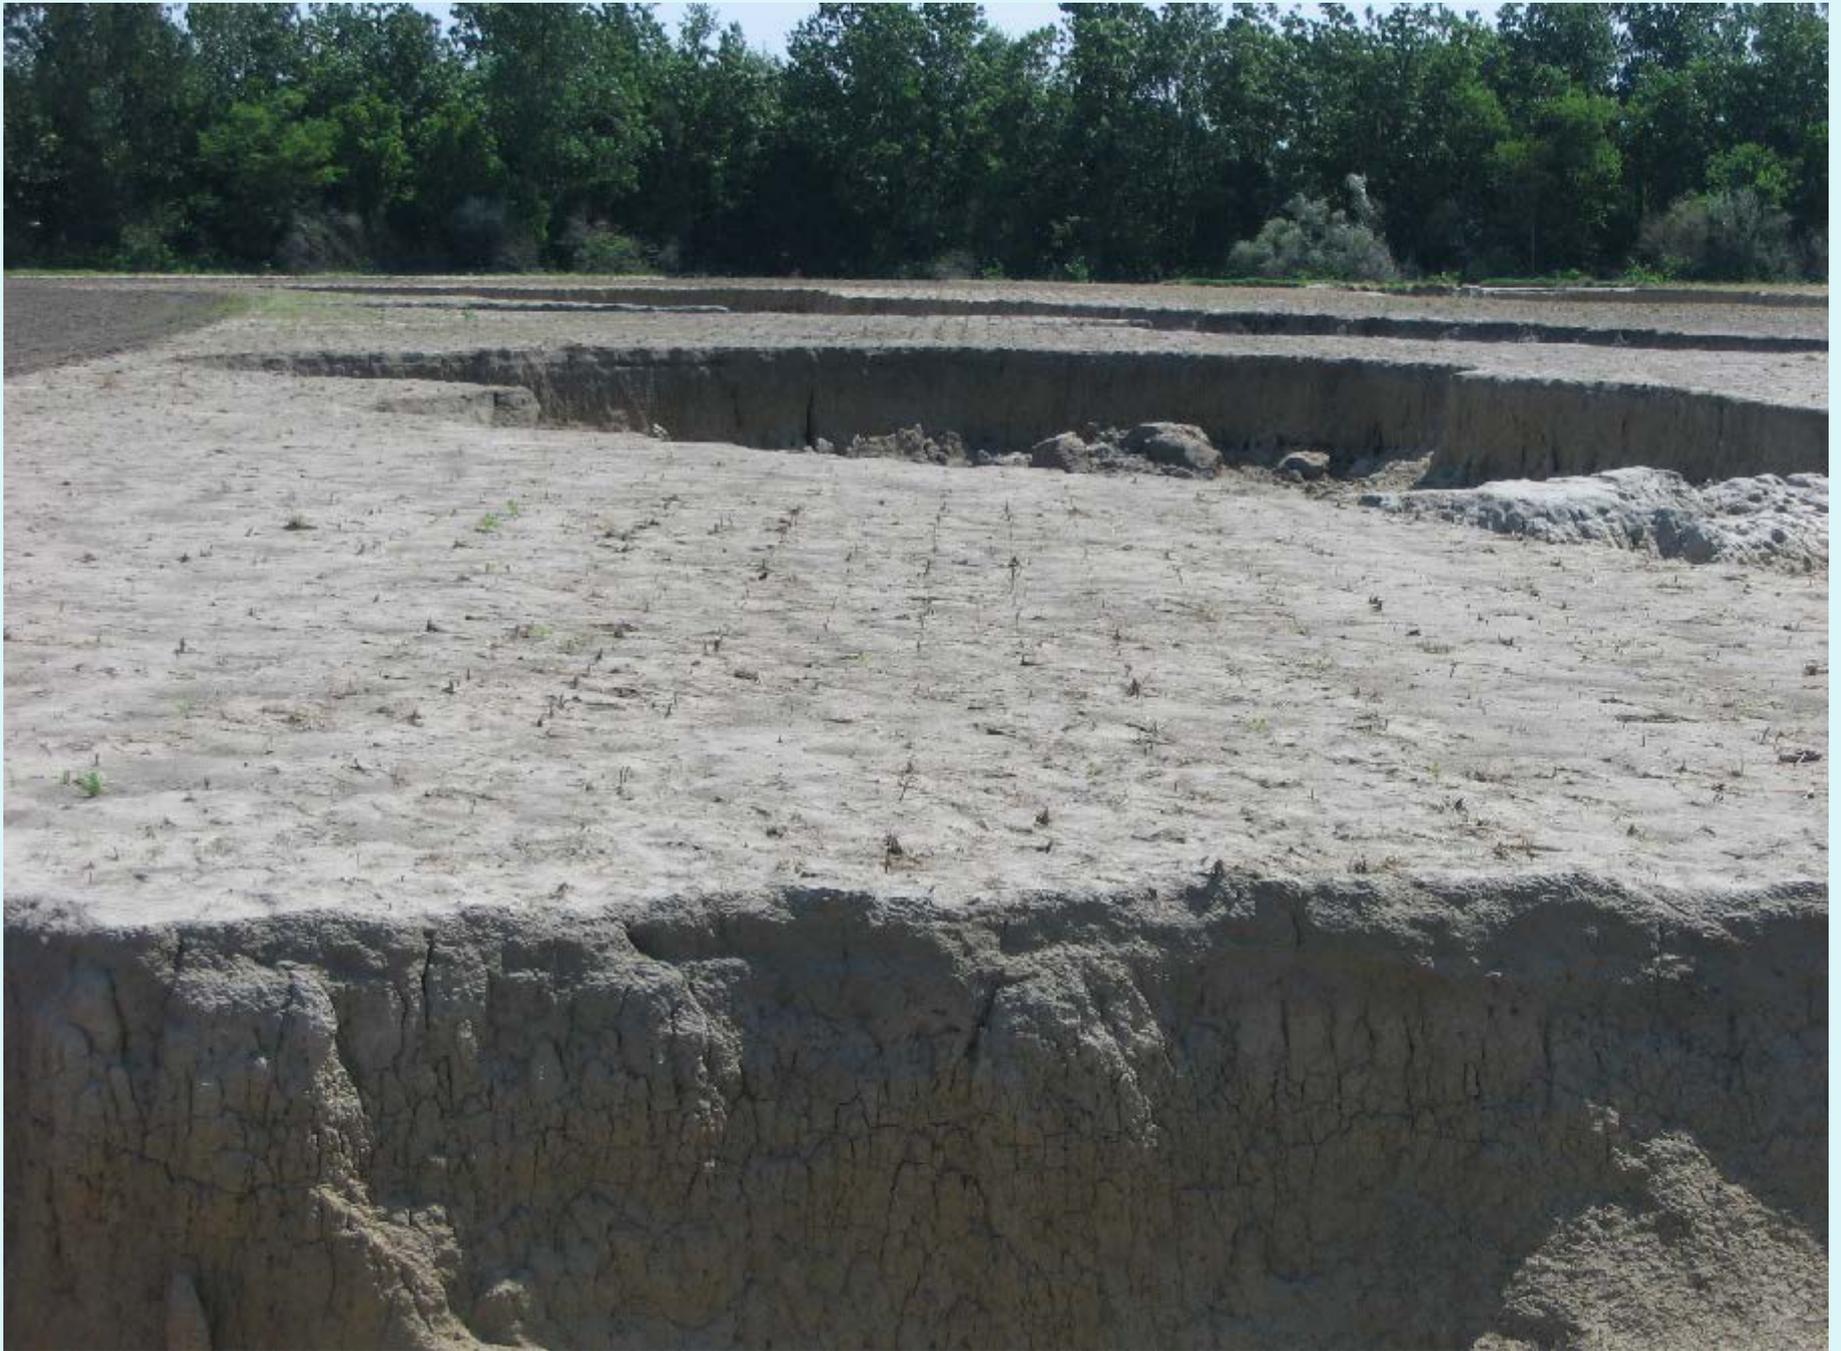
- All of the drainage ditches were filled with sediment and 30 excavators were required to open the channels and drainage ditches.
- Hundreds of acres of sand deltas were created with the largest being near Big Oak Tree State Park and the site of the frontline levee blast.

- The fuse plugs and frontline levee need to be repaired
- The crater lakes filled in.
- The gully fields reclaimed.
