**Supplemental Watershed Plan-Environmental Assessment
for the
Pohick Creek Watershed**

Supplement No. 4 to the original watershed plan for the rehabilitation
of Pohick Creek Watershed Dam No. 3 (Woodglen Lake)

Fairfax County, Virginia

June 2008

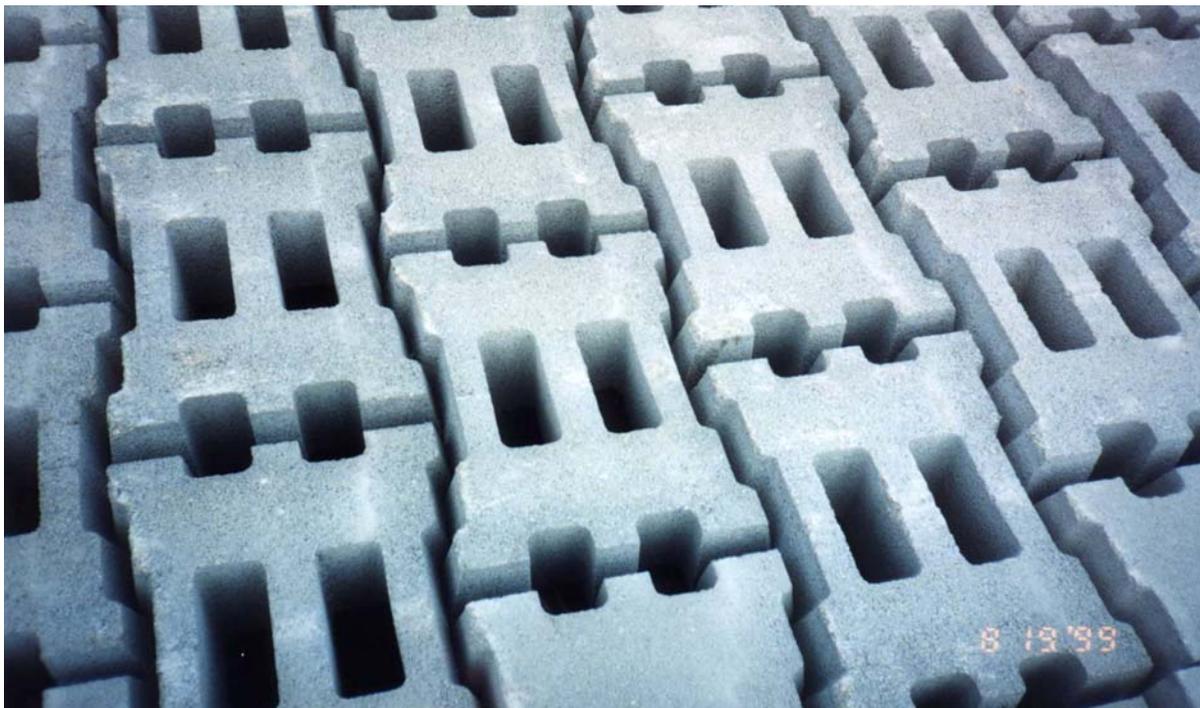
Figure 1. Open-Cell Articulated Concrete Blocks

The ACBs can be manufactured off-site and trucked in for installation which reduces the amount of space needed for a staging area.

Installation of Articulated Concrete Blocks would cost about \$1,940,000. This includes building the training dikes.

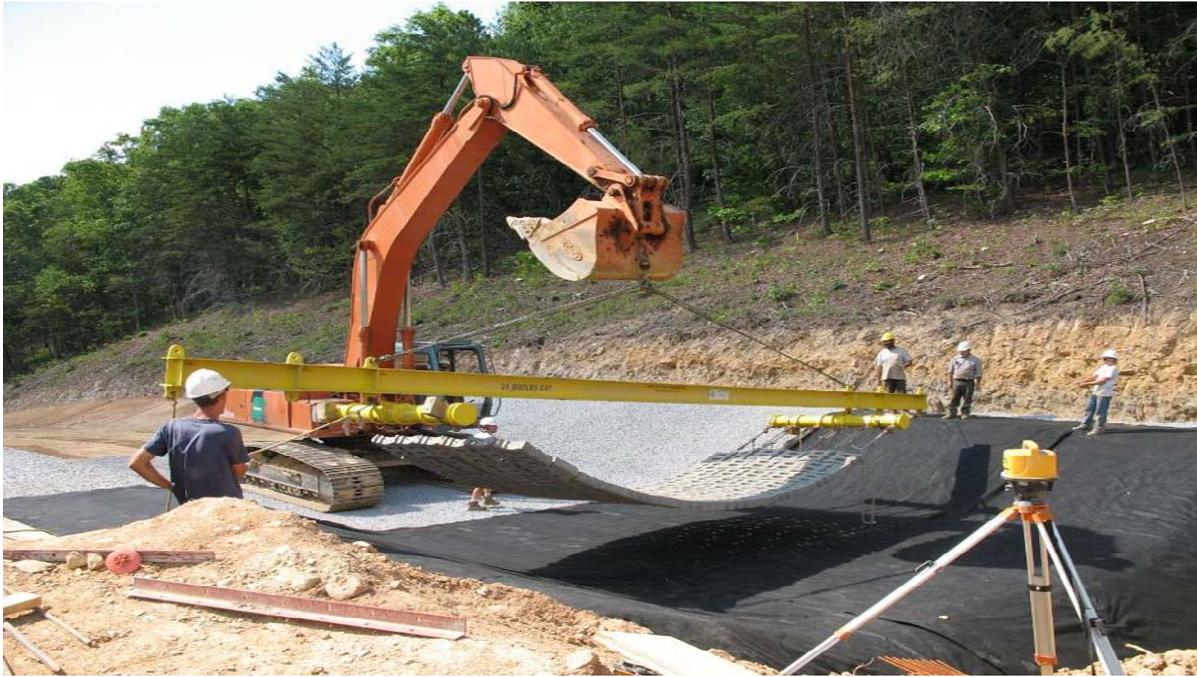
Figure 2. Installation of Articulated Concrete Block Mattress

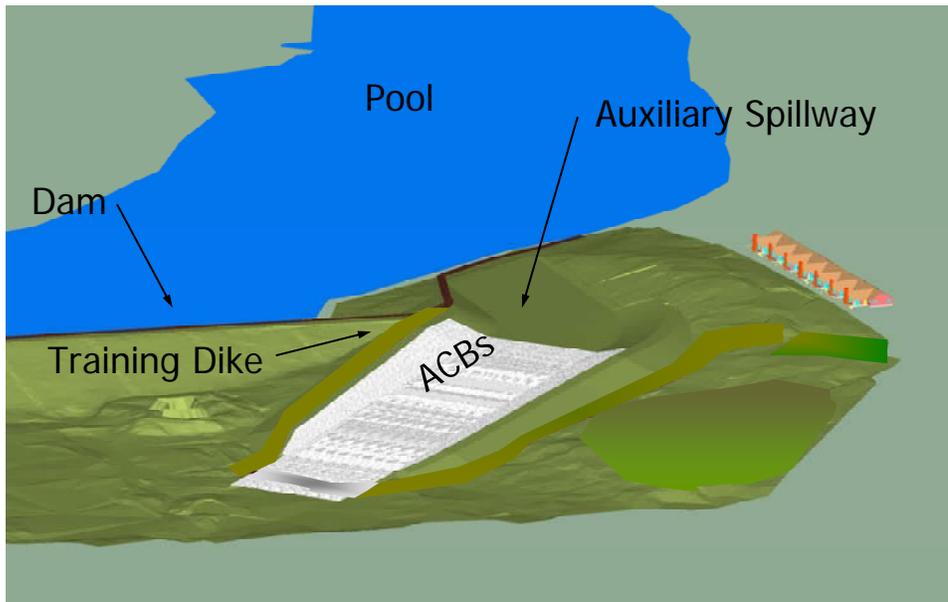
Figure 3. Perspective View of Recommended Alternative

The potential solutions were evaluated for cost and engineering feasibility. This information was presented to the Sponsors at a meeting on November 8, 2007, and to the public at a meeting on November 28, 2007. The selected alternative for Woodglen Lake is install earthen training dikes to control the flow direction of the water and to armor the spillway and interior slopes of the training dikes with ACBs. The construction cost for this solution would be \$1,940,000.

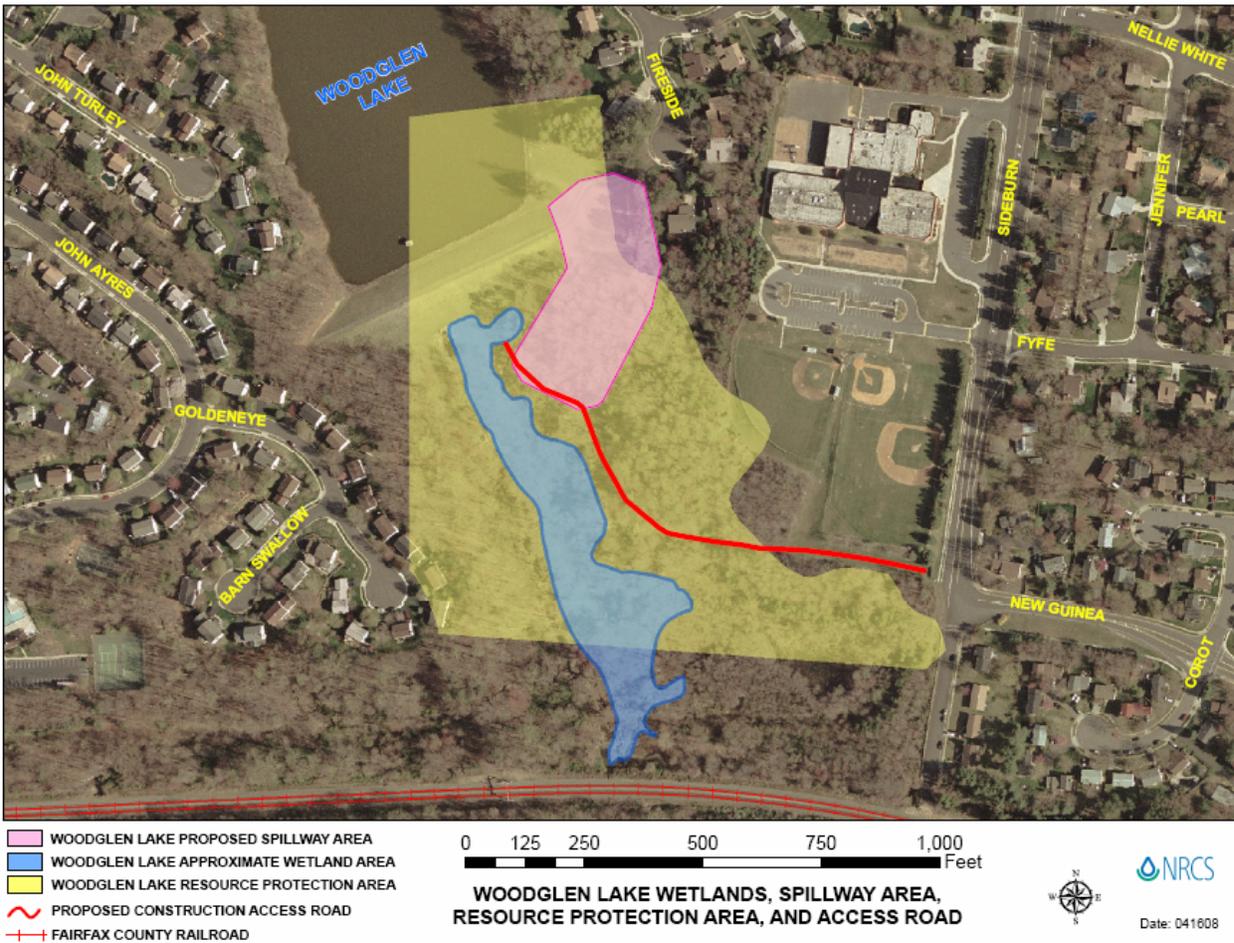
The map on page 47 depicts a section of the RPA which intersects with the proposed spillway area. In addition, the map shows the downstream wetlands and the location of the proposed access road for construction. The actual impacts to the forested areas, RPA, and wetlands, will be determined during final design of the project. Impacts to these important resources will be avoided, minimized or mitigated as required.

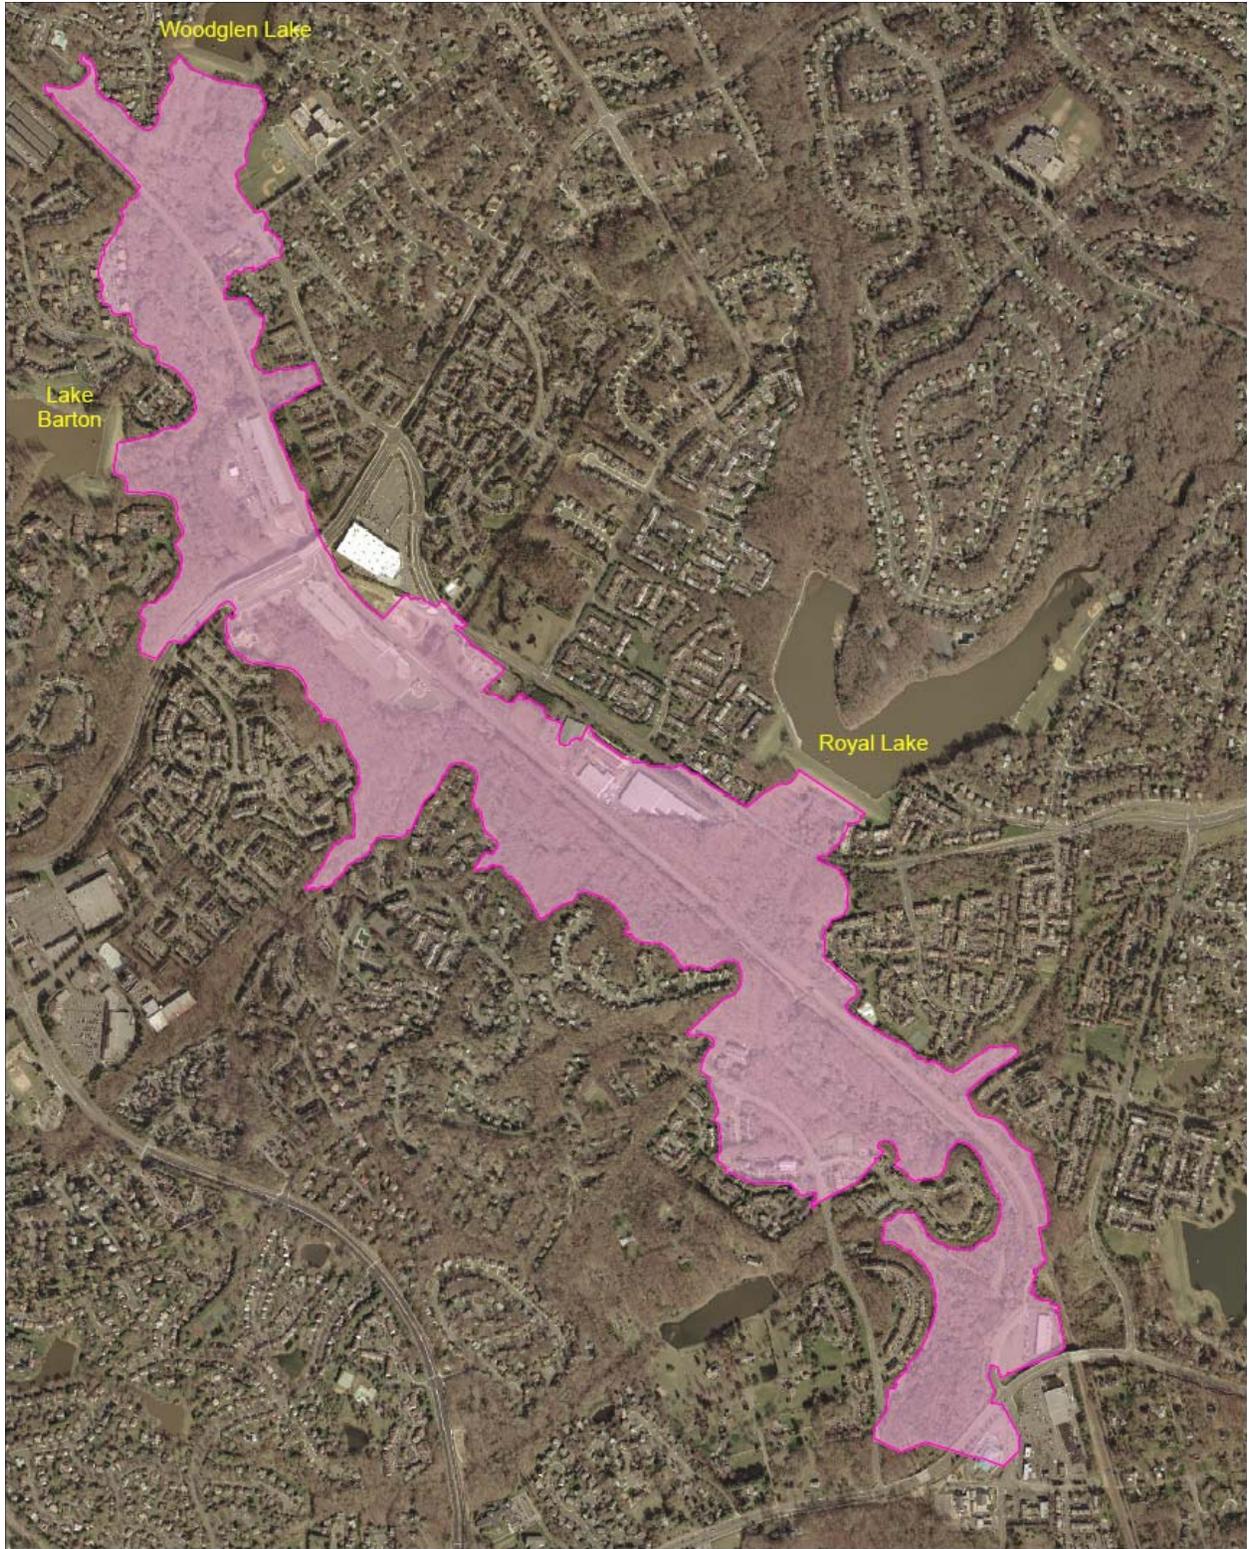
**WOODGLEN LAKE - POHICK CREEK 3
BREACH INUNDATION ZONE FROM
AMT - ENGINEERING ANALYSIS**

The maximum breach discharge of 54,283 cfs was computed using the criteria in Technical Release No. 60, Earth Dams and Reservoirs. The As-Built drawings dated December 1981 and the field surveyed data obtained for Lake Woodglen were used to determine the maximum height used in the breach discharge. The As-Built data was used for determining the depth of water (H) of 38.4 feet at failure.

The breach inundation zone analysis will be used by the Sponsors to update the Emergency Action Plan (EAP) that currently exists for the dam. The purpose of an EAP is to outline appropriate actions and to designate parties responsible for those actions in the event of a potential failure of the dam. The Sponsors will update the EAP annually with assistance from local emergency response officials. As resources allow, NRCS will provide technical assistance with updating the EAP. The NRCS State Conservationist will ensure that a current EAP is prepared prior to initiation of construction.
