Natural Resources Conservation Service – Caribbean Area

Guánica / Río Loco Update

2nd Qtr FY15

RÍO LOCO / GUÁNICA BAY WATERSHED PROJECT IMPLEMENTATION UPDATE 2015

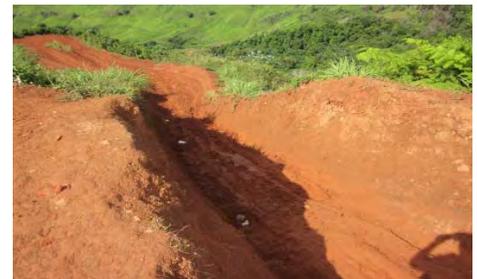
Heavily eroded farm trail. Some farmers charging fees for off-road enthusiasts to use farm trails.
Photo by M Rodriguez, NRCS-CB.

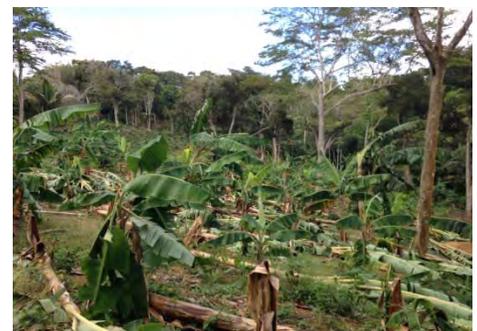
August 2014 tropical storm damages to plantain crop in Yauco.
Photo by M Rodriguez, NRCS-CB.

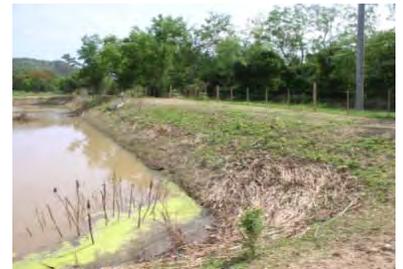
Sediment and debris trapped in sediment control basin at Maria Antonia Farm.
Photo by: L H Rosado, NRCS-CB.

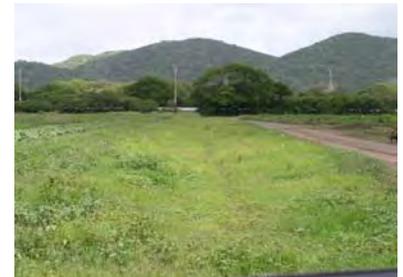
Grassed Waterway completed in Fraternidad Farm Guánica.
Photo by: L H Rosado, NRCS-CB.

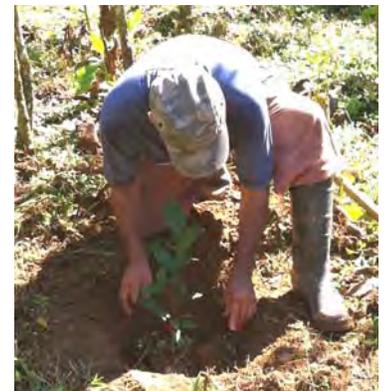
Farmer planting native shade trees on Río Loco coffee plantation.
Photo: M. Rodríguez, NRCS-CB.

- ◇ Since 2010, NRCS and the US Fish & Wildlife Service (FWS) have planted approximately 690 acres of native shade trees through 43 EQIP/WHIP contracts between Yauco, Maricao and Sabana Grande counties.
