**Supplemental Watershed Plan-Environmental Assessment
for the
Pohick Creek Watershed**

Supplement No. 4 to the original watershed plan for the rehabilitation
of Pohick Creek Watershed Dam No. 3 (Woodglen Lake)

Fairfax County, Virginia

June 2008

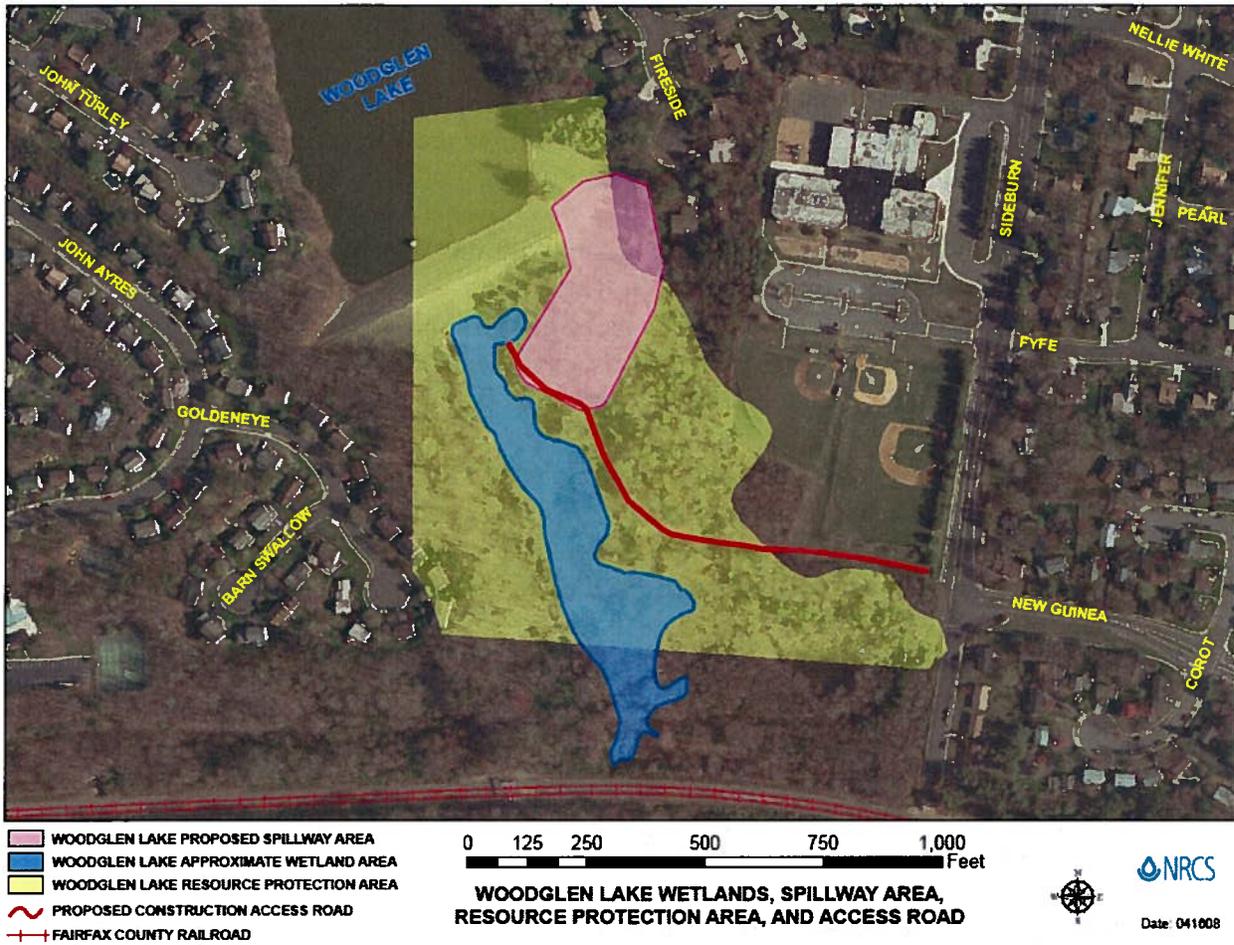
The map on page 47 depicts a section of the RPA which intersects with the proposed spillway area. In addition, the map shows the downstream wetlands and the location of the proposed access road for construction. The actual impacts to the forested areas, RPA, and wetlands, will be determined during final design of the project. Impacts to these important resources will be avoided, minimized or mitigated as required.

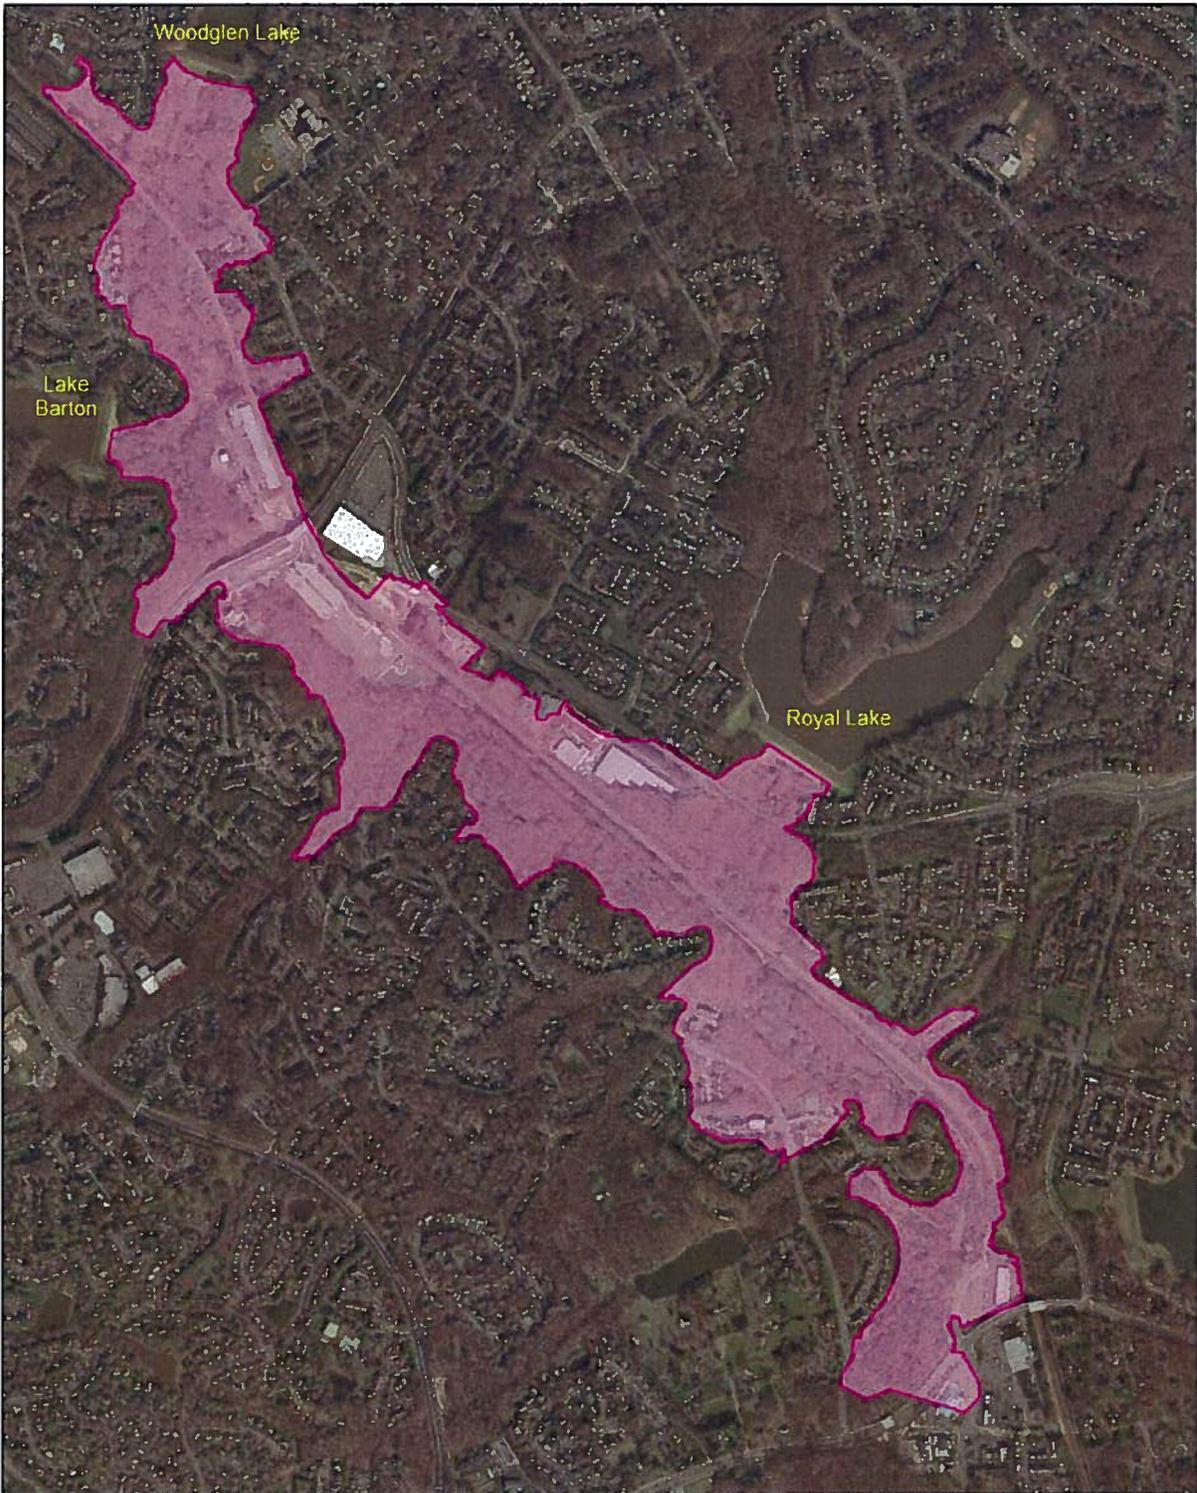
**WOODGLEN LAKE - POHICK CREEK 3
BREACH INUNDATION ZONE FROM
AMT - ENGINEERING ANALYSIS**

The maximum breach discharge of 54,283 cfs was computed using the criteria in Technical Release No. 60, Earth Dams and Reservoirs. The As-Built drawings dated December 1981 and the field surveyed data obtained for Lake Woodglen were used to determine the maximum height used in the breach discharge. The As-Built data was used for determining the depth of water (H) of 38.4 feet at failure.

The breach inundation zone analysis will be used by the Sponsors to update the Emergency Action Plan (EAP) that currently exists for the dam. The purpose of an EAP is to outline appropriate actions and to designate parties responsible for those actions in the event of a potential failure of the dam. The Sponsors will update the EAP annually with assistance from local emergency response officials. As resources allow, NRCS will provide technical assistance with updating the EAP. The NRCS State Conservationist will ensure that a current EAP is prepared prior to initiation of construction.
