**FINAL**  
**Supplemental Watershed Plan No. 6 & Environmental Assessment**  
**for the**  
**Rehabilitation of Floodwater Retarding Structure No. 10**  
**of the Upper North River Watershed**  
**Augusta County, Virginia**

**USDA Natural Resources Conservation Service**

**SEPTEMBER 2012**

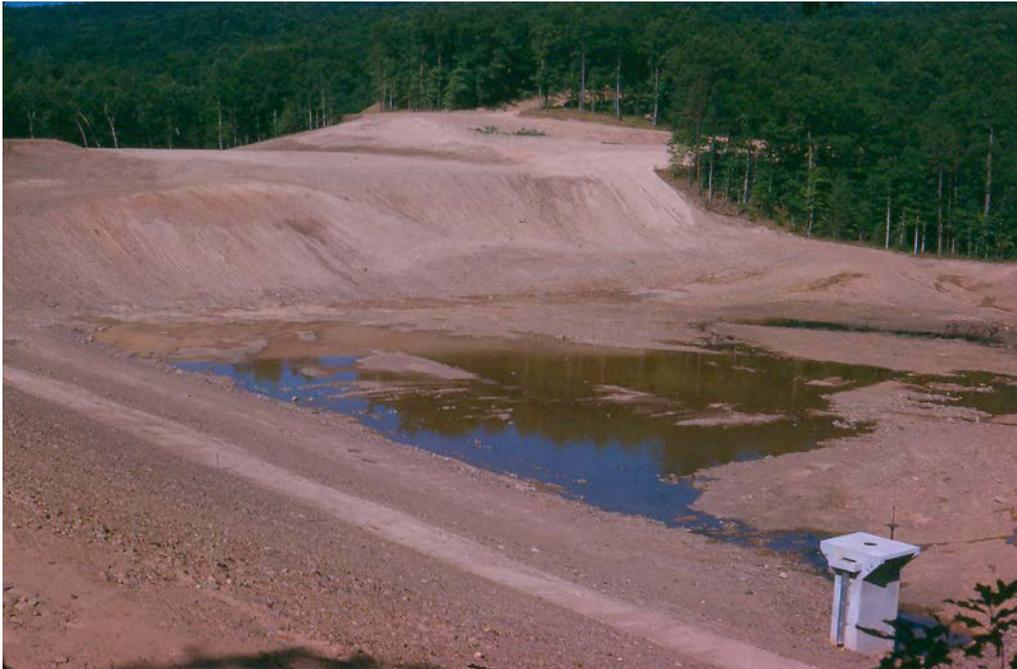
Figure 1. The Todd Lake dam, auxiliary spillway, and pool, post-construction, July 1963.

The dam embankment is comprised of two zones of earthfill. Zone 1, the “Core” material, is clayey gravel, silty gravel, and silty clay from the ridge pit borrow area and the auxiliary spillway excavation. Zone 2, the “Shell” material which covers the crest and downstream slope, is silty gravel from the permanent pool borrow area. The top of the embankment is 19 feet wide

with 2.5 horizontal to 1 vertical side slopes on the downstream slope. A 10-foot wide stability berm is located about midway down the slope. The upstream face of the dam has a 2.5:1 side slope from the top of the dam to the wave berm. The slope is 3:1 below the elevation of the wave berm. The wave berm is 10 feet wide and is located on the upstream slope at an elevation slightly higher than the principal spillway crest.

According to the As-Built drawings, the top of dam was constructed 65 feet above the downstream toe of the embankment with an allowance of 1.0 foot of settlement for a settled height of 64 feet. The 2008 field survey shows an average dam height of 64.3 feet above the downstream toe at a nominal elevation of 1939.3 (NAVD88). The crest of the dam extends approximately 987 feet from the right abutment (looking downstream) to the auxiliary spillway. Figure 2 shows a cross-section of a dam.

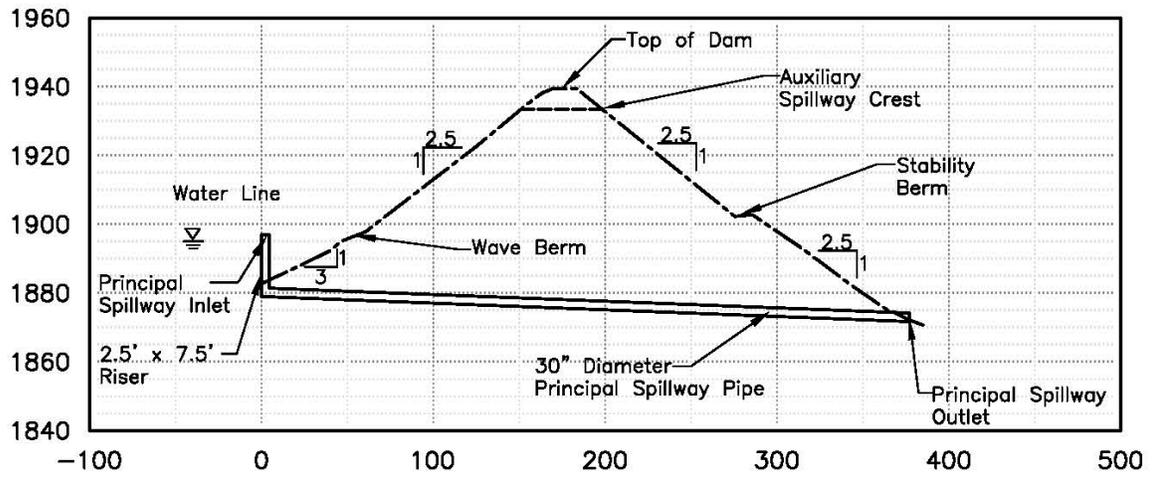
Figure 2. Cross-section of a dam.

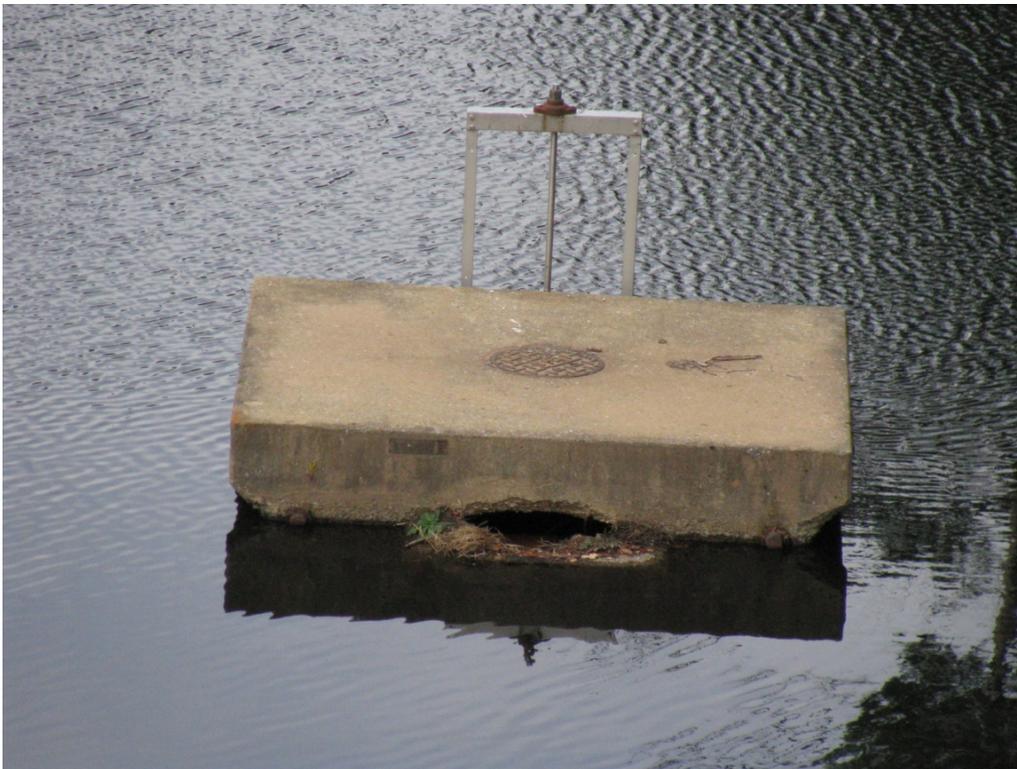
Figure 3. Principal spillway riser at Todd Lake (October 2010).

Principal Spillway: The principal spillway consists of a 388-foot long, 30-inch-diameter, reinforced concrete pipe with 13 concrete anti-seep collars; a 2.5x7.5 foot (interior dimensions), 19.2 foot high, NRCS standard closed-top reinforced concrete riser with a trash rack; and a plunge pool outlet. The riser controls the normal pool with a weir, 15 feet long, at the top of the riser. A coldwater release was installed to control the temperature of the water released from the structure and to allow for an extended period of release during low flow conditions. A 30-inch-diameter circular gate at the base of the riser, operated by crank, is provided for dewatering. The conduit discharges into a plunge pool. The outlet works, including the plunge pool and downstream channel, are in good condition. Although the principal spillway riser is functioning correctly, it has begun to show some age-related concrete deterioration (Figure 3).

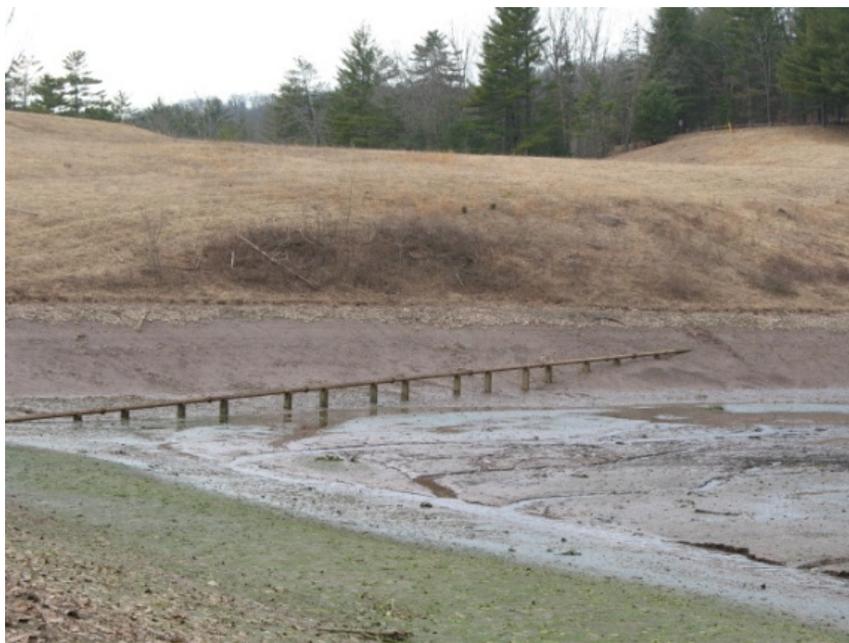
Figure 4. Sewer line observed when lake is drained.

Appurtenant Structures: A 6-inch cast iron sanitary sewer line runs through the dam embankment near the center of the dam. This part of the sewer line was installed at the time of construction at the request of the U.S. Forest Service to allow construction of sanitary facilities at the campground that was established after the dam was complete. The part of the sewer line shown in Figure 4 was installed by the U.S. Forest Service. The sewer line drains into a septic system and drain field below the dam. This will be camera-surveyed at the time of the principal spillway survey.

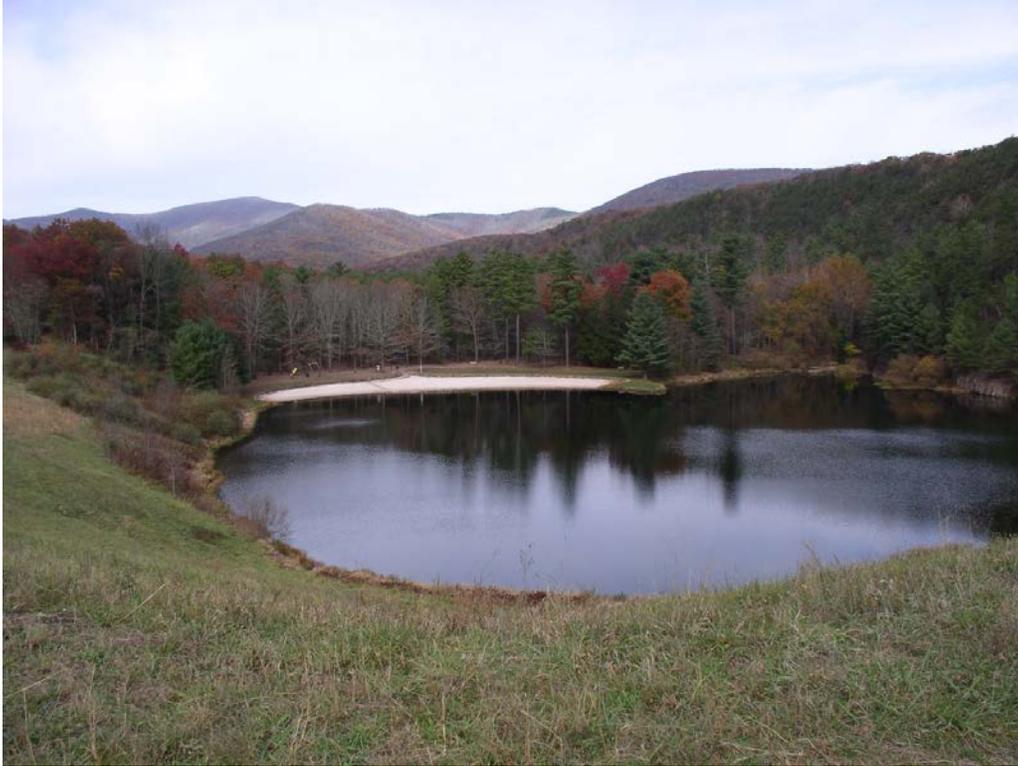
Figure 5. Beach in front of campground.

In 1977, the U.S. Forest Service increased the size of the swimming area by placing a rock embankment in the permanent pool area and backfilling the area with approximately two acre-feet of sand (Figure 5). This was done to establish a constant water depth of four feet.

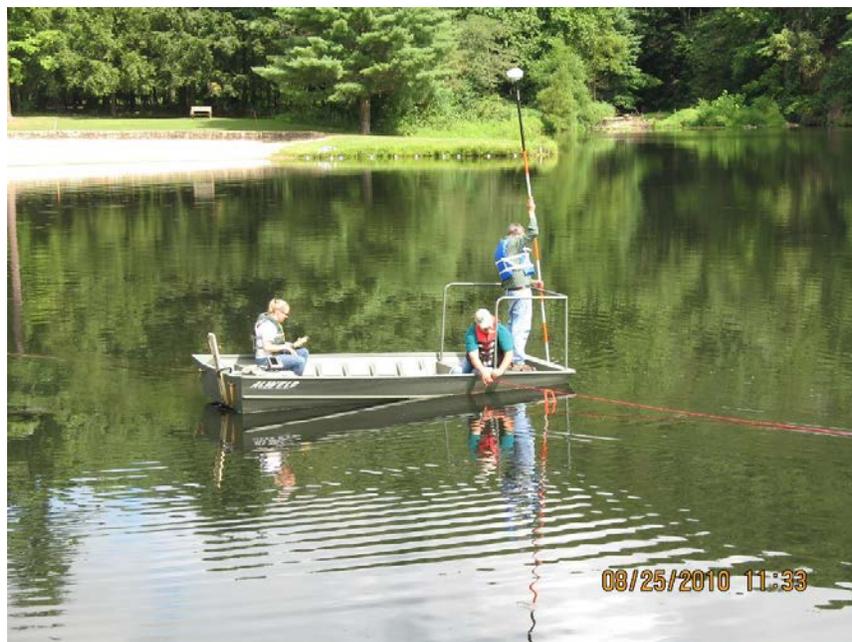
Figure 6. Sediment survey, in progress.

There were 15 acre-feet of aerated sediment storage planned. Aerated sediment is sediment that is deposited above the normal pool during high flows. The designed deposition rate for the aerated sediment was 0.3 acre-feet per year. The estimated volume of aerated sediment in the pool in 2010 was 1.0 acre-feet. The available aerated sediment storage capacity is 14.0 acre-feet. Based upon the historic accumulation rate of 0.02 acre-feet per year, there is more than adequate room for 50 more years of aerated sediment deposition.

The measured sediment accumulation is much lower than what was originally estimated for Todd Lake during the planning process. There are two possible reasons for this difference. First, the sediment accumulation rate calculated during the design of the structure was too conservative and required a sediment pool much larger than needed. Second, the U.S. Forest Service drains Todd Lake approximately every other winter (Figure 7). Each time the lake is drained, the stream (Skidmore Fork) re-establishes a channel through the collected sediment in the pool. (See Figure B3 in Appendix B.) That action probably flushes some volume of sediment from the pool but there have been no complaints of excess sediment in the stream channel downstream. These two factors have no adverse effect on the function of the dam.

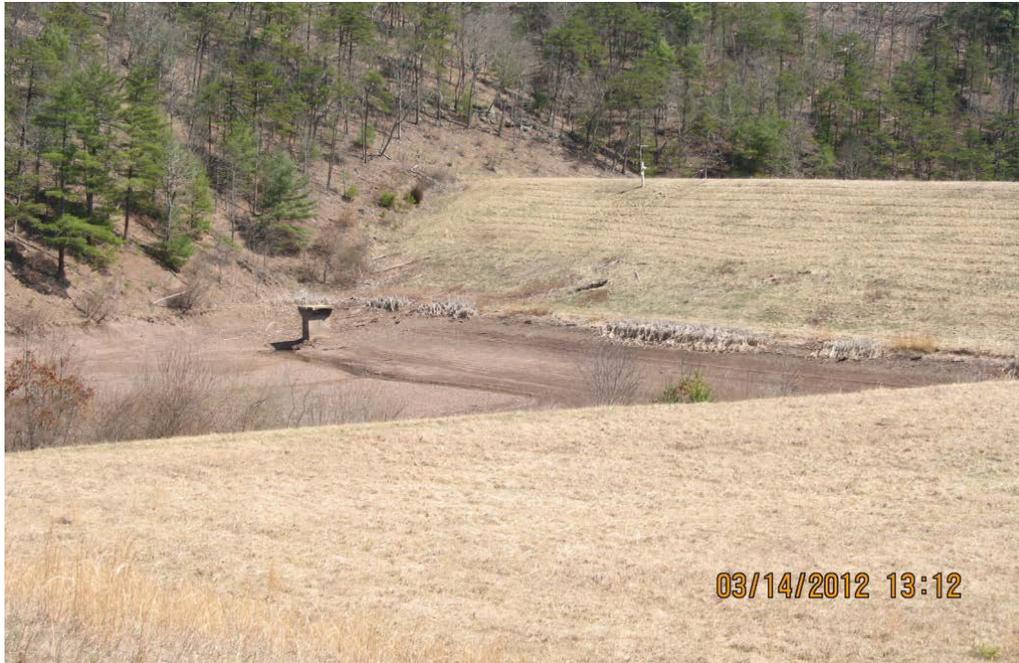
Figure 7. Todd Lake, drained in the winter of 2012.

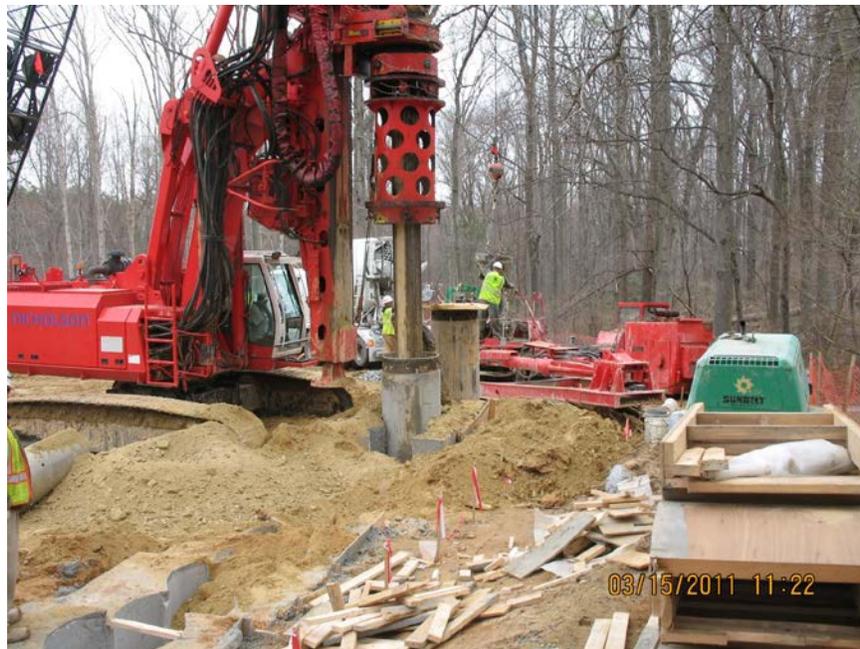
Figure 8. Installation of secant pile wall.

The control section and outlet section would be armored by installation of Articulated Concrete Blocks (ACBs) to attain the needed measure of stability against surface erosion. The ACBs are individually constructed concrete blocks that are cabled together to form a continuous erosion-

resistant mattress. The proposed blocks are “open cell” which provides about 20% open space within and around the block. Geotextile fabric and six inches of gravel would be placed on the prepared subgrade to provide permeability and filtration while providing soil retention. The ACB mattress would then be set over the geotextile fabric (Figure 9). Six inches of topsoil placed in and around the blocks would allow more extensive vegetation of the site and would conceal the armoring and the top of the secant pile wall. The auxiliary spillway would look very similar to the way it does now. The ACBs are manufactured offsite and trucked in for installation which reduces the amount of space needed for a staging area. The cost of the secant pile wall and the ACB armor includes the cost of design by a consultant and the cost of replacement of the principal spillway riser. During the PMF event, the ACBs and underlying soils in the outlet section would be lost due to headcutting. Approximately 10,000 square feet of ACBs and 15,000 cubic yards of soil material would have to be replaced to return the site to the as-built condition. The estimated cost of these repairs is \$450,000.

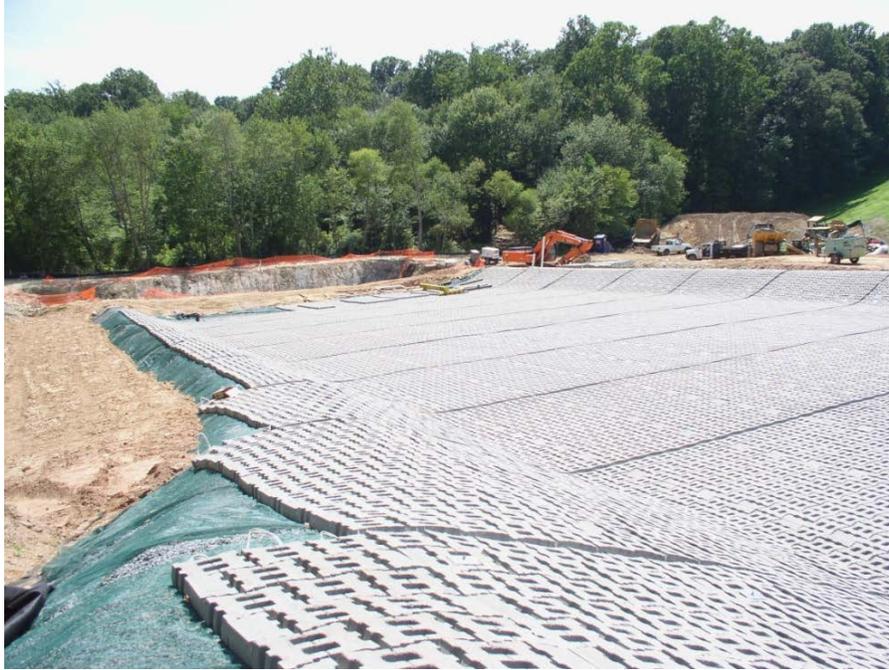
Figure 9. Installation of ACBs.

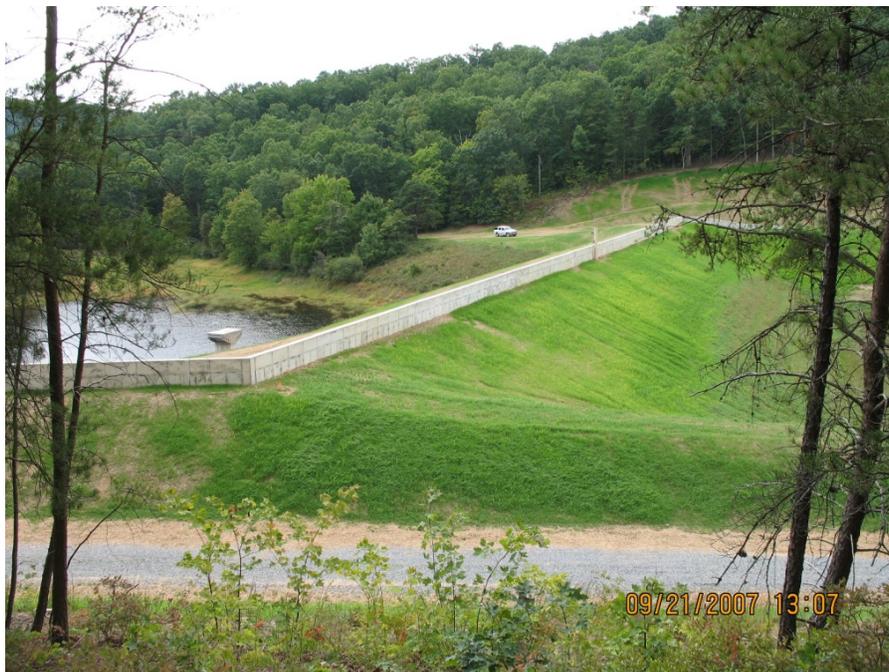
Figure 10. Parapet wall on top of a dam.

*Alternative 1A: Structural Rehabilitation with Federal Assistance – Secant Pile Wall, ACB Armor, Raise Top of Dam by 5.5 Feet with a Concrete Parapet Wall:* To achieve the needed capacity in the auxiliary spillway, the dam would be raised 5.5 feet by installation of a concrete parapet wall. A parapet wall is a “T” shaped piece of concrete that is embedded into the top of the dam (Figure 10). The part that would be seen would be one foot wide and 960 feet long. Annual maintenance of a parapet wall is more expensive than for an earthen structure since the area around the wall must be mowed by hand and there is greater potential for vandalism due to proximity to the campground. The annual maintenance cost is estimated to be \$2,000. The estimated cost of raising the dam is \$1,527,000. The total construction cost of this alternative would be \$4,885,000 and includes the cost of replacing the principal spillway riser. The total project cost would be \$5,419,000.

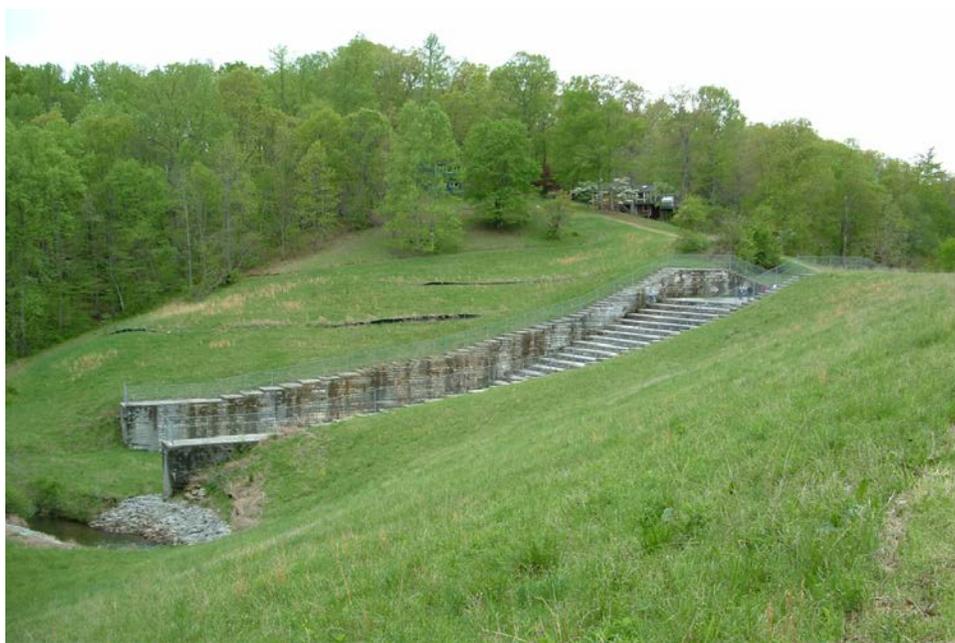
Figure 11. The RCC auxiliary spillway at White Oak dam, Madison County.

Roller-Compacted Concrete is a non-reinforced concrete that is durable and easy to install. However, RCC has a very limited window of installation time. Each batch of concrete must be placed within a time window of less than an hour. This would necessitate installation of a portable concrete mixing plant on site.

Maintenance of an RCC structure would be more complicated than that for an earthen structure because of the need to hand-mow the area adjacent to the concrete. Also, there may be some potential for vandalism due to the proximity to the campground. However, the structure should have little or no damage during passage of the PMF event. The annual maintenance cost is estimated to be \$750. The estimated cost of this alternative is \$7,350,000 and includes the cost of replacing the principal spillway riser.

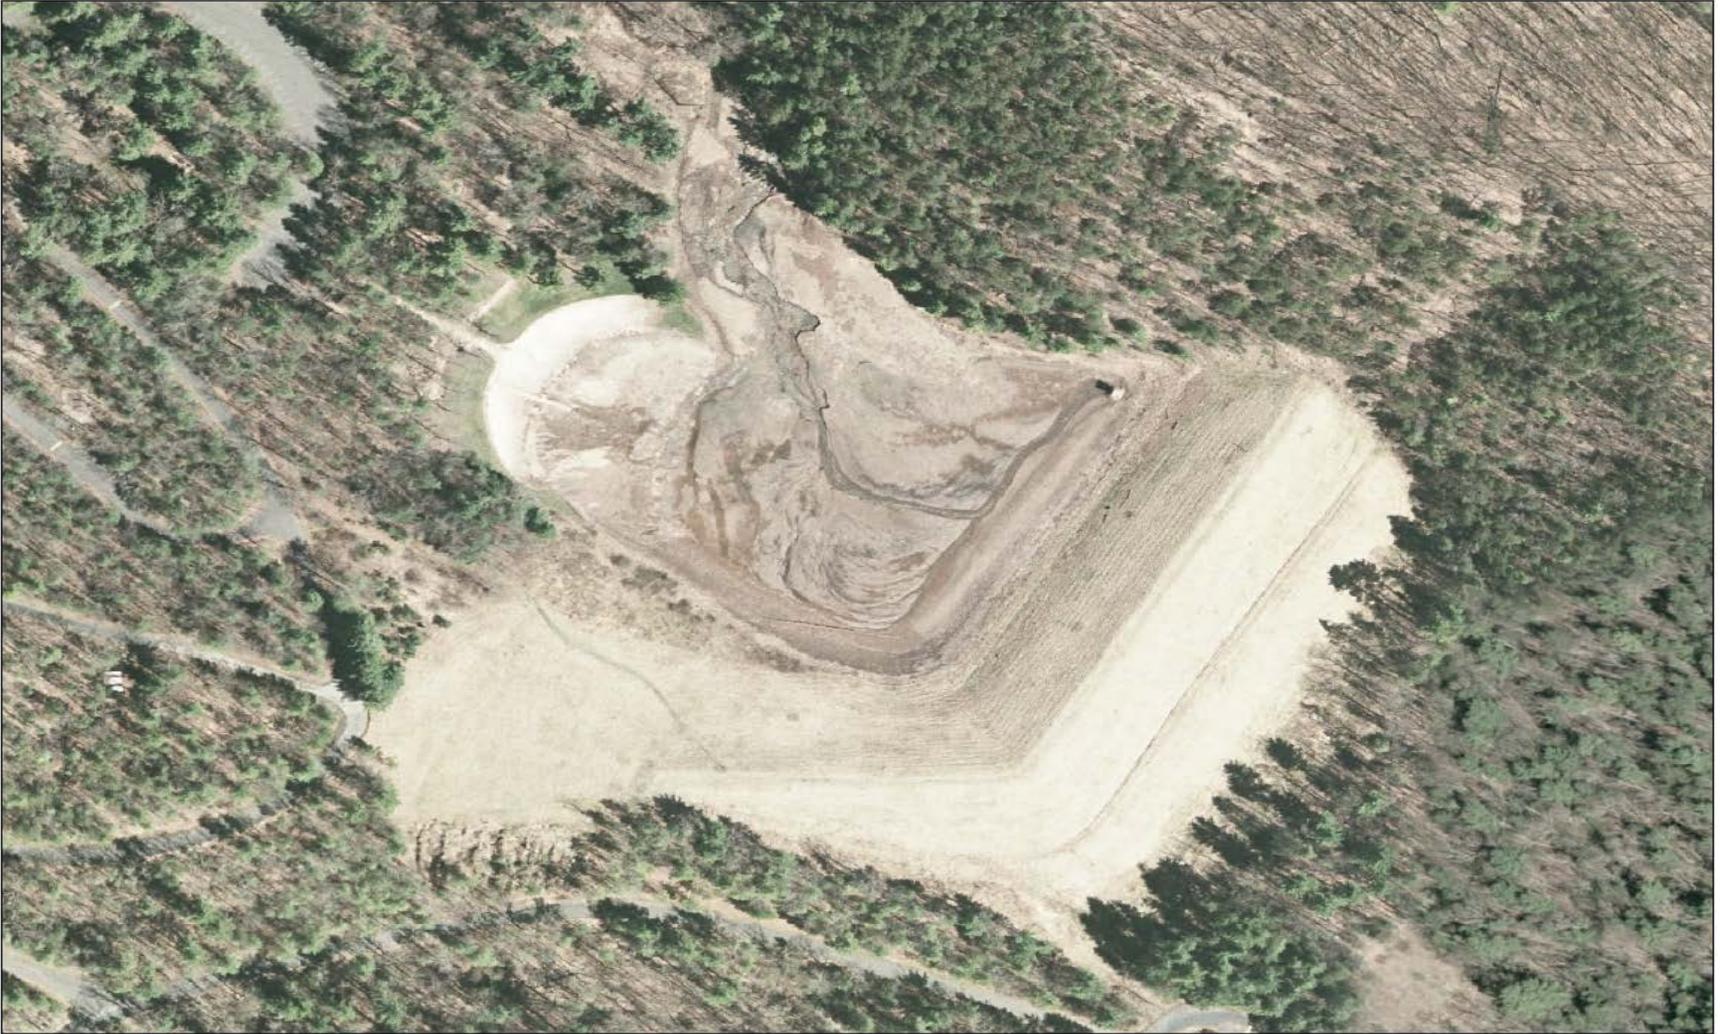
Figure B3. Aerial view of lake, drained.

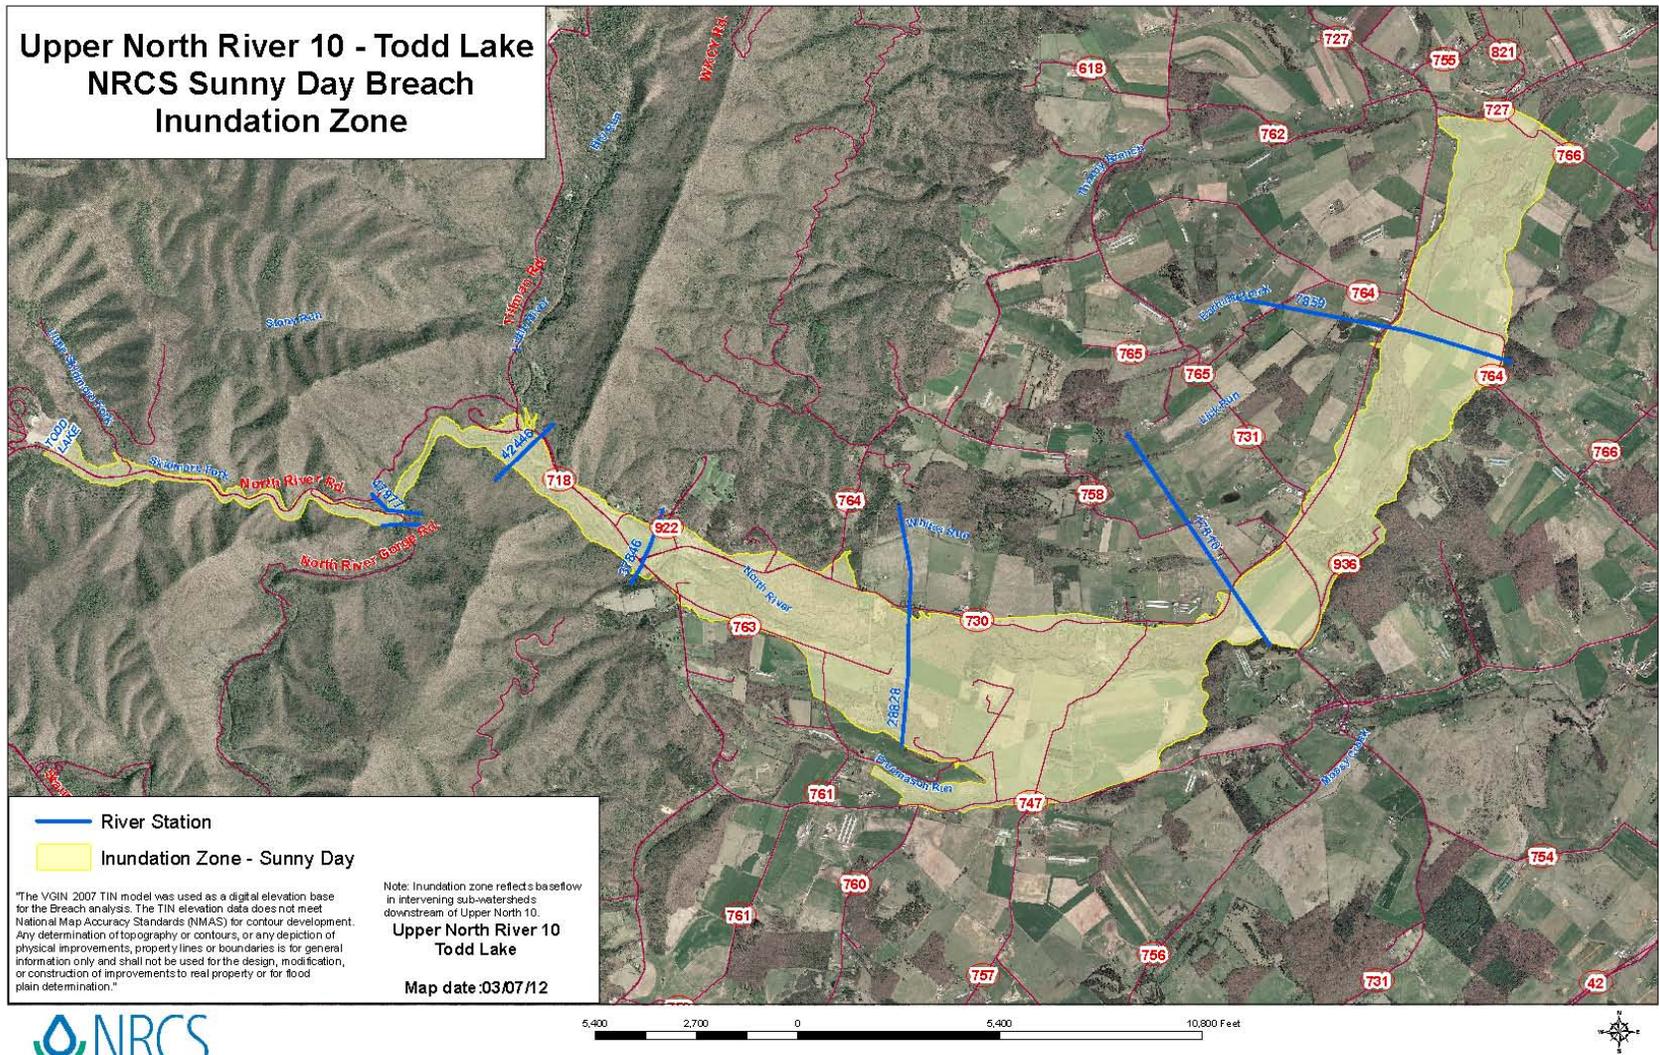
**Figure C1. Sunny Day Breach Inundation Map.**

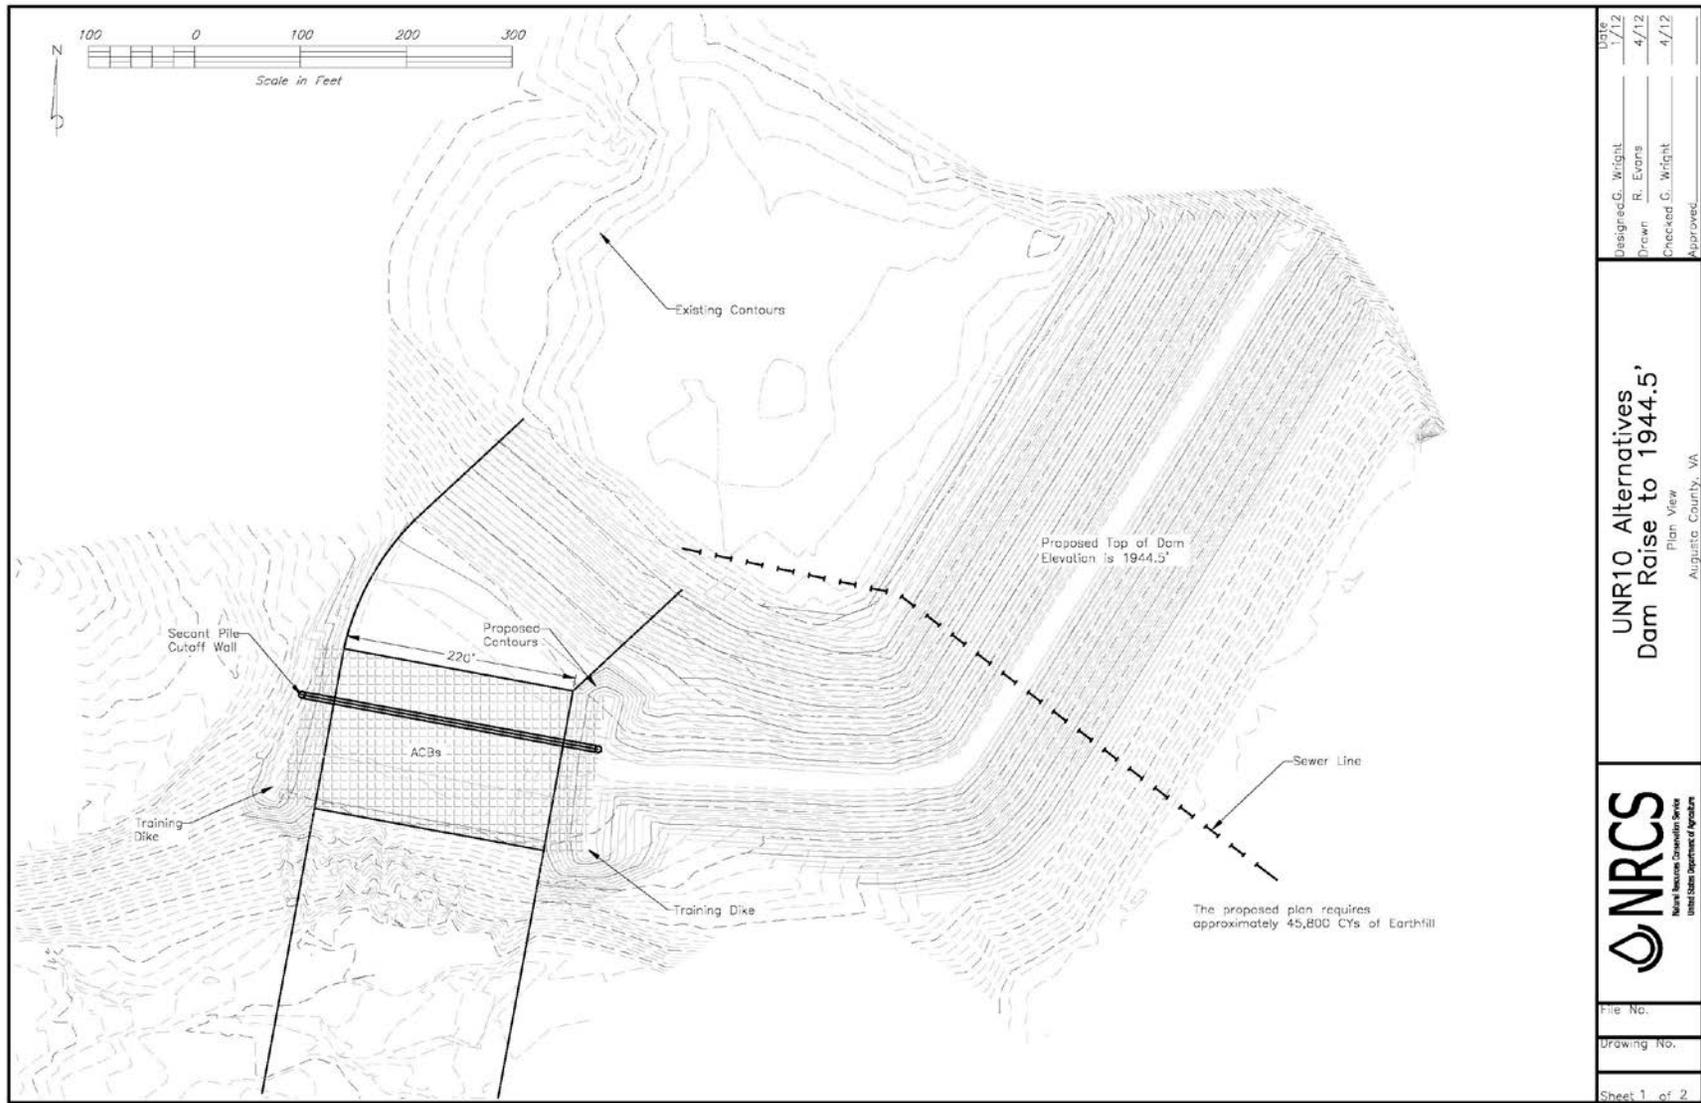
Figure D1. Plan view of site with a secant pile wall, ACB armor, and earthfill for the dam raise (Preferred Alternative).

**Description of Preferred Alternative:** The plan provides for widening the auxiliary spillway by 20 feet and lengthening the control section. A secant pile wall will be installed at the downstream end of the control section. Articulated Concrete Blocks will be used to armor the auxiliary spillway from the upstream end of the control section to the end of the constructed outlet. Upstream and downstream training dikes will be installed. The dam embankment will be raised by 5.5 feet with earthfill. The principal spillway riser will be replaced. There will be no change in the current levels of flood protection downstream as a result of project activity.

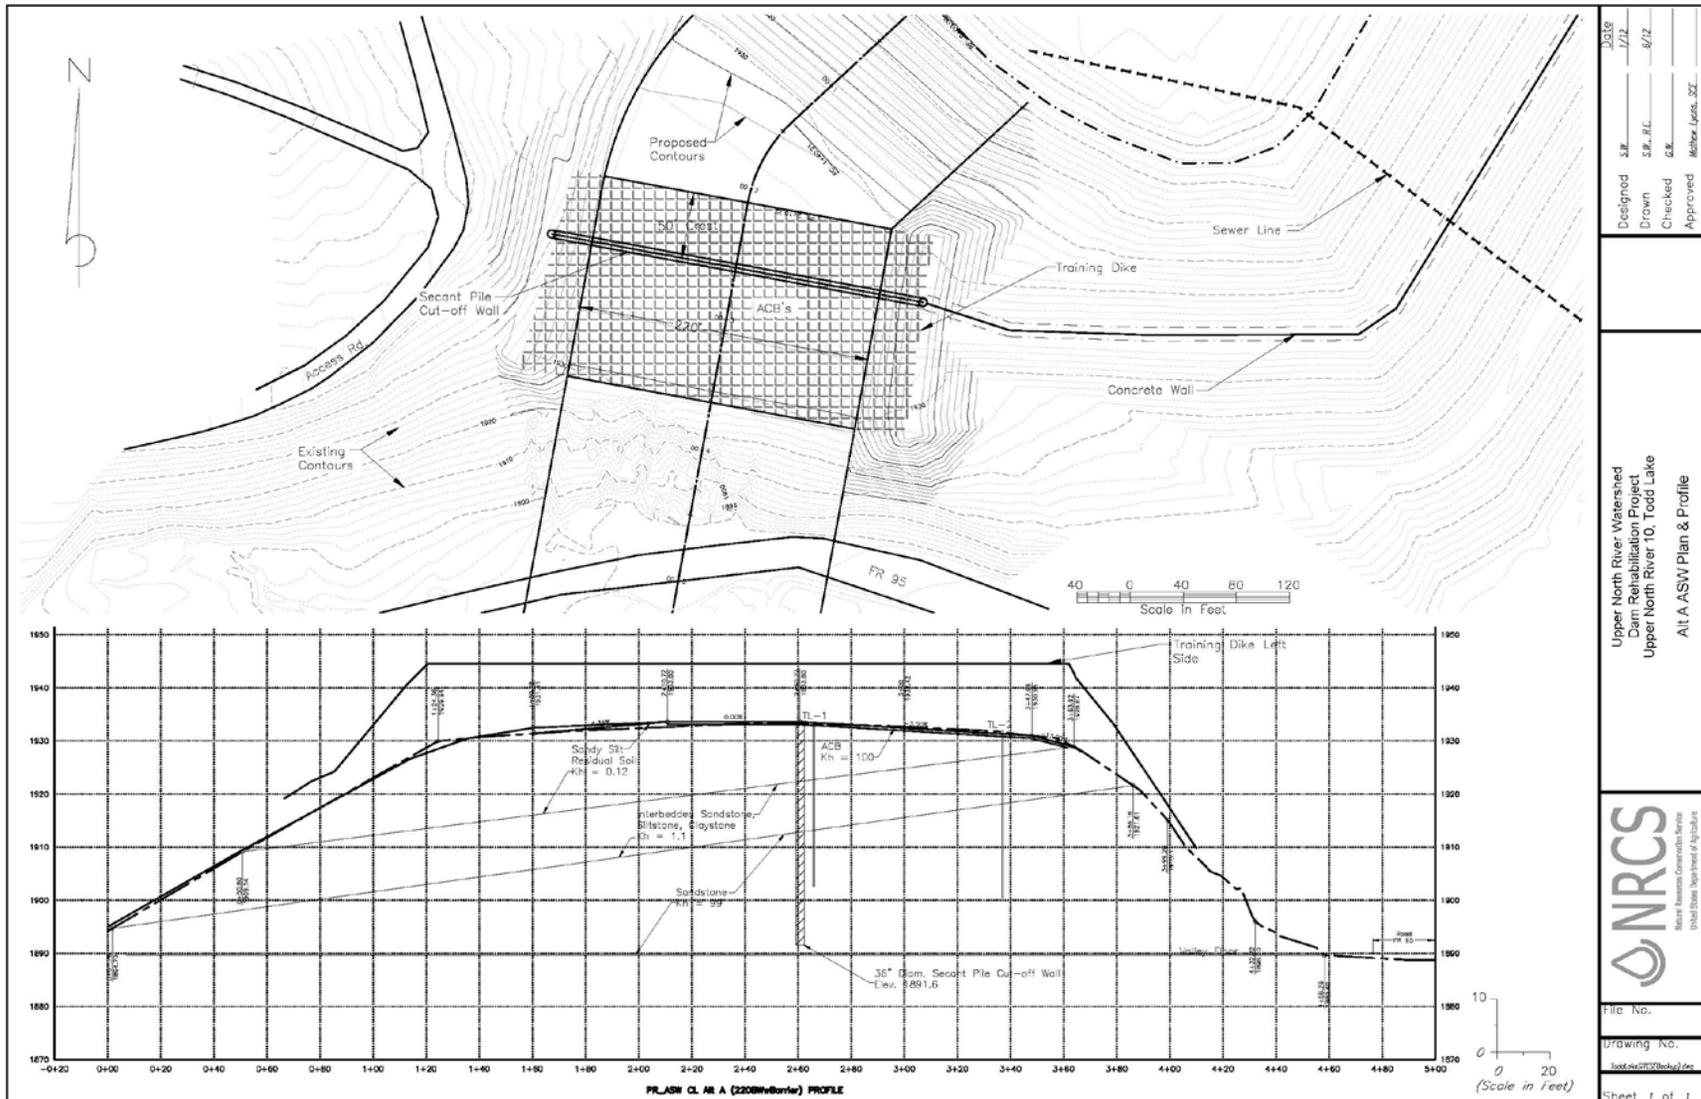
Upper North River Watershed  
 Dam Rehabilitation Project  
 Upper North River 10, Todd Lake  
 Alt A ASW Plan & Profile

Figure D2. Plan view of site with a secant pile wall, ACB armor, and a parapet wall for the dam raise.

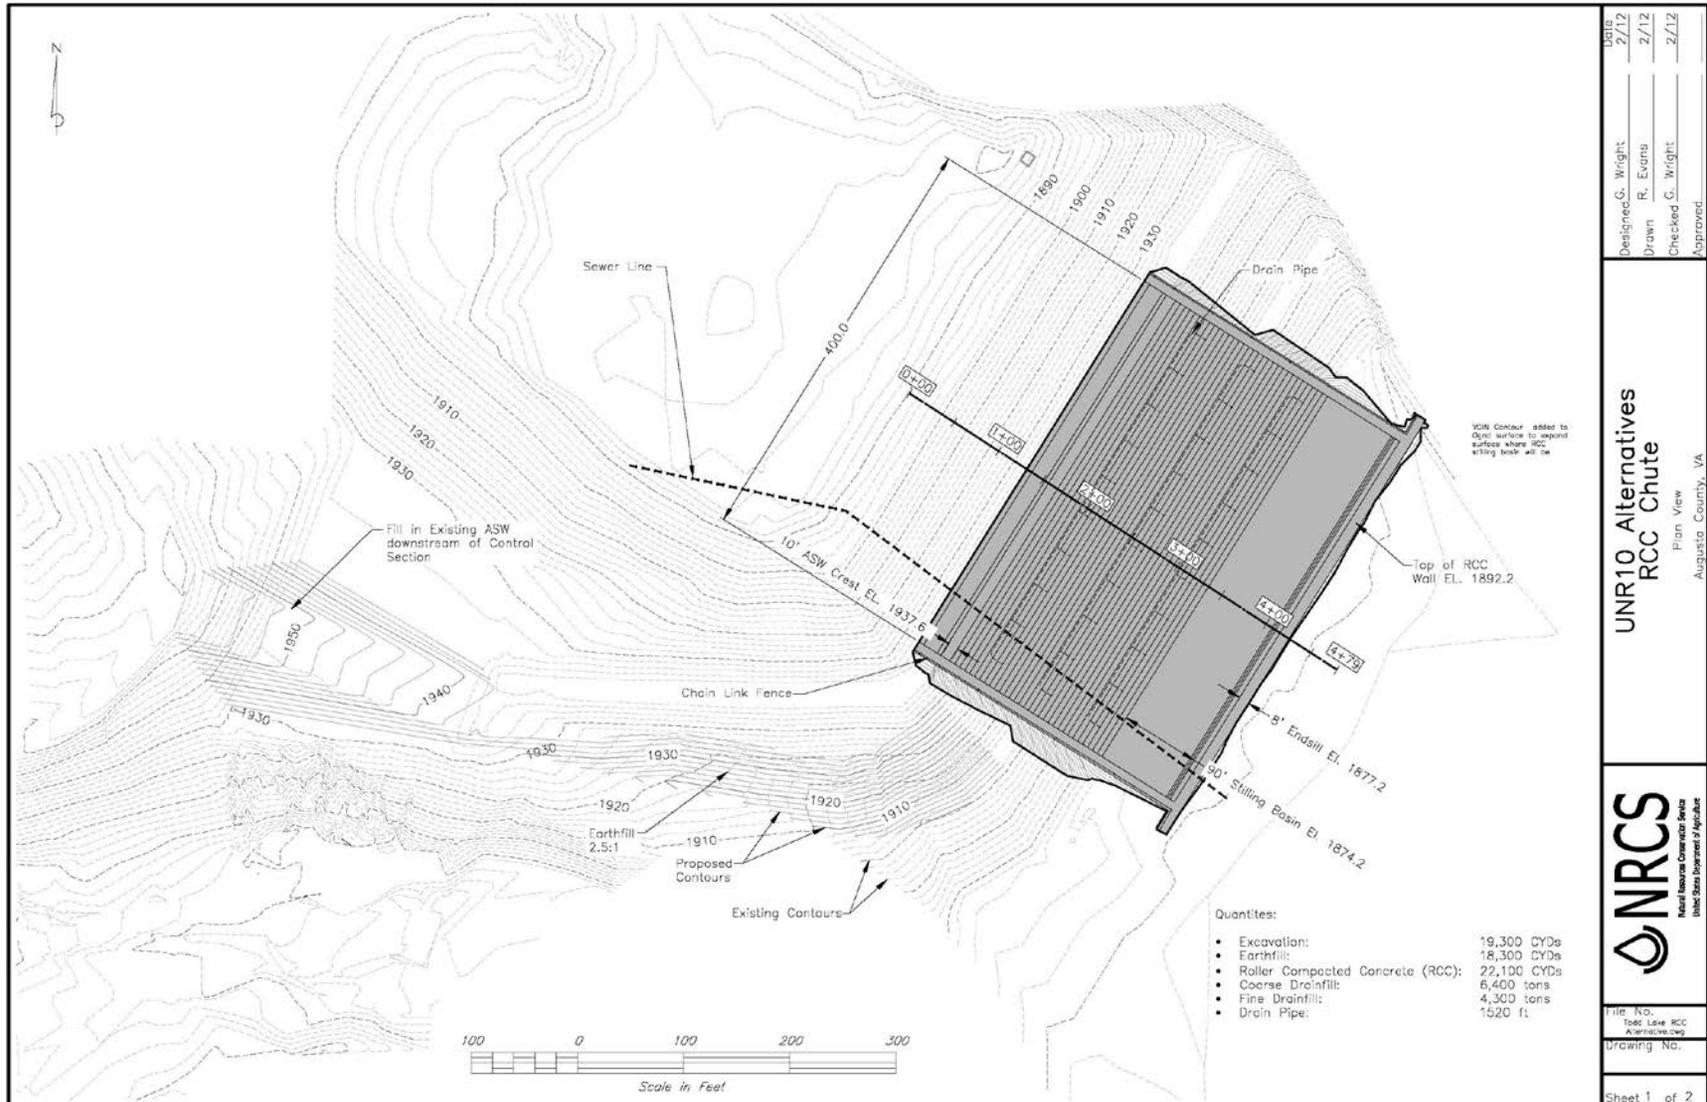
Figure D3. Plan view of site with a Roller-Compacted Concrete Chute auxiliary spillway.

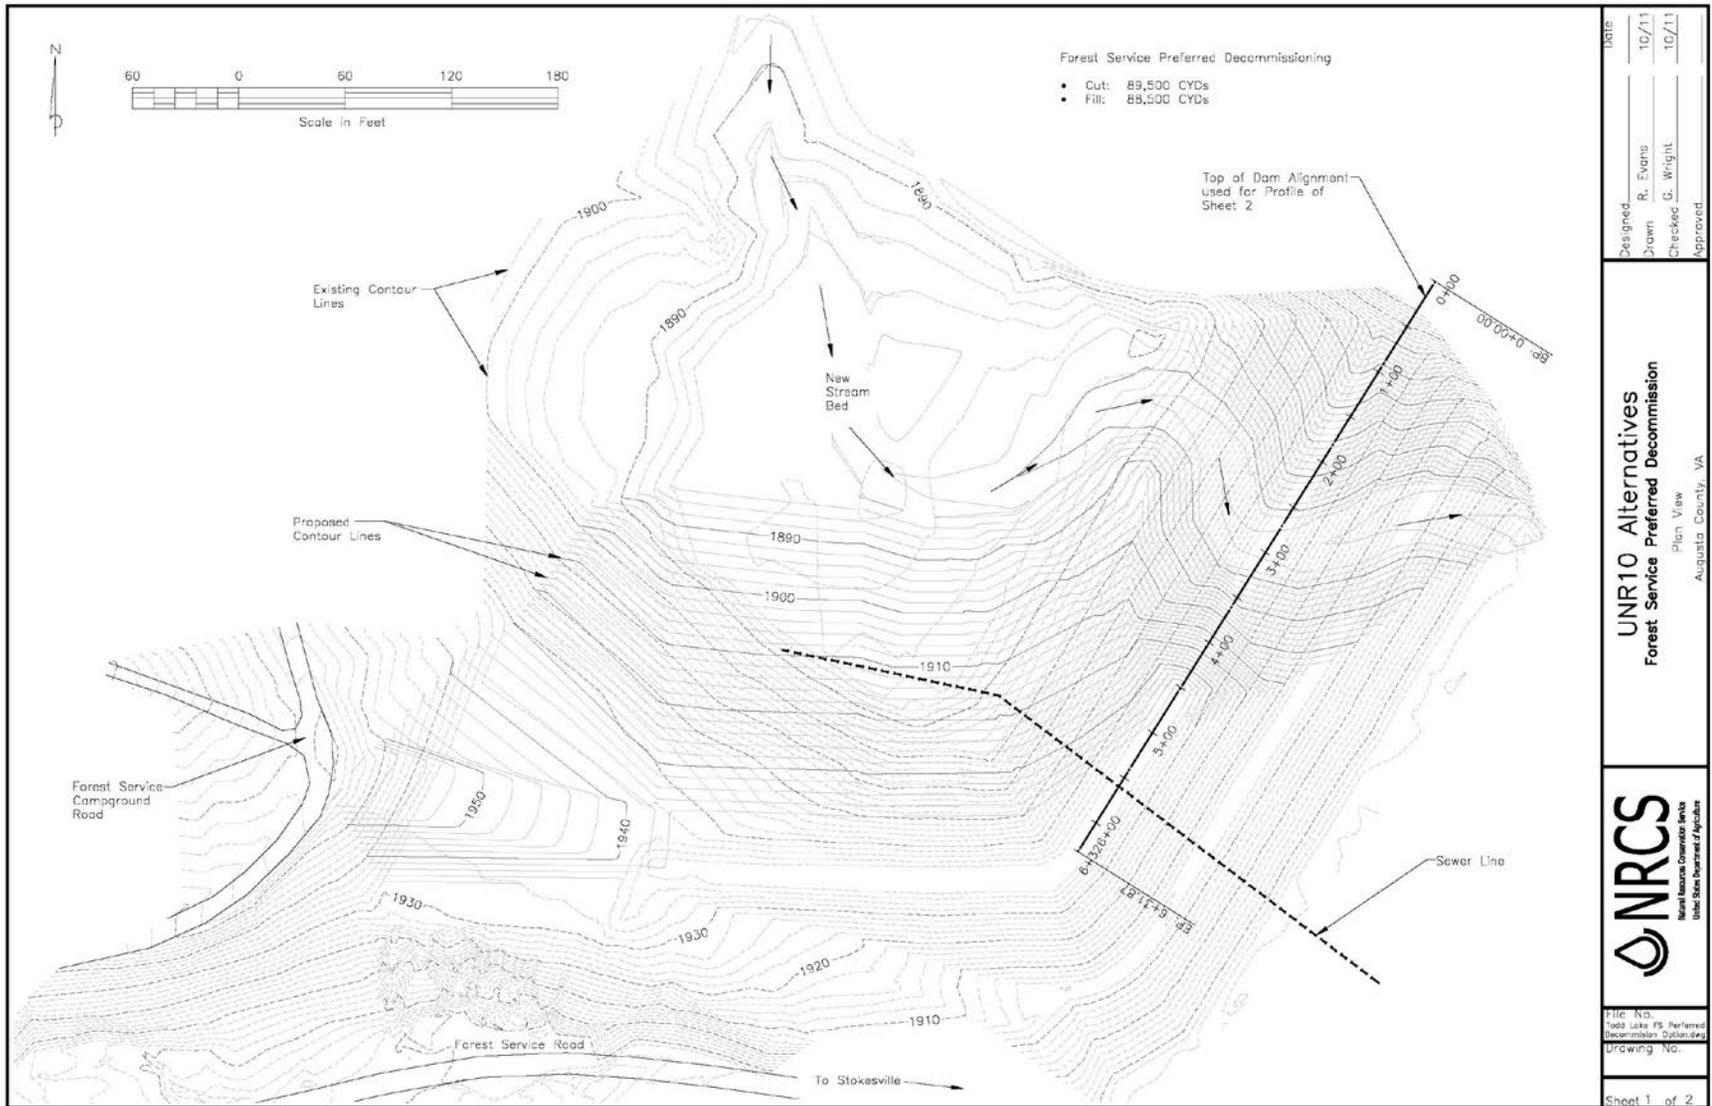
Figure D4. Plan view of site with partial decommissioning of the embankment.
