**FINAL
Supplemental Watershed Plan-Environmental Assessment
for the
Pohick Creek Watershed**

Supplement No. 3 to the original watershed plan for the rehabilitation
of Pohick Creek Watershed Dam No. 4 (Royal Lake)

Fairfax County, Virginia

September 2006

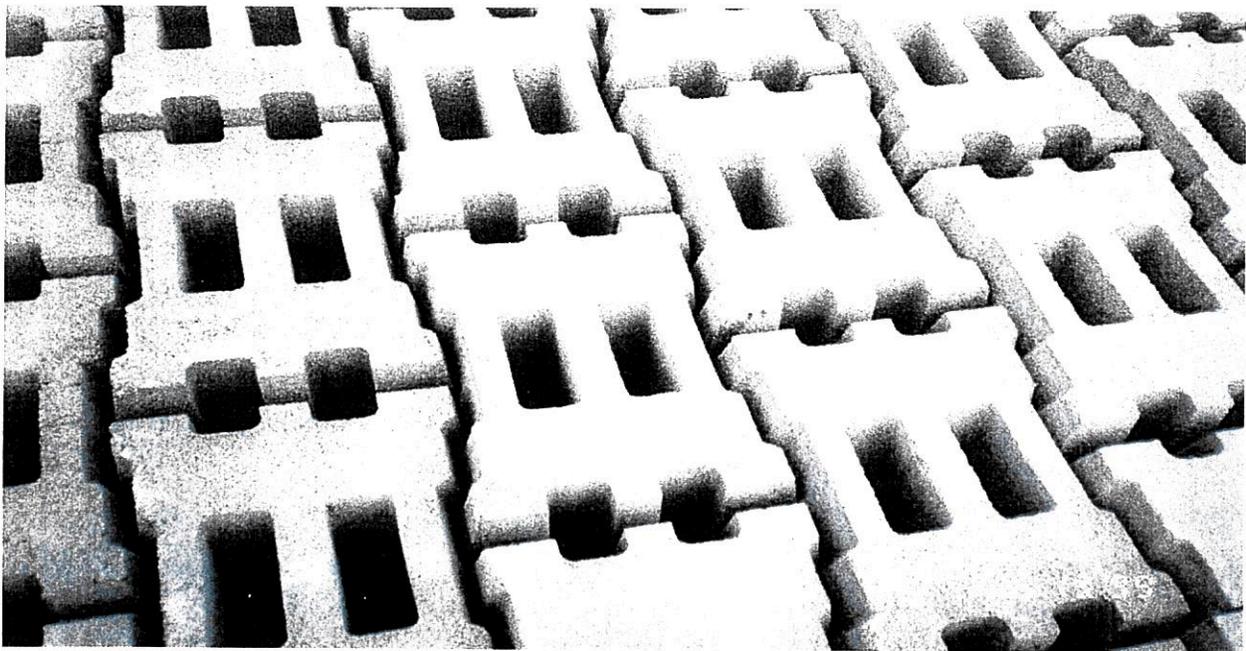
Figure 2 - Open-Cell Articulated Concrete Blocks

Design and installation of Articulated Concrete Blocks would cost about \$3,059,000. This includes the realignment of the spillway and building the training dikes.

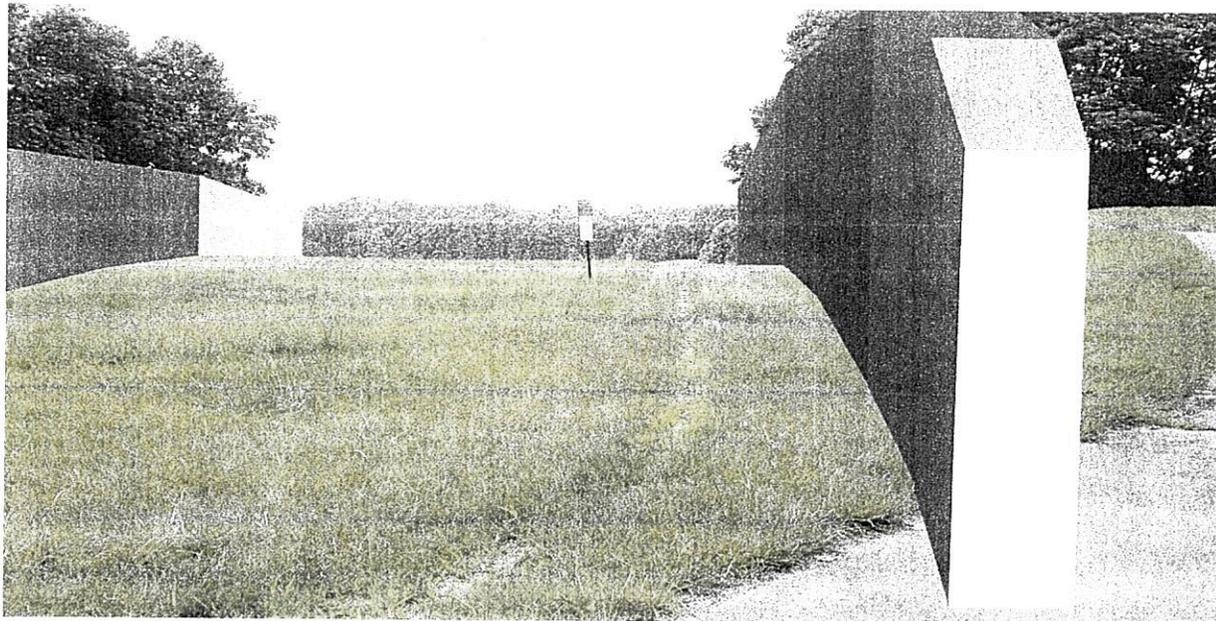
Figure 5 – Projected Appearance of a Concrete Training Dike

Option 2: The training dikes could also be made with a vertical concrete wall. This wall would be about one foot wide and would take up very little space along the spillway. However, it is visually unappealing, would be difficult to keep people off of, and would be vulnerable to vandalism by graffiti. The Royal Lake Task Force determined that this option was undesirable. See Figure 5.

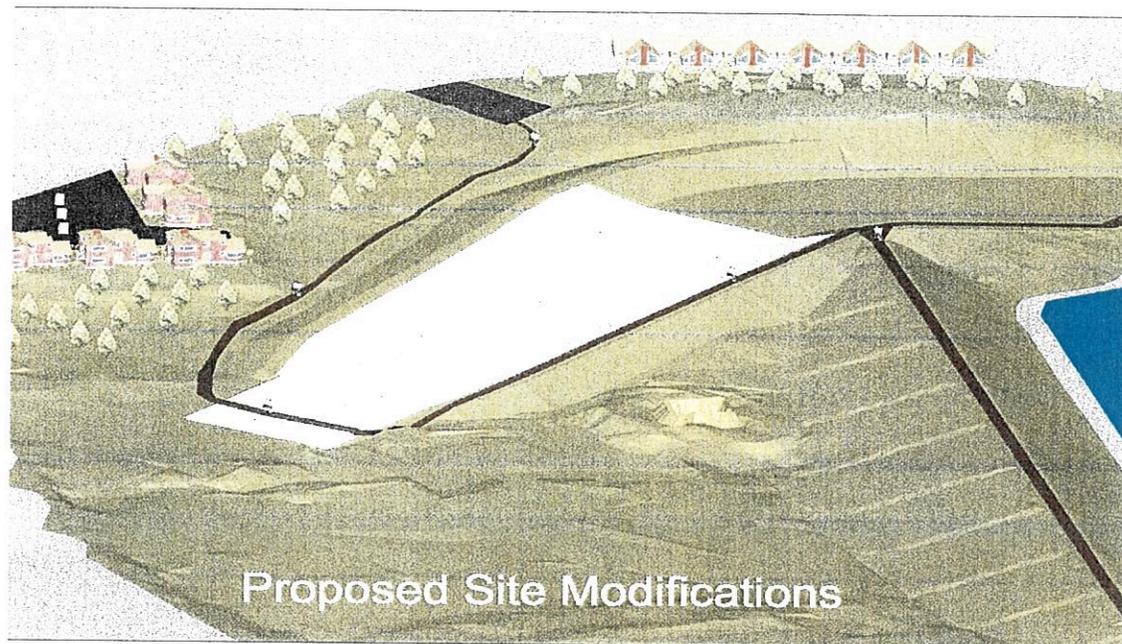
Figure 8 - Perspective View of Recommended Alternative. The ACBs are shown as they will appear before the topsoil is installed and seeded. Once the site is vegetated, the ACBs will not be seen at all.

The potential solutions were evaluated for cost and engineering feasibility. This information was presented to the Sponsors at meetings on May 24, 2006 and June 7, 2006 and to the public at a meeting on June 20, 2006. The selected alternative for Royal Lake is to realign the auxiliary spillway, install earthen training dikes to control the flow direction of the water, and armor the spillway and interior slopes of the training dikes with ACBs. The design and construction cost for this solution would be \$3,059,000. Figure 6 shows the existing alignment of the auxiliary spillway. Figures 7 and 8 show two different views of the recommended alternative.

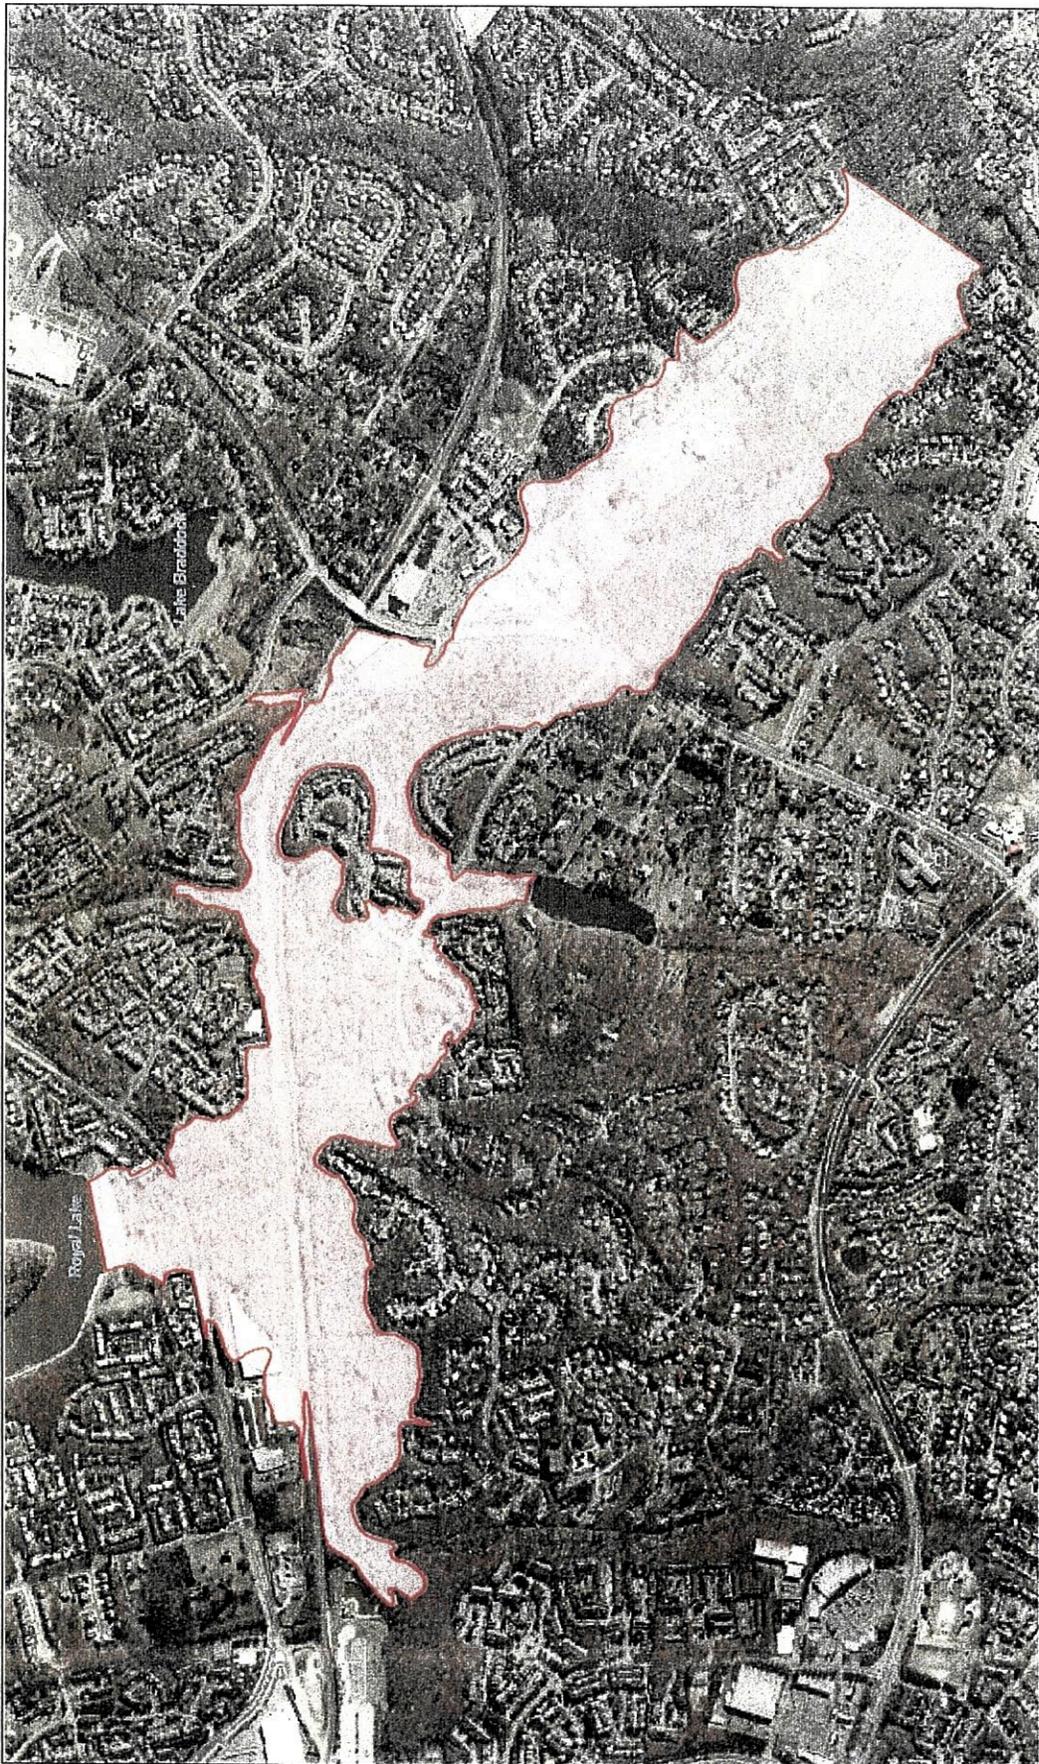
ROYAL LAKE BREACH INUNDATION ZONE

WATER SURFACE ELEVATION DATA

The breach inundation zone analysis will be used by the Sponsors to update the Emergency Action Plan (EAP) that currently exists for the dam. The purpose of an EAP is to outline appropriate actions and to designate parties responsible for those actions in the event of a potential failure of the dam. The Sponsors will update the EAP annually with assistance from local emergency response officials. As resources allow, NRCS will provide technical assistance with updating the EAP. The NRCS State Conservationist is to ensure that a current EAP is prepared prior to initiation of construction.
